120" Shane Primary Cleaning David Hilyard and Brian DuPraw

12/9/11

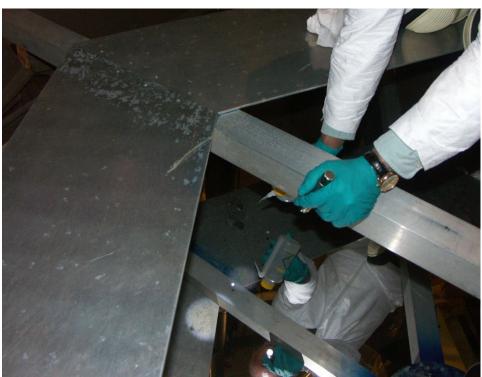
The surface of the mirror was hazy, overall, as shown in the photo below (easiest to see in the smaller of the two light spots from the flashlight). The larger spot is the reflection of the flashlight on the bottom of the scaffold.

Hazy surface in field area of primary mirror

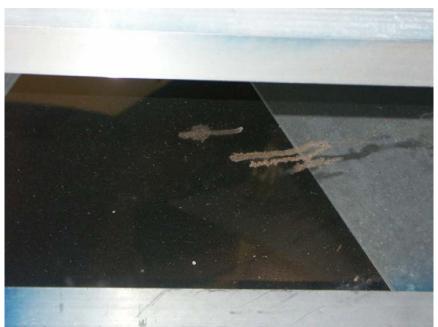
There were fewer oil spots on it than there had been the last time we cleaned the mirror. We removed the oil spots with ethanol and then acetone as necessary. We squirted ethanol on each spot and then lifted off the bulk of the oil with the Kaydry, not wiping but just lifting it off. What oil was left we dabbed with more ethanol and then acetone.

Worst of the oil spots on this trip

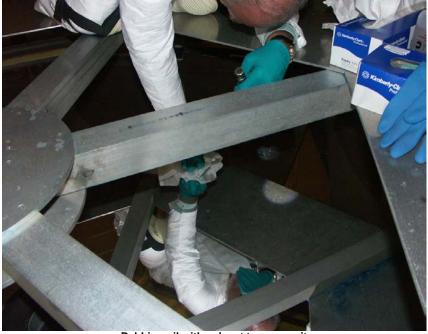
Dabbing oil with solvent to remove it

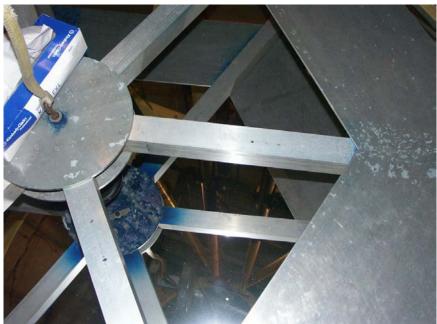
After blotting up the water we were left with a much cleaner surface, as the representative picture below shows.

Shiny surface restored
