Re-Coating 120" Mirror February 13 – 16, 2006

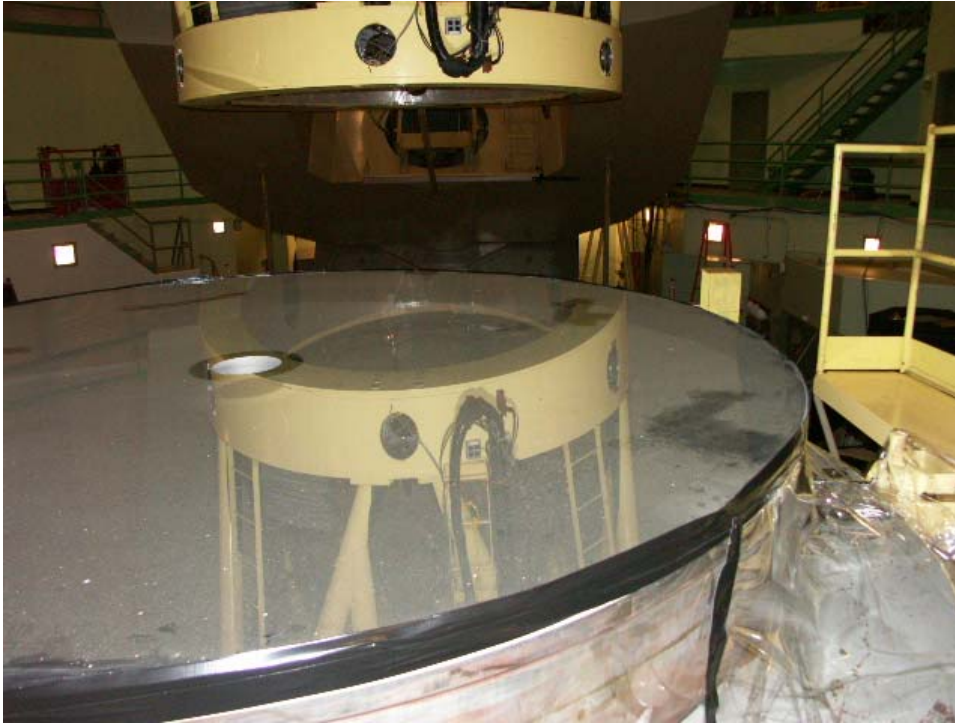
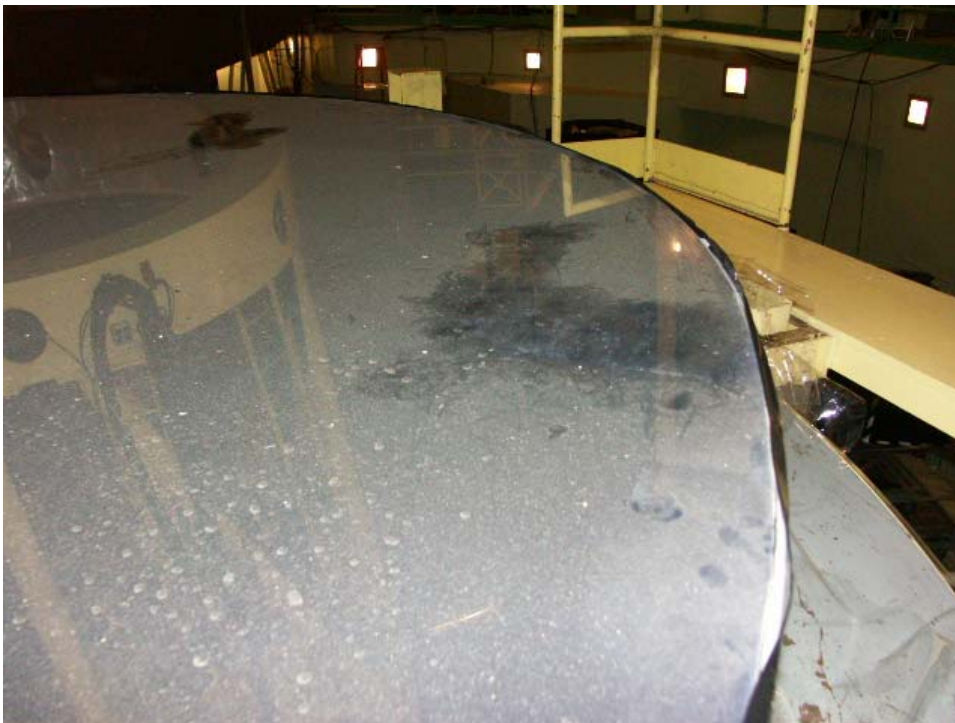
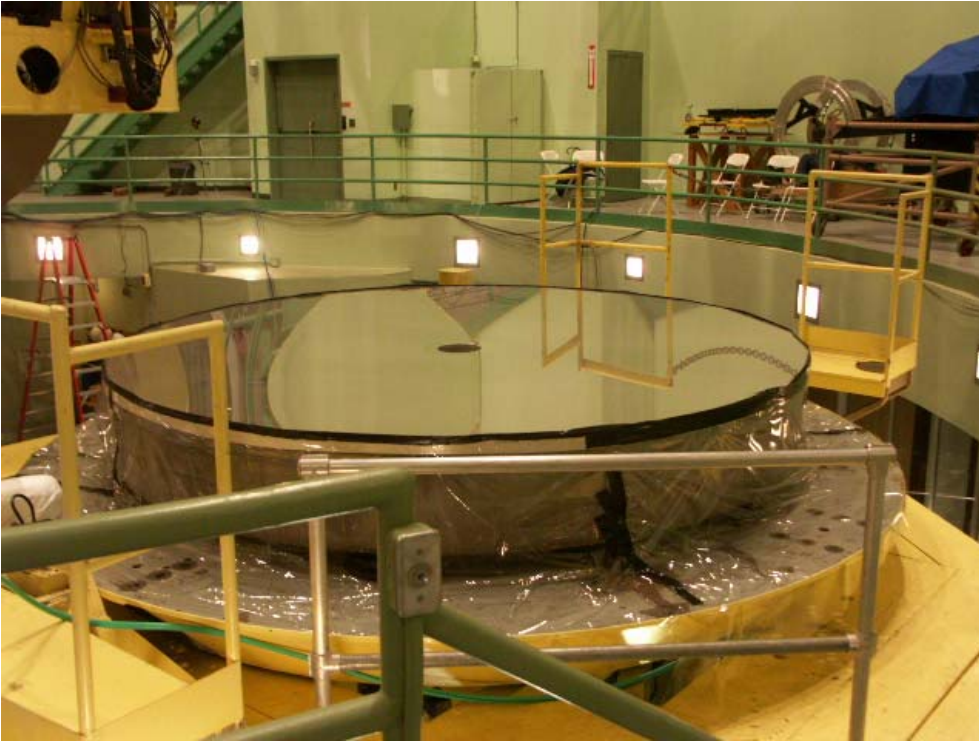
On top of the vinyl we made a ½" dam around the circumference by folding a piece of 2" duct tape over on itself and sticking the unfolded portion down on the vinyl. The result was designed to keep the fluids on the mirror, flowing into the central hole, and not off the edges and onto surfaces and people below. The central hole was connected to a drain line that was held in place by an inflatable tube (not shown)...it drained to the darkroom sink. For future re-coats we recommend a pre-formed dam, possibly of plastic.

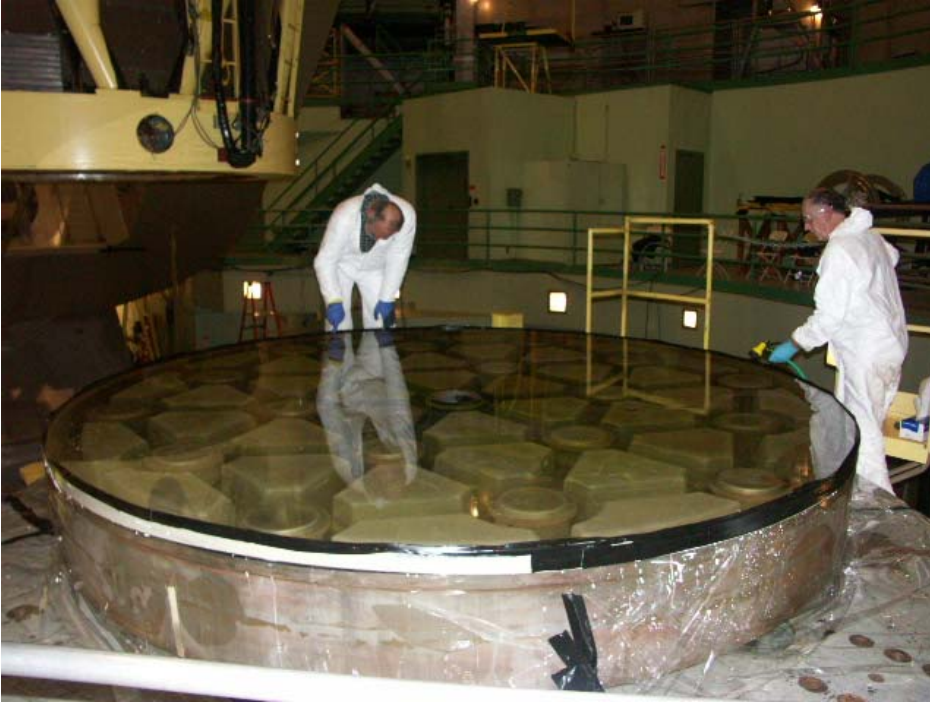
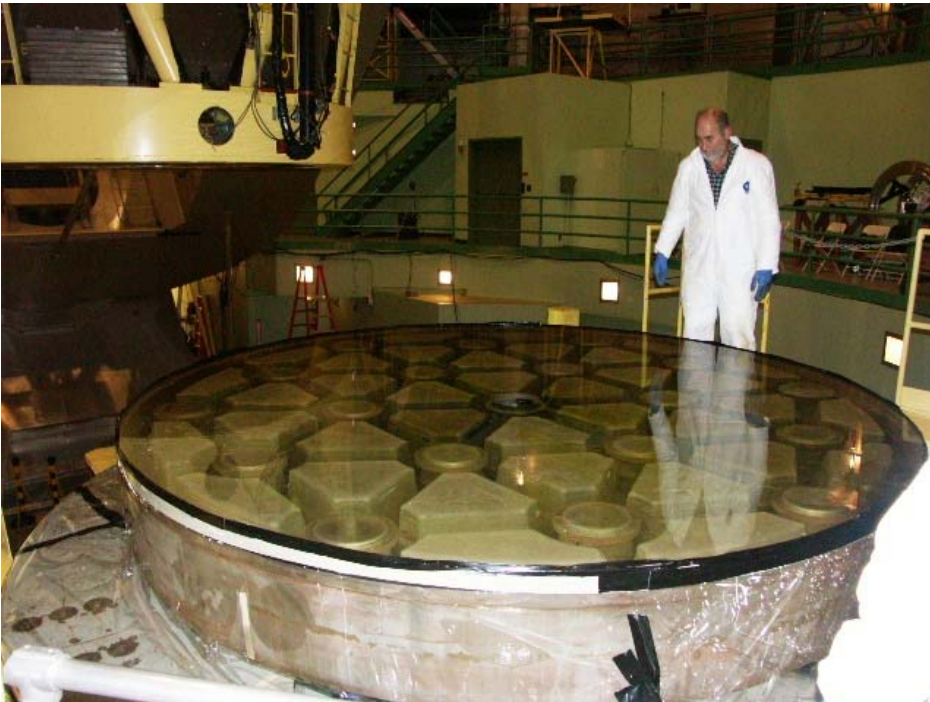
When it was all stripped we rinsed the Green River down the drain in the central hole. A second hose might have made it easier to “herd” the fluid down the drain.

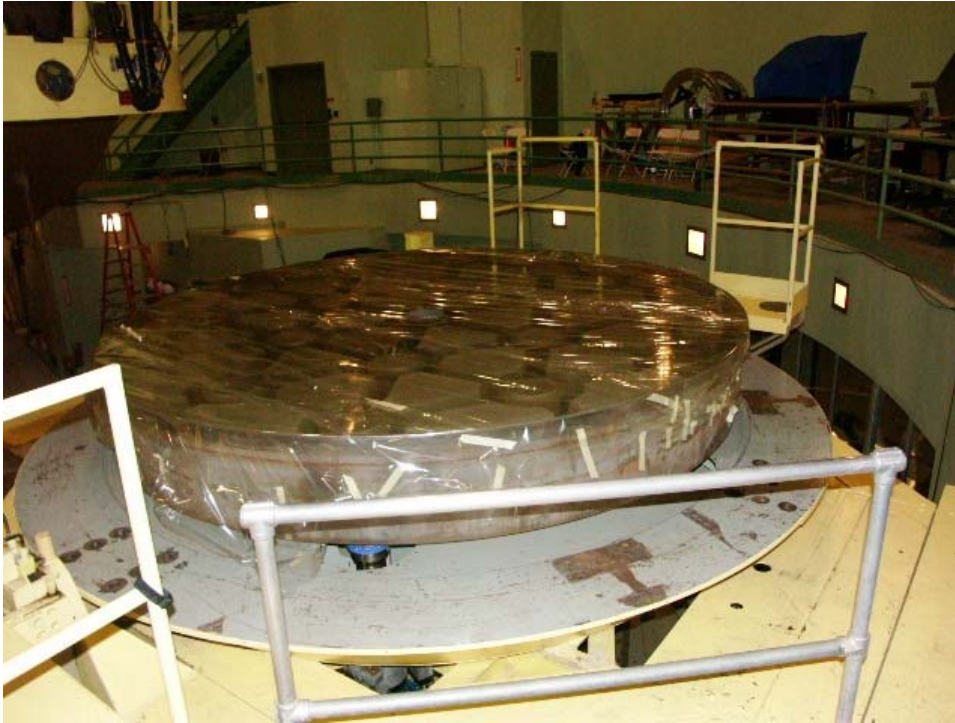
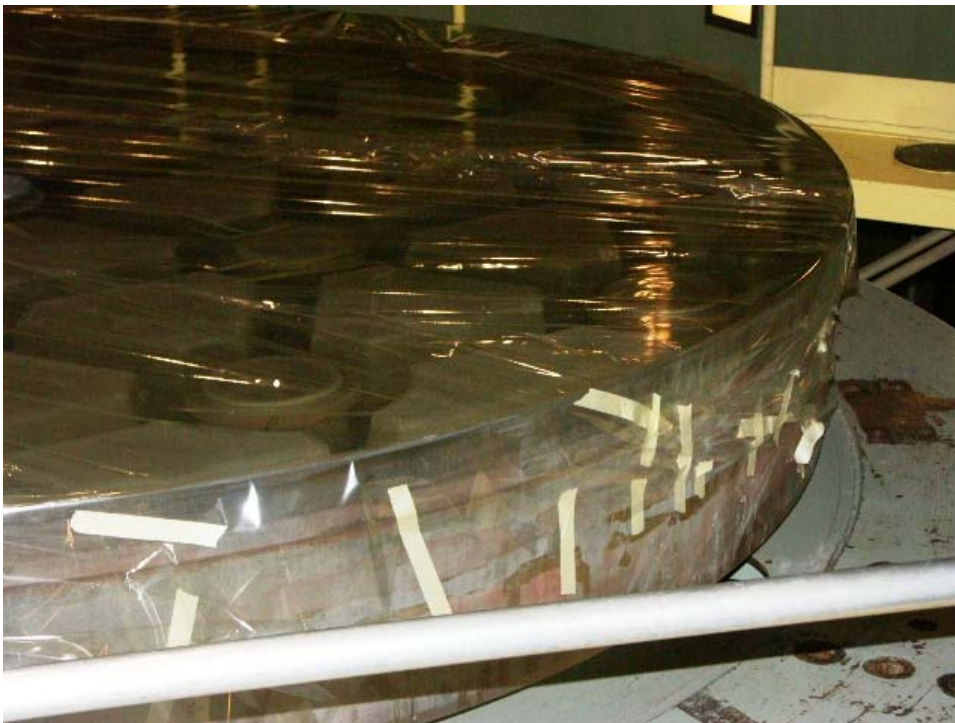
The last step for the night was to cover the mirror with cellophane, which came on a roll in a 4' wooden box. We taped it to the edge of the mirror on one side and unrolled it without dragging it on the surface, then taped it down on the other side. This is another area where we suggest improvement...perhaps a giant shower cap made of sail-cloth or some other light material. Something in the center hole would keep it from touching the surface of the mirror.

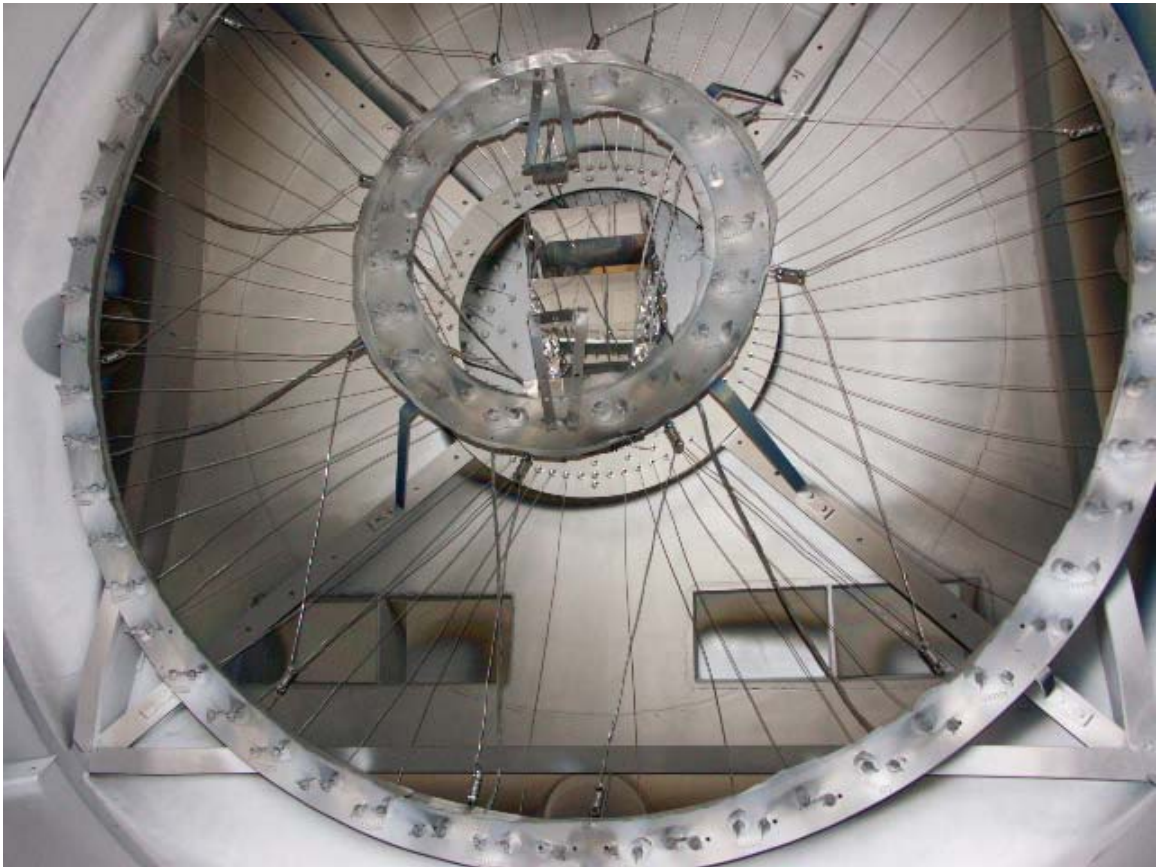
Here is a picture of the filaments of the tank...they are hard to see in the picture but basically go between the pairs of screws around the two rings. They look like thick light bulb filaments and have staples of aluminum (10 or 12, roughly) hung from each one. Note that there is an inner ring of them and an outer ring. They are addressed separately during coating. The first few filaments (verify) of the inner ring are "getters" designed to lower the pressure in the tank. The aluminum that comes off them is directed away from the mirror. The two vertical brackets are to hold SiO₂ boats, I believe (verify).

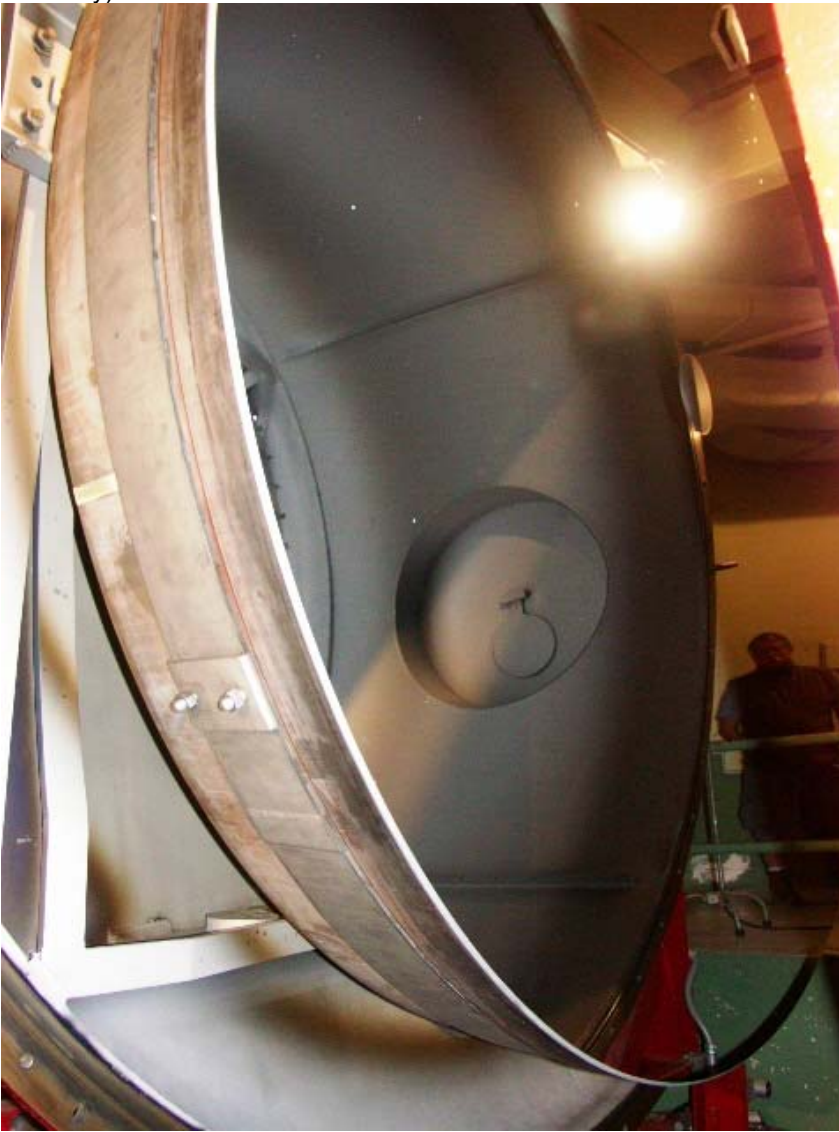
After the coating process we vented the tank and opened it to see if we would need to strip it the next day. It seemed good, although there were some smudges that looked like cleaning residue in the southeast quadrant (which would have been up and to the left looking at the mirror hanging vertically).

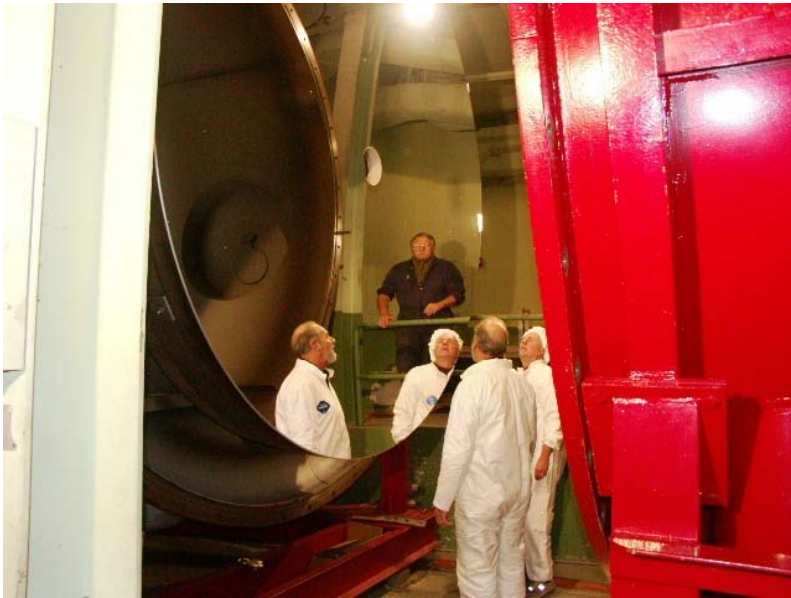
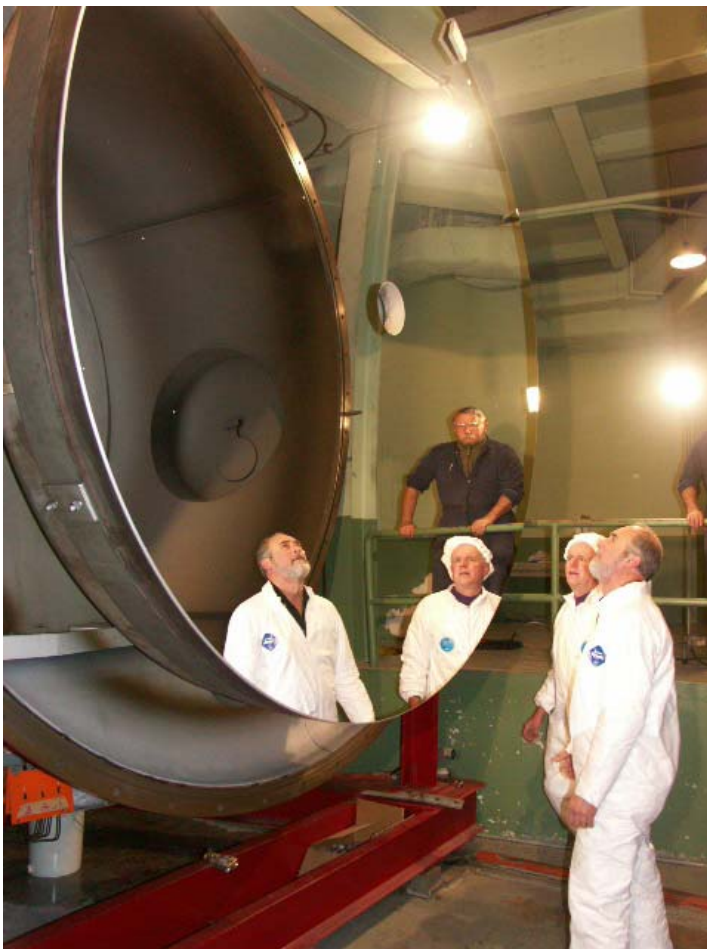
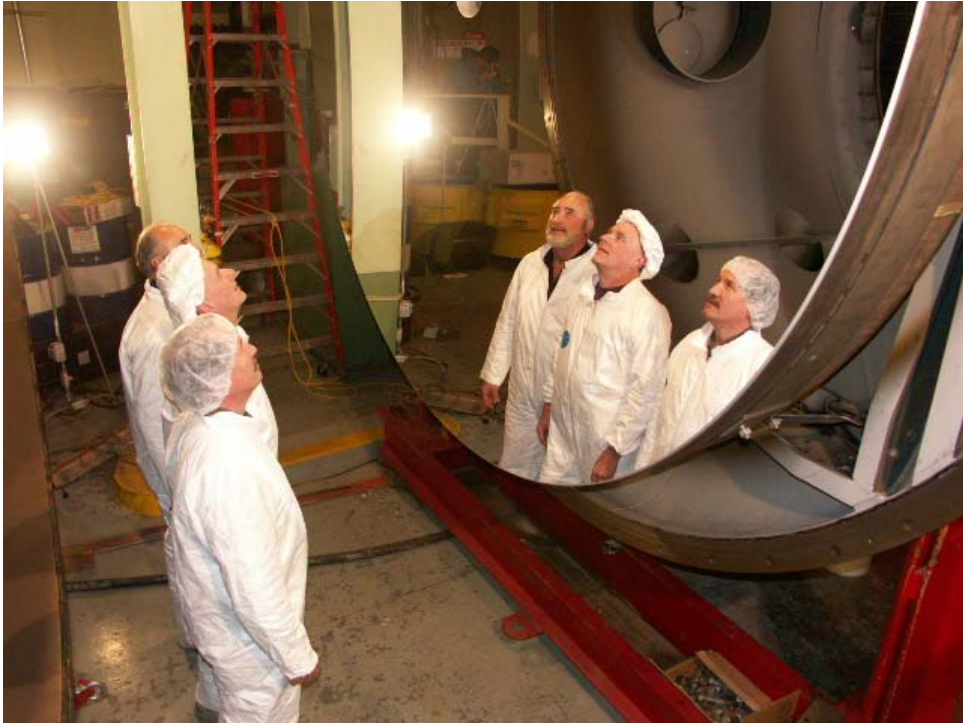
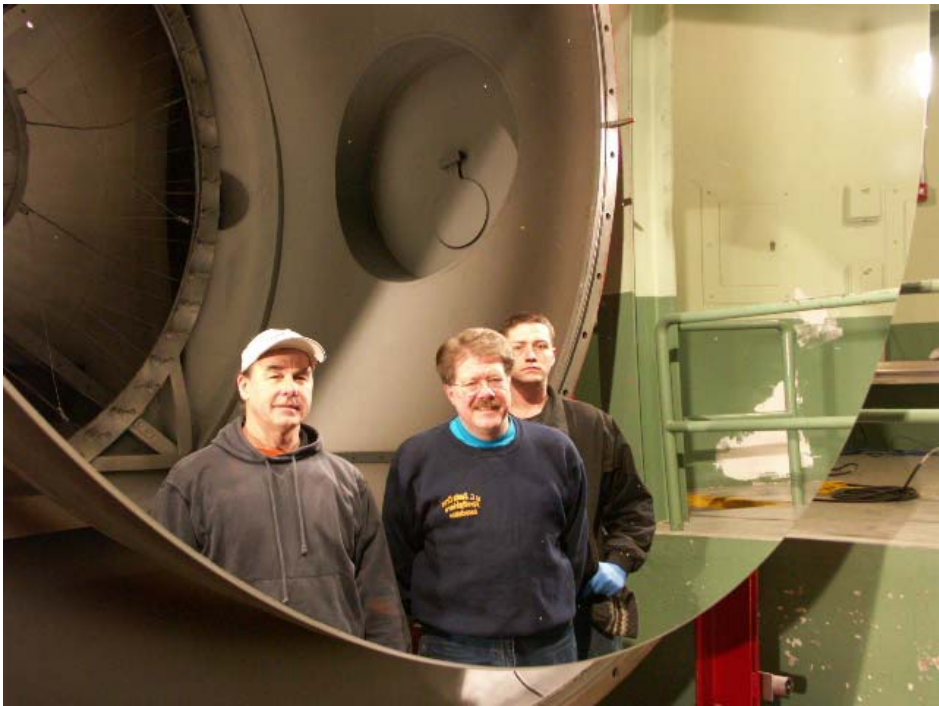
On the third day we did a more thorough inspection of the surface.

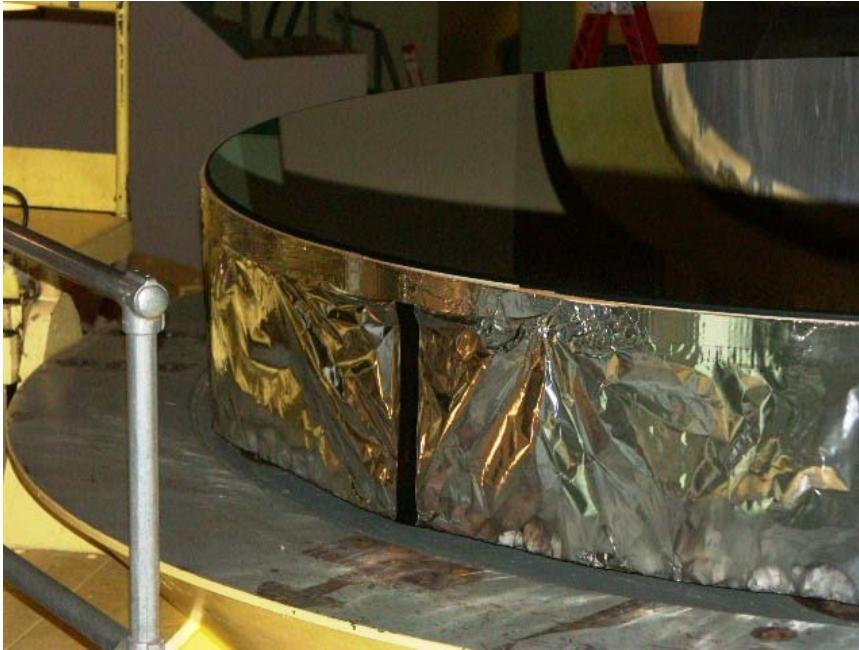
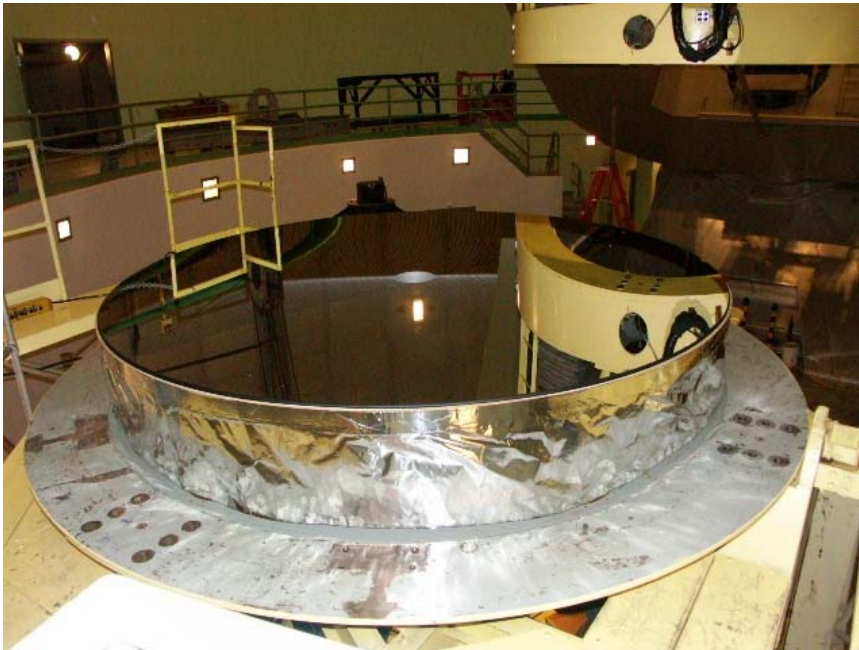
We noticed when we put corrugated cardboard around it that the cardboard shed lots of fibers onto the surface of the pristine mirror. It was never blown off, to my knowledge. We recommend finding an equivalent material that is lint-free, like a foam strip, perhaps.

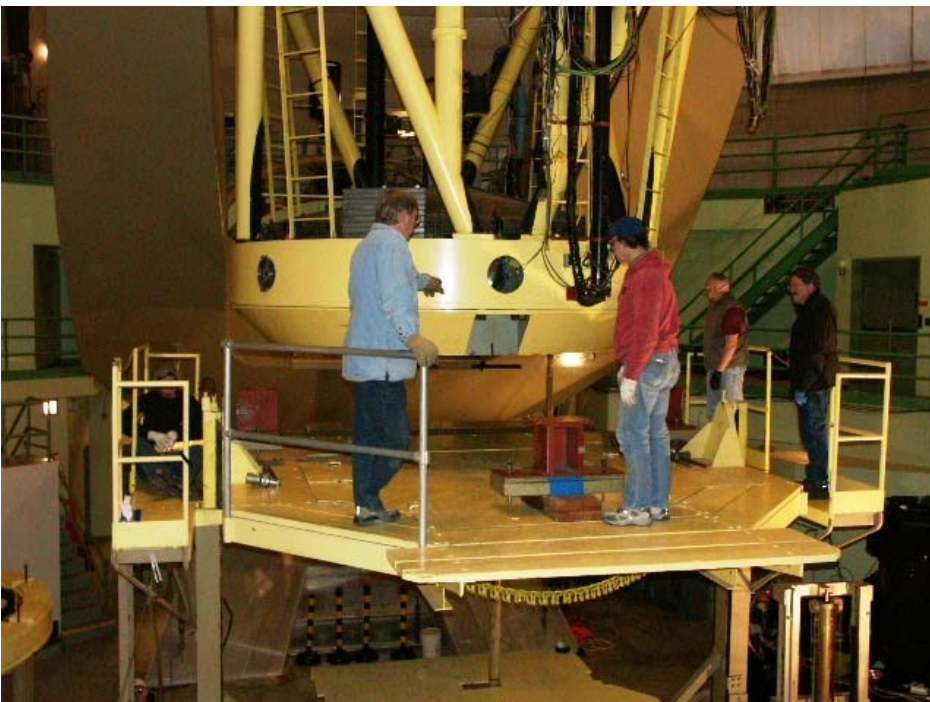
Later the other three were put on the platform. It was noted that the alignment marks for the weights had been painted over, so there was some pushing and pulling on the massive weights that was required to get them in to position. Next time the mirror comes out the positions of the weights should be re-marked before they are taken off. This will make replacing them much easier.

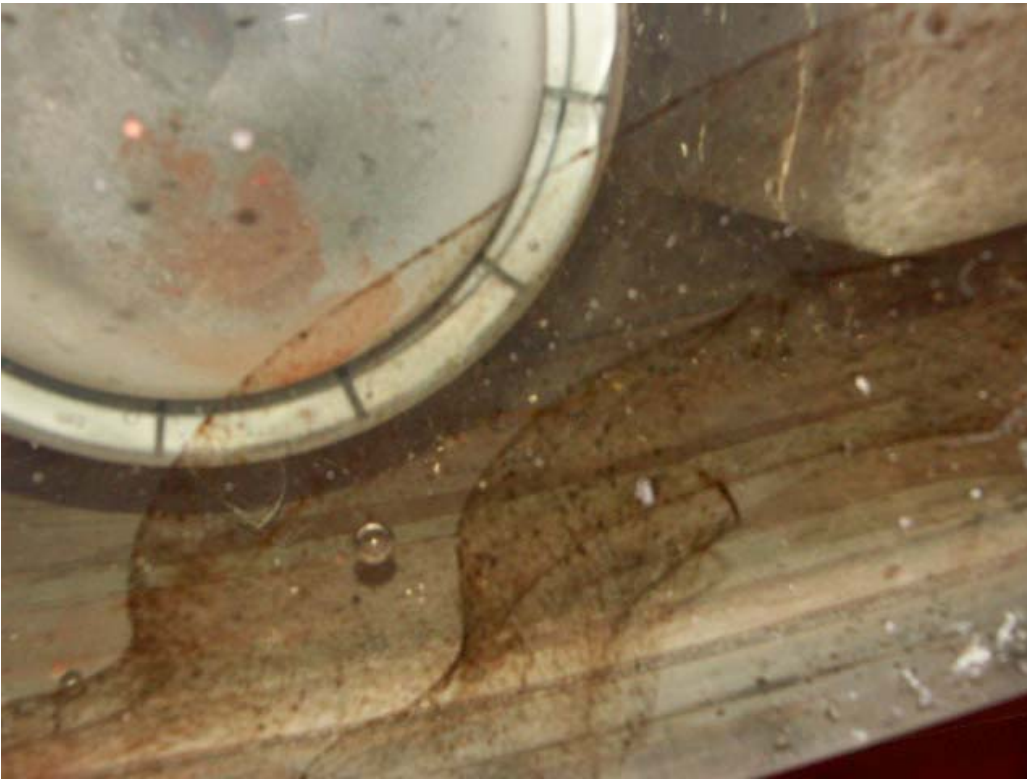
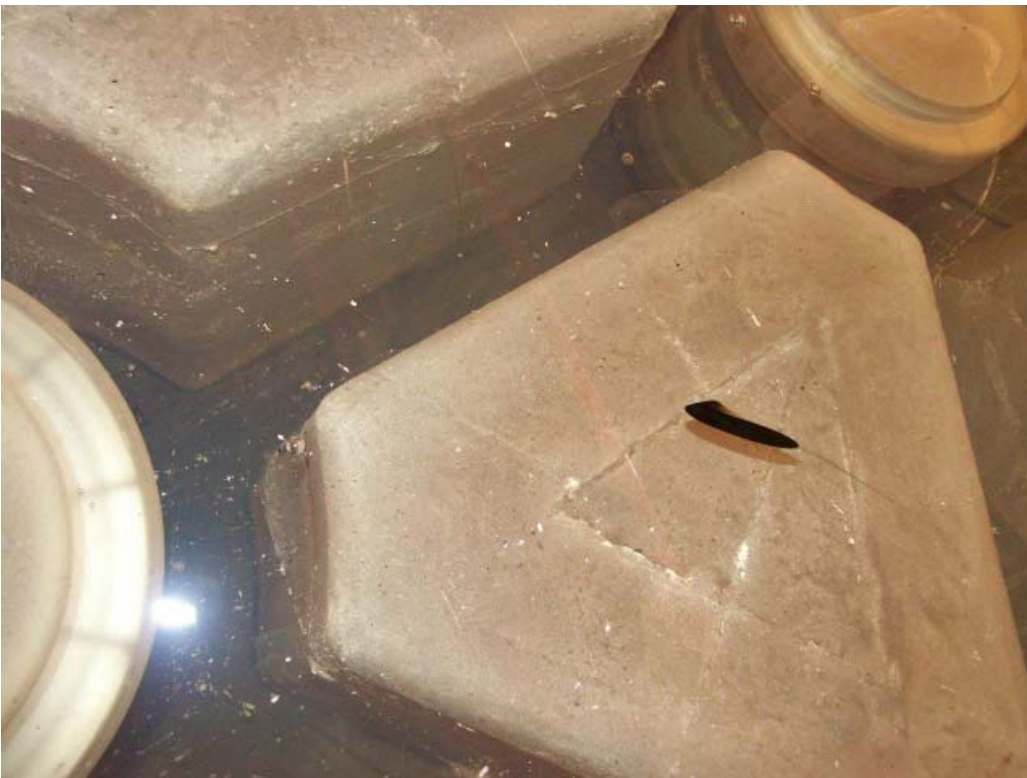
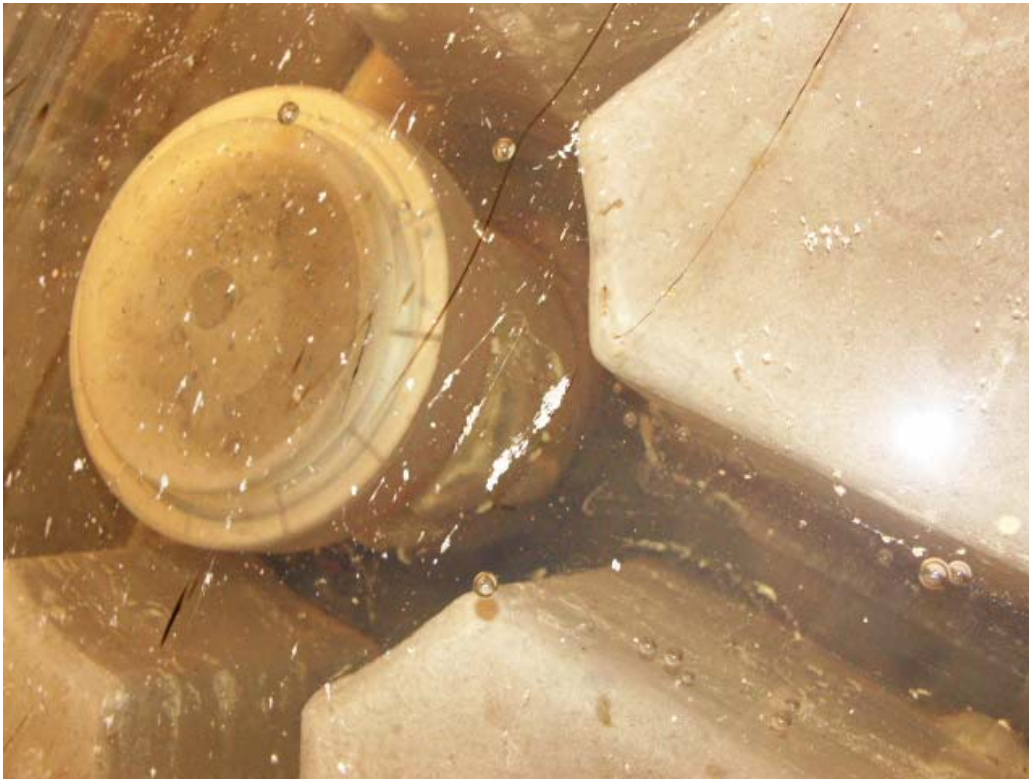
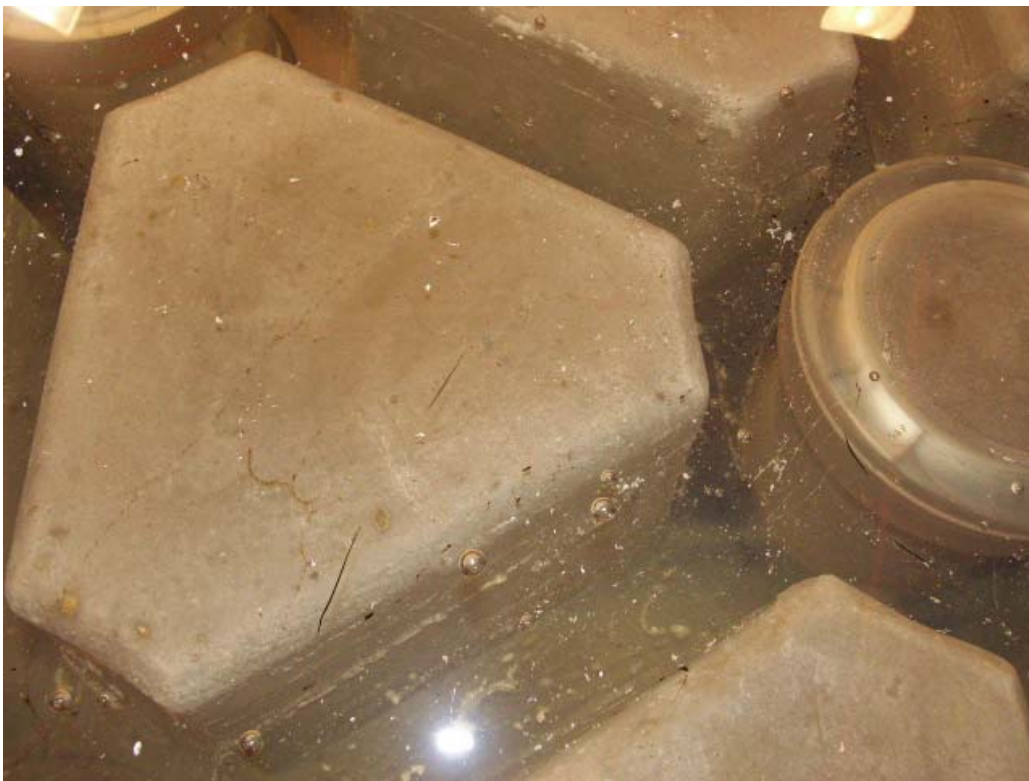
Addendum 1 - Photos of the substrate of the mirror.

There were lots of floating debris and swirls of brown fluid beneath the surface.

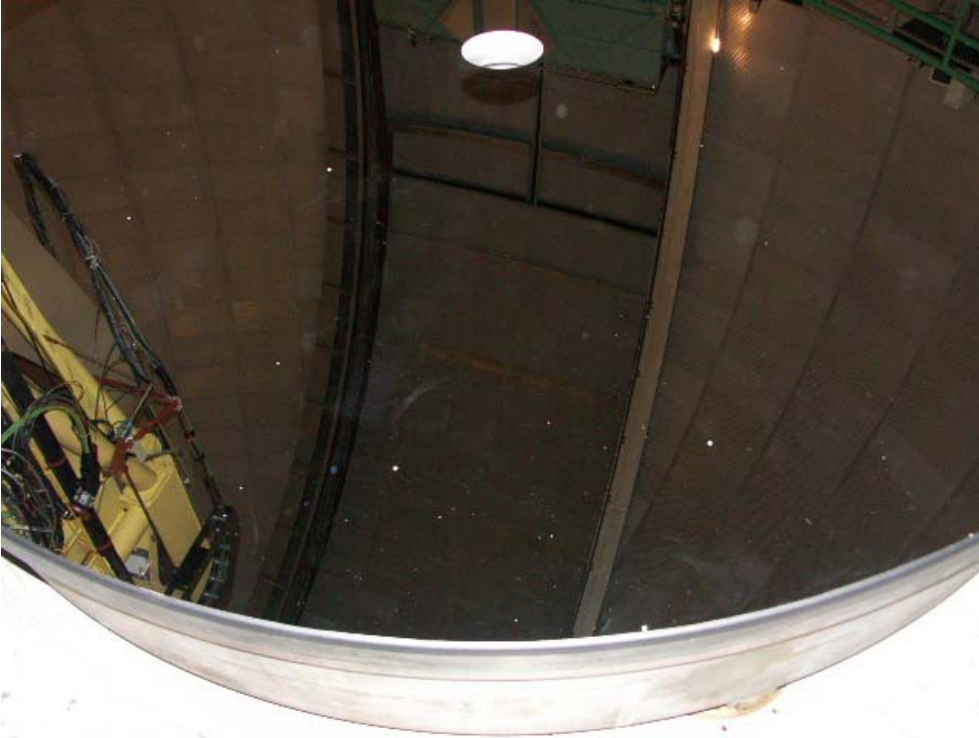
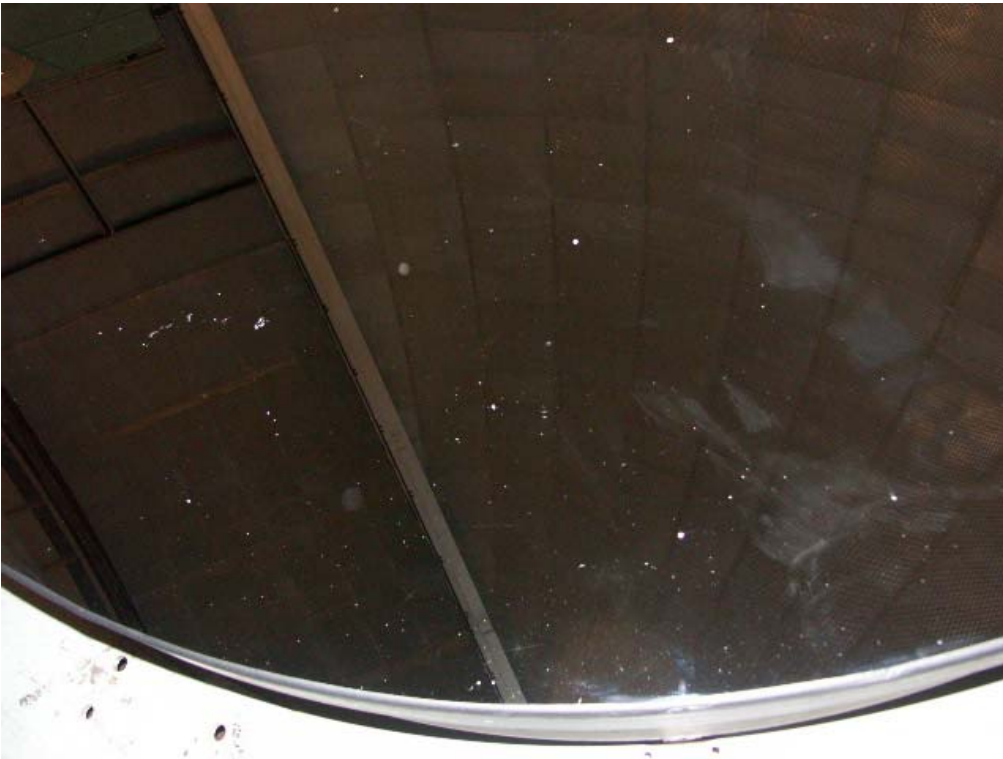
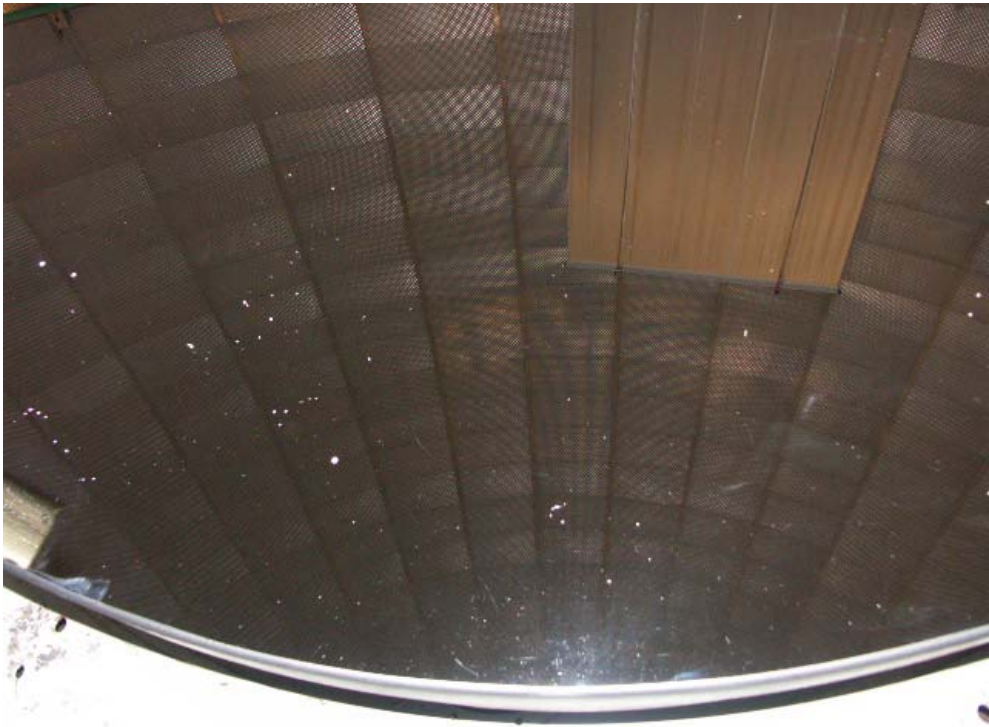
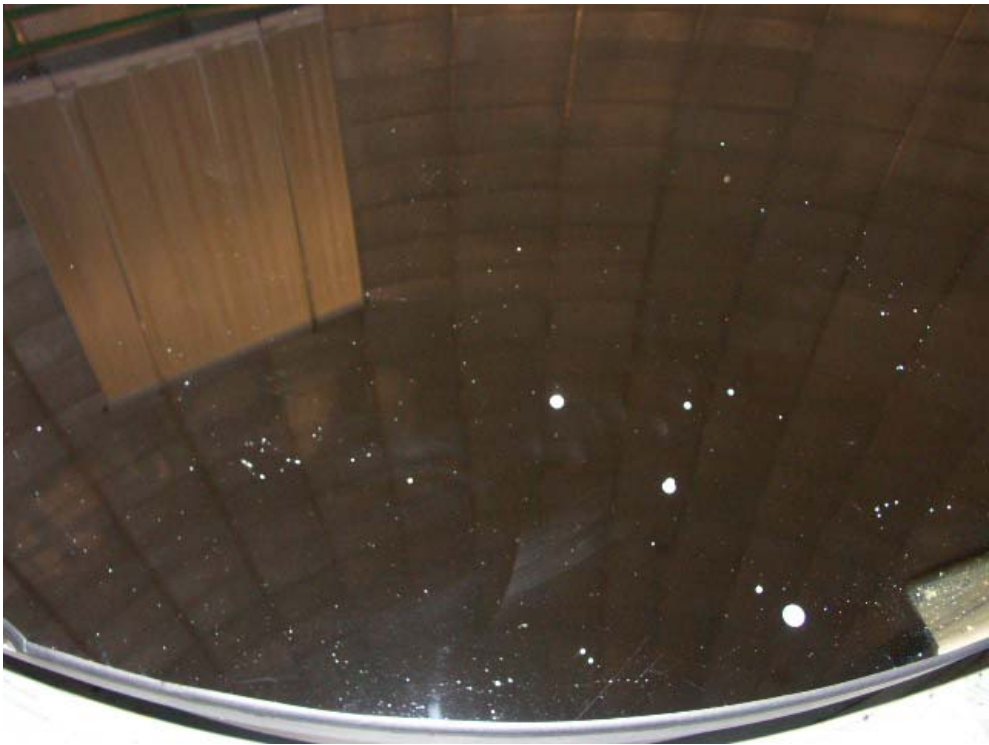
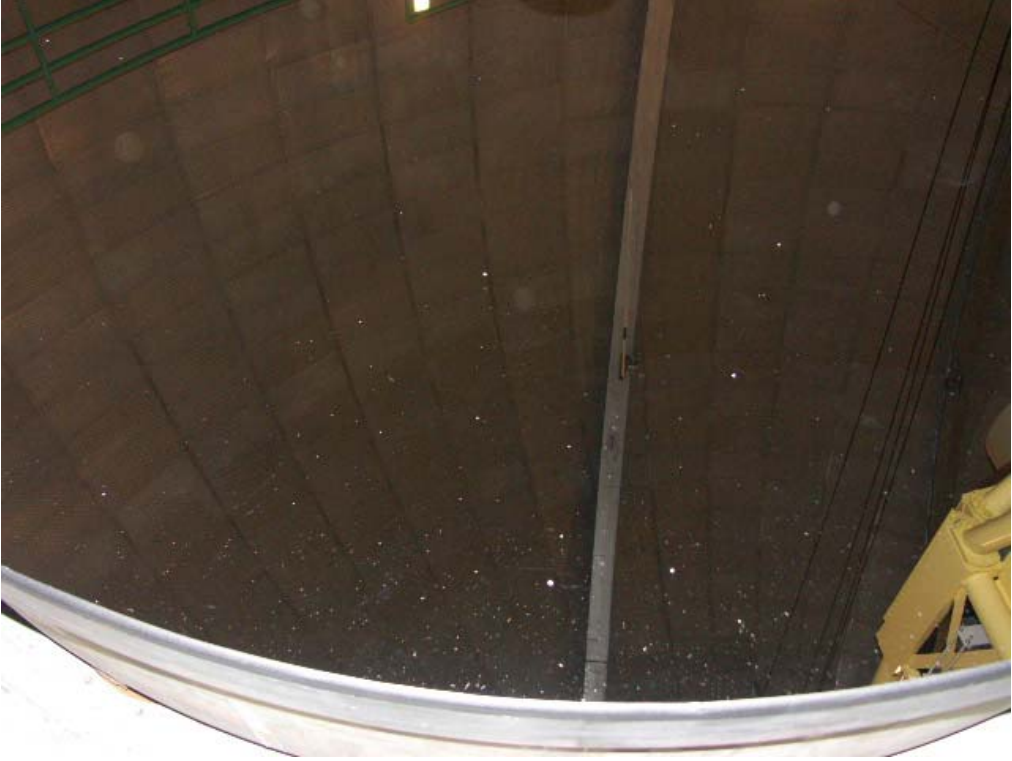
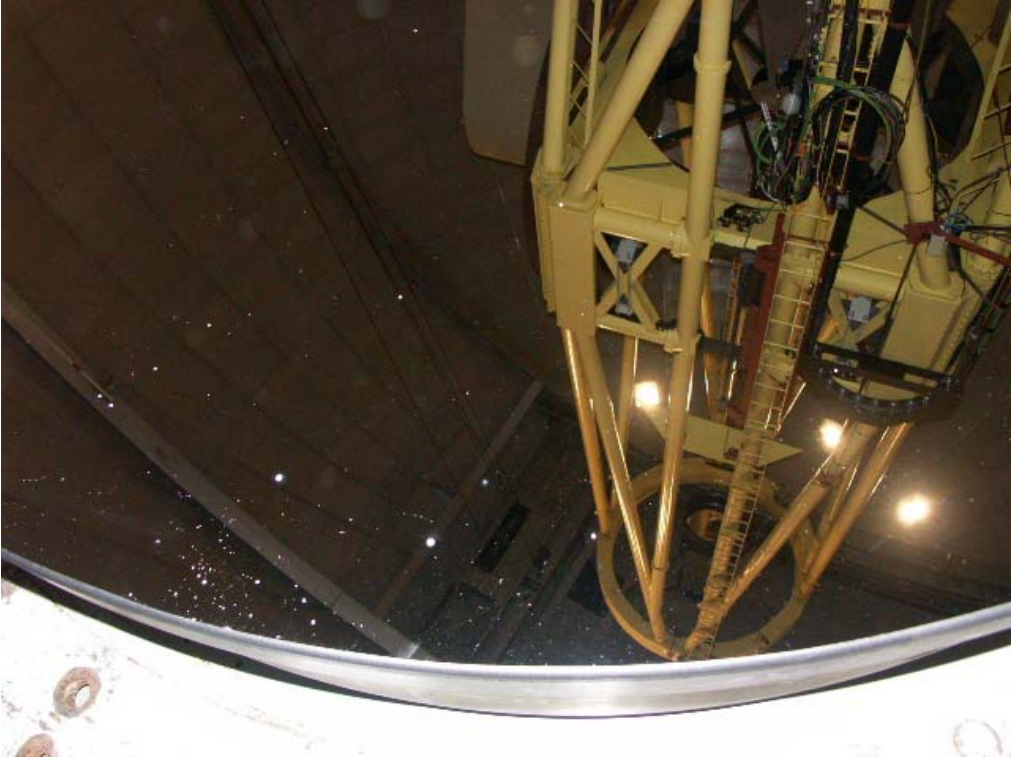
Addendum 3 – New mirror surface

These six pictures were taken starting from standing at the NE position as the mirror sat on the platform and moving around it clockwise.
