Automated Planet Finder Primary Mirror Cleaning

David Hilyard, Jim Ward and Brian DuPraw

7/11/12

Automated Planet Finder

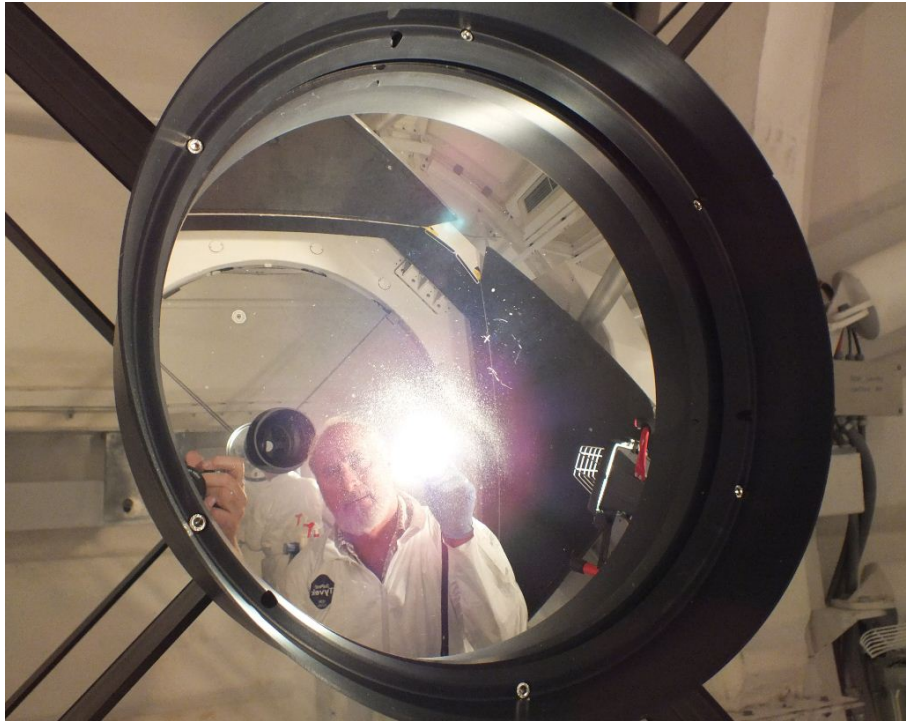
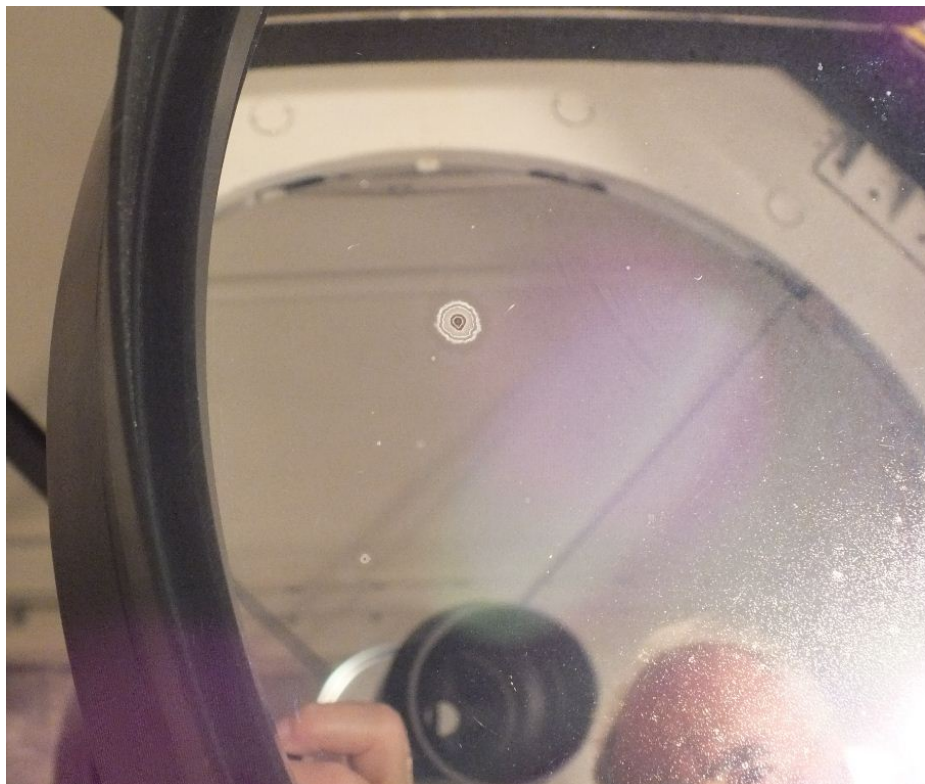
Dave cleaned the secondary and tertiary mirrors while we waited for the dry nitrogen to be set up (the N2 hose had to be fed through a small hole between the floors of the dome). These photos show those two mirrors after cleaning. The secondary had several scratches near the center and one particularly bad coating blemish that had progressed to about 3/8" diameter.

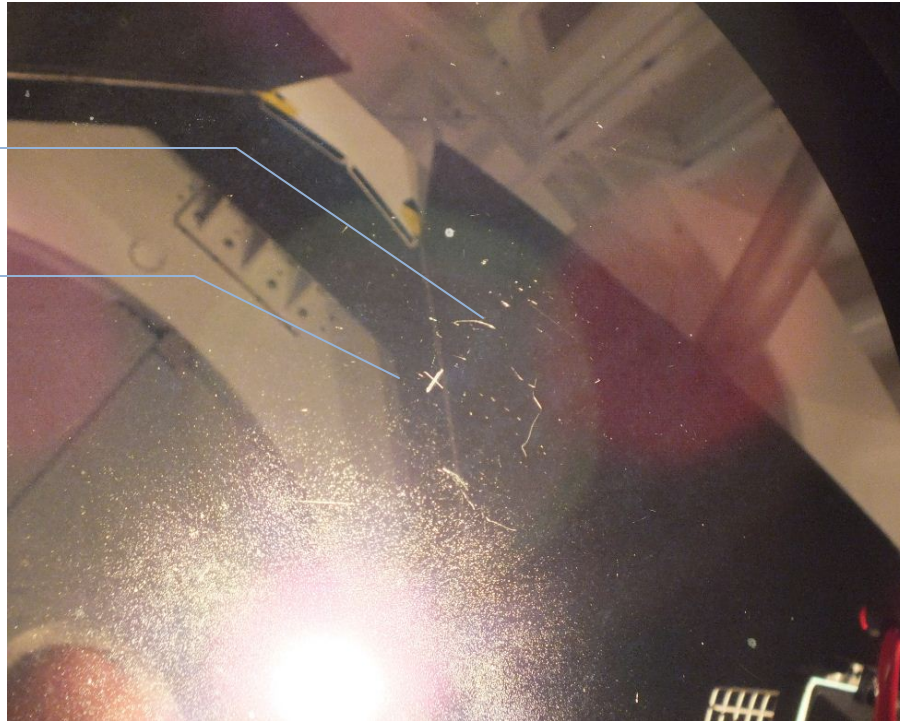
Surface scratches

Center alignment crosshair

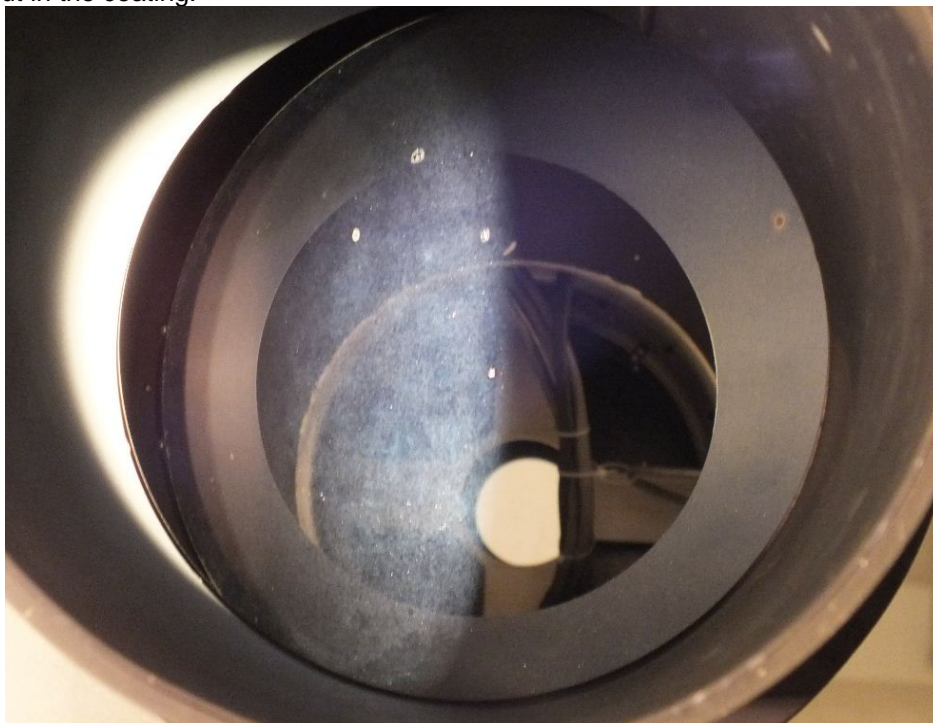
The tertiary mirror still had a film after cleaning, and several spots 1/4" – 3/8" diameter that were not on the surface but in the coating.

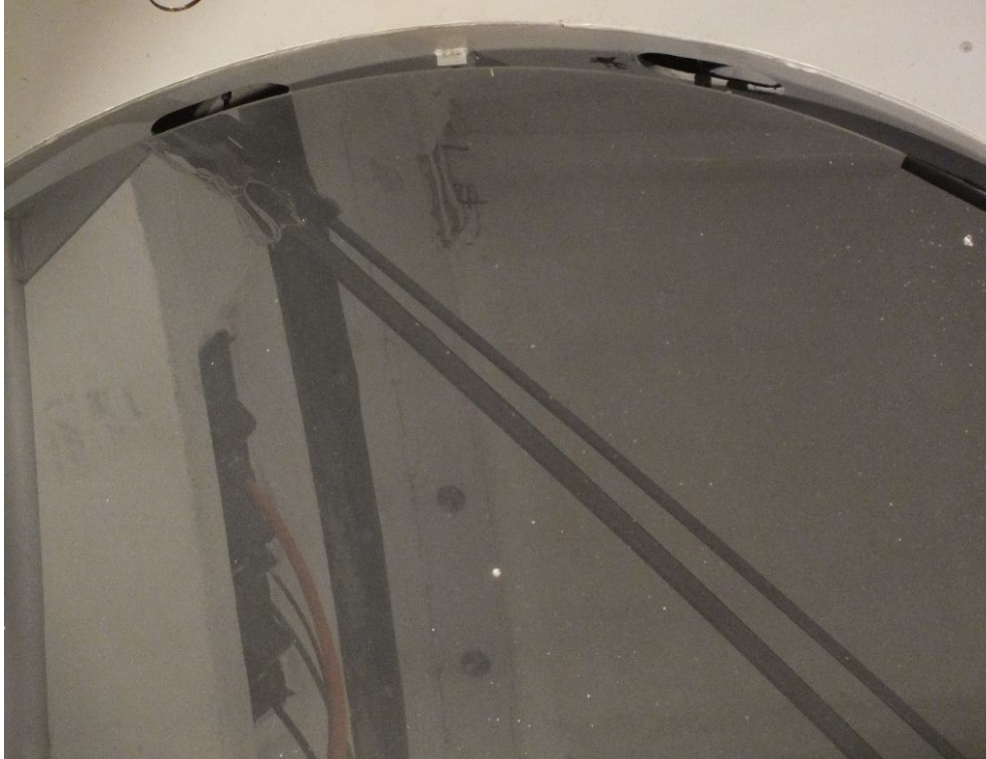
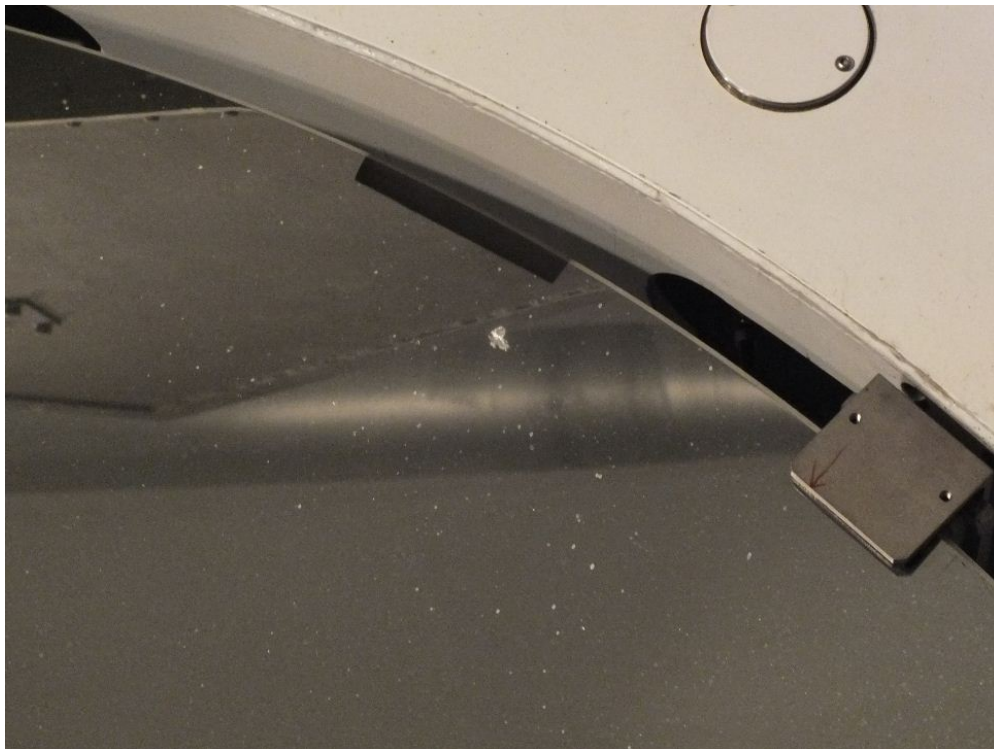
The primary mirror was fairly uniformly dirty. We measured 83% reflectivity with the blue filter and 90% with the red (not absolute, but compared to the reference mirror).

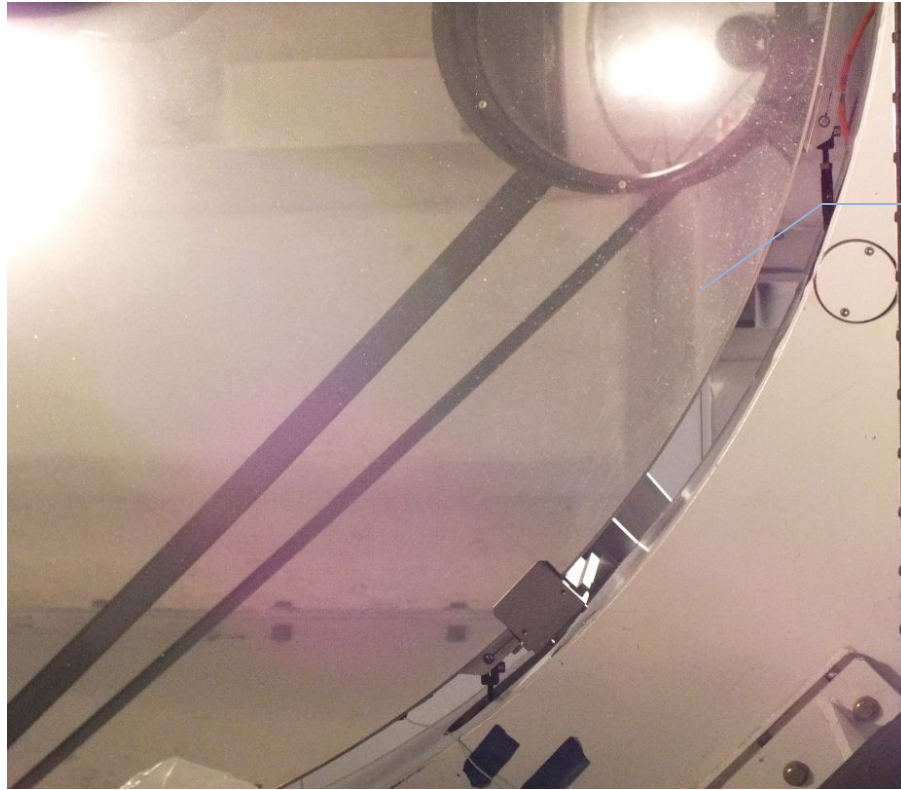
Particularly
dirty
quadrant

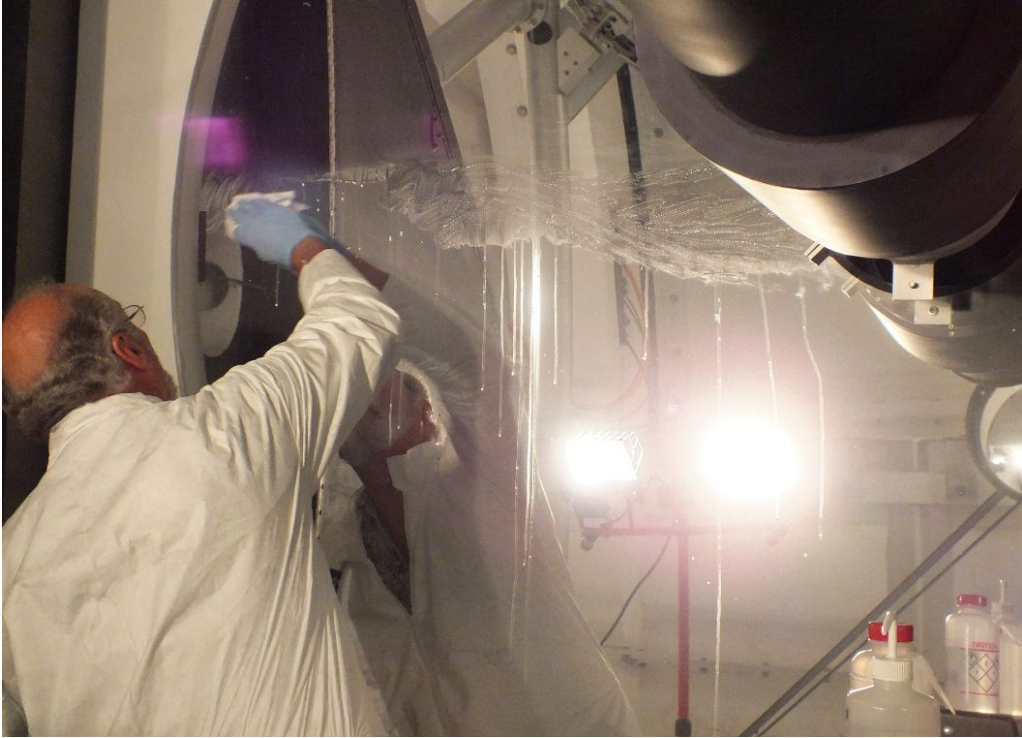
In this picture he had already cleaned the top 12" or so all the way across and another 9" – 12" on the left side.

Clean / dirty
dividing line

Temporary
soap buildup

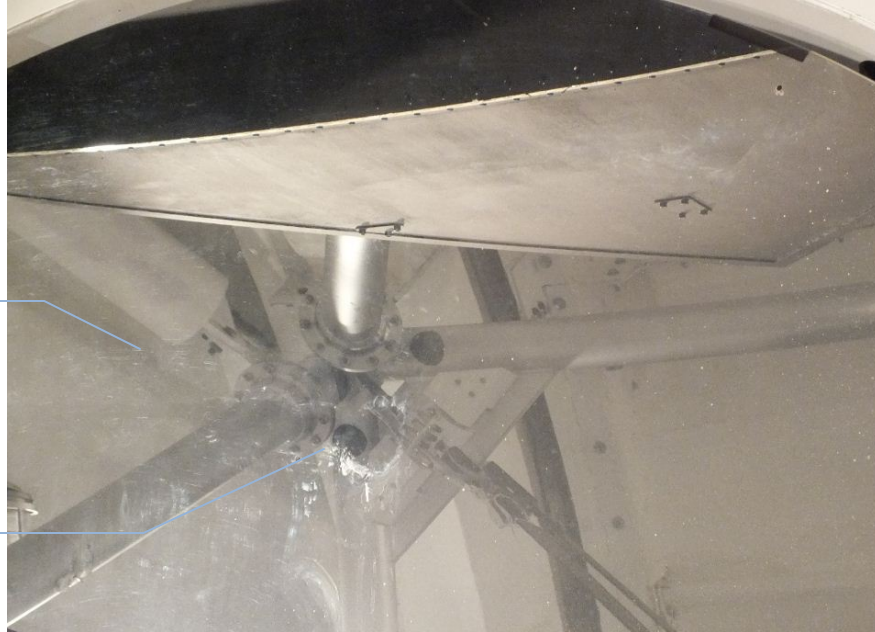
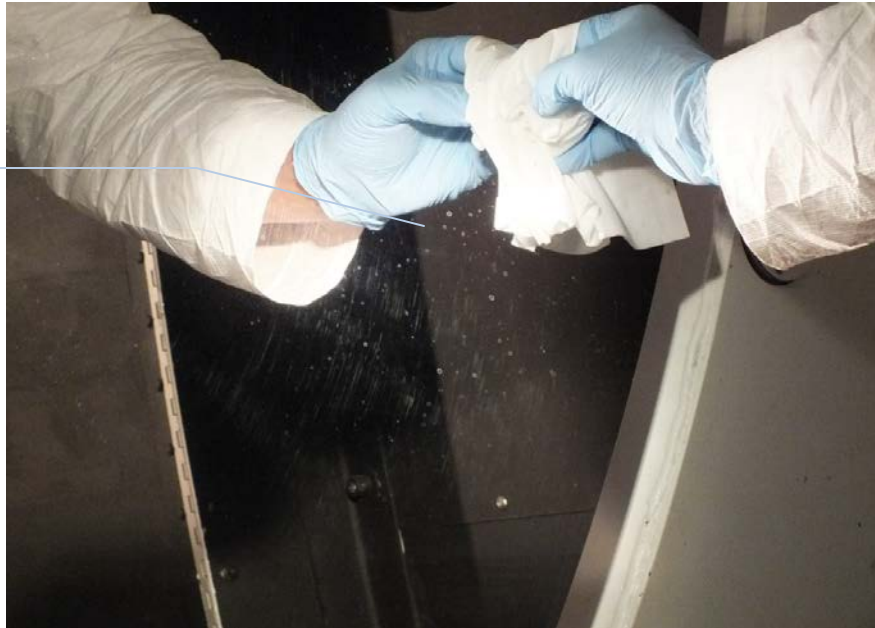
Uncleanable
older and
water spots

After working his way down the left side of the mirror he did the same for the right half, then followed up with a final overall acetone wipe-down. There were some spots that were permanent (at least until it gets its first recoating); they were caused by a dome leak during the mirror installation phase.
