## Mt. Hamilton Optics Cleaning Trip 8/21/13

David Hilyard and Brian DuPraw

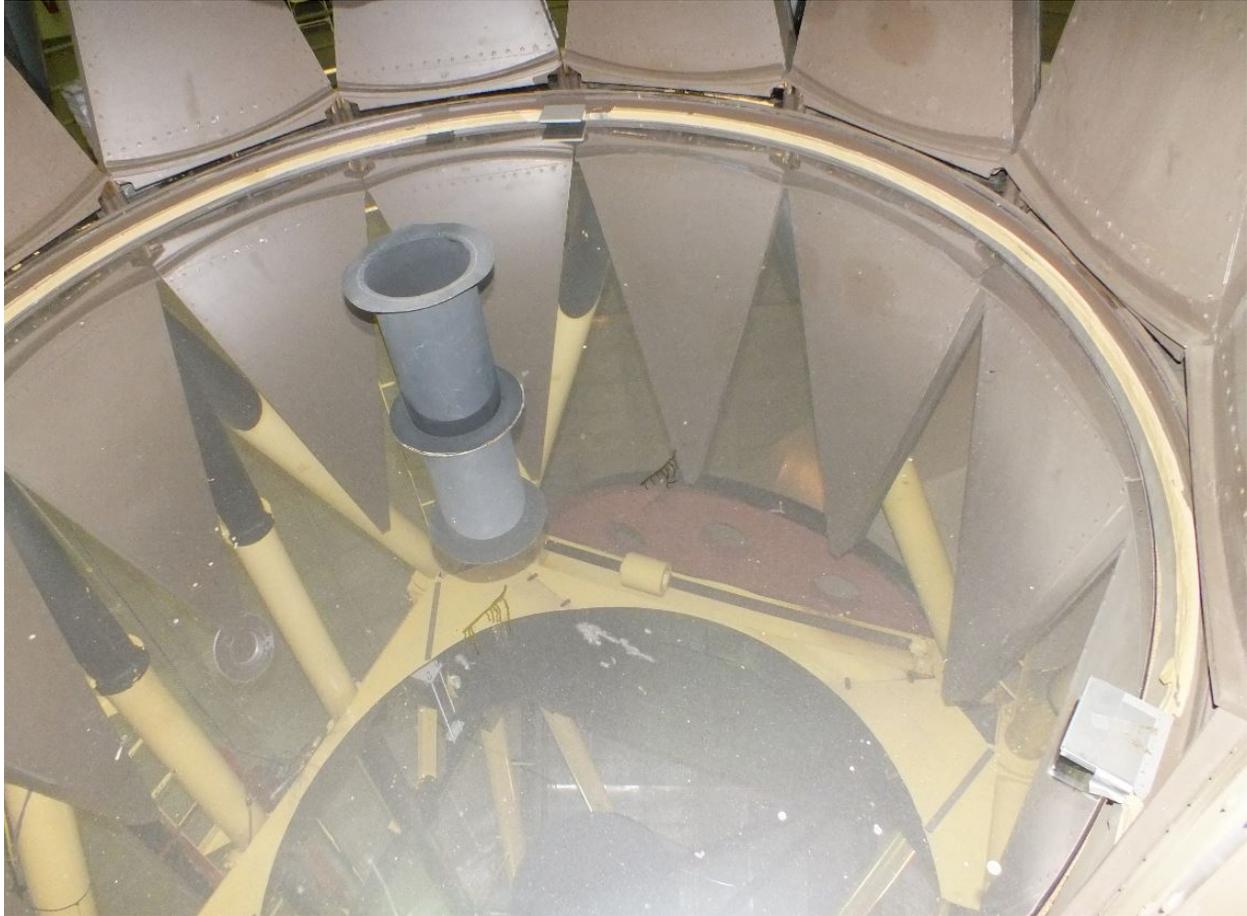
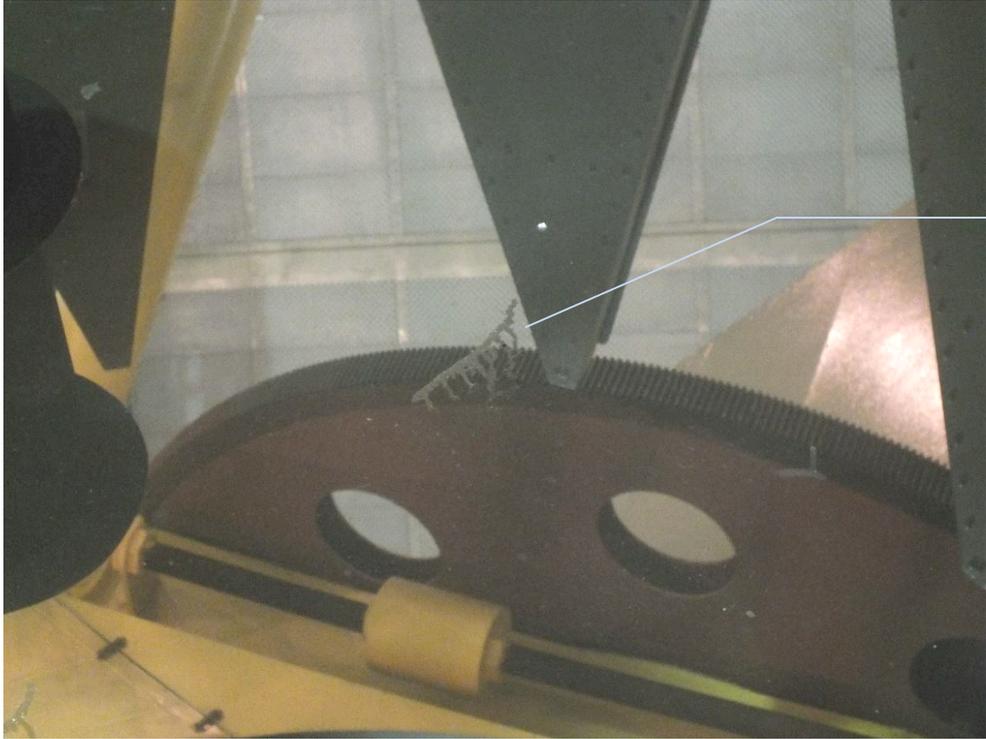
We looked at the 120" primary mirror and found it to have an overall dirty look, in keeping with the fact that they have not been able to do CO<sub>2</sub> cleaning for months due to scaffolding safety issues. In addition, there were several oil spots that had not been there on our last visit – two of which were several inches in length. They were too far from the perimeter to reach for cleaning. We measured 80% reflectivity with the blue filter and 82% with the red, relative to our reference mirror.

Oil Spot on  
120" primary  
mirror surface

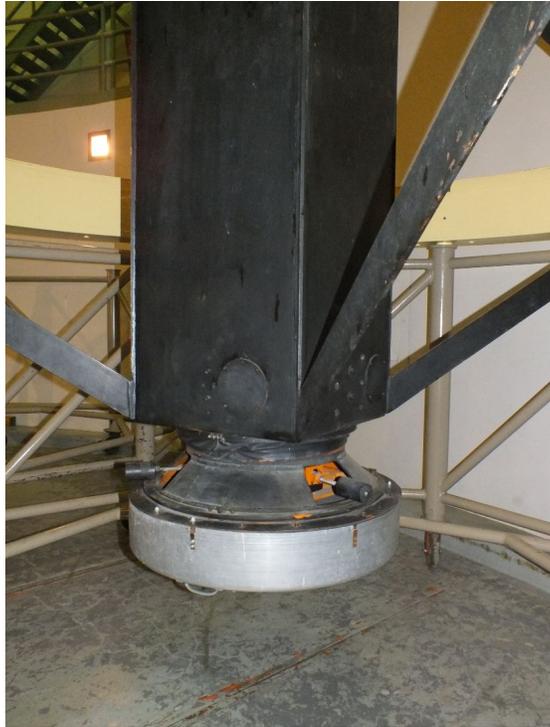
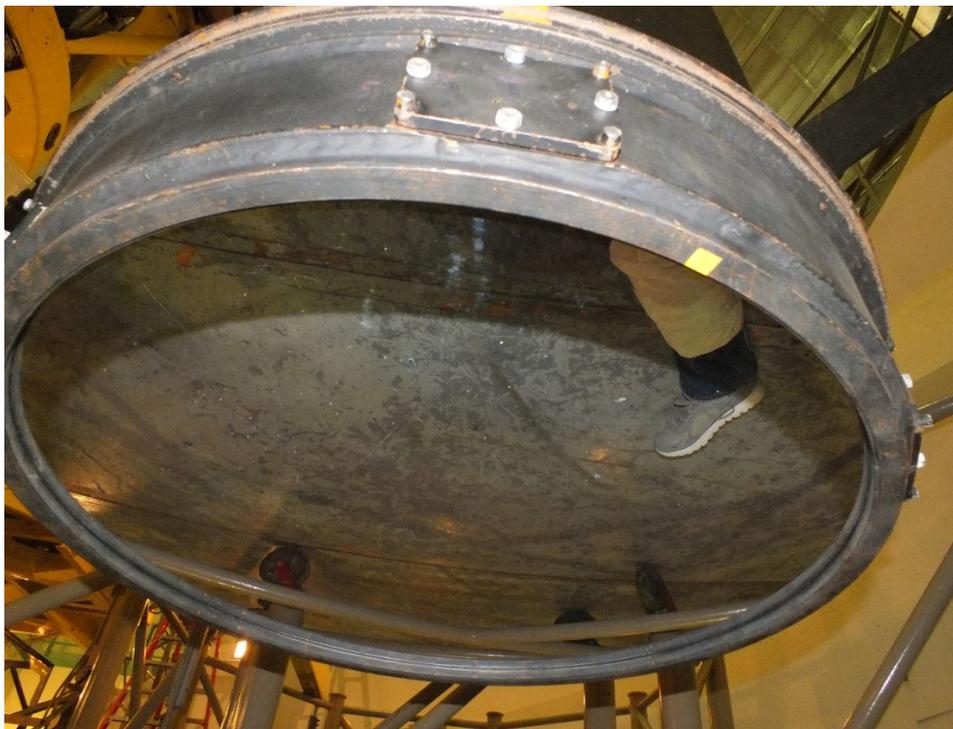
We measured the reflectivity of the Coude secondary mirror to be 84% of our reference using both red and blue settings. There were numerous spots in the  $\frac{1}{2}$ " to  $\frac{3}{4}$ " diameter range, but cleaning with ethanol didn't help.

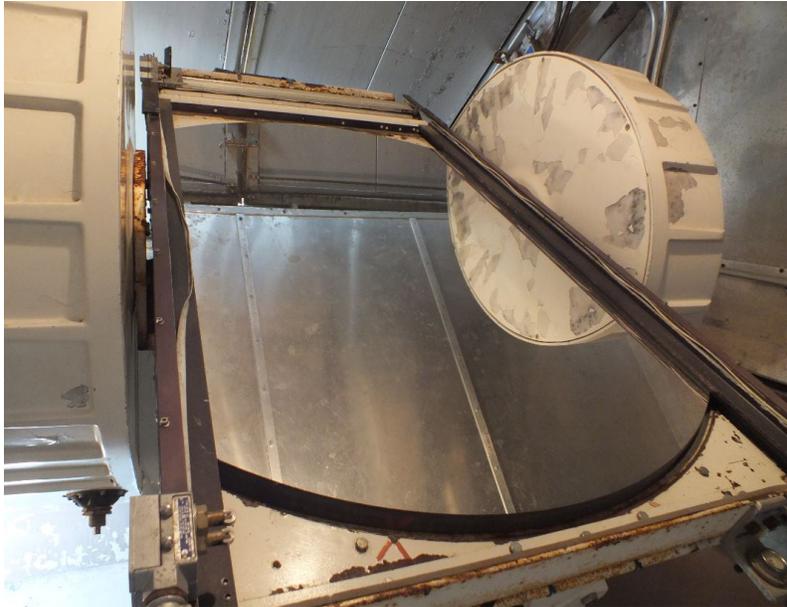
The CAT mirror M1 in the out-building next to the dome had been dusty but not too bad. Dave cleaned it by spraying H<sub>2</sub>O and squirting Orvus/acetone/H<sub>2</sub>O mix, then blotting it off. After cleaning we measured 88% relative reflectivity with the blue filter and 89% with the red.

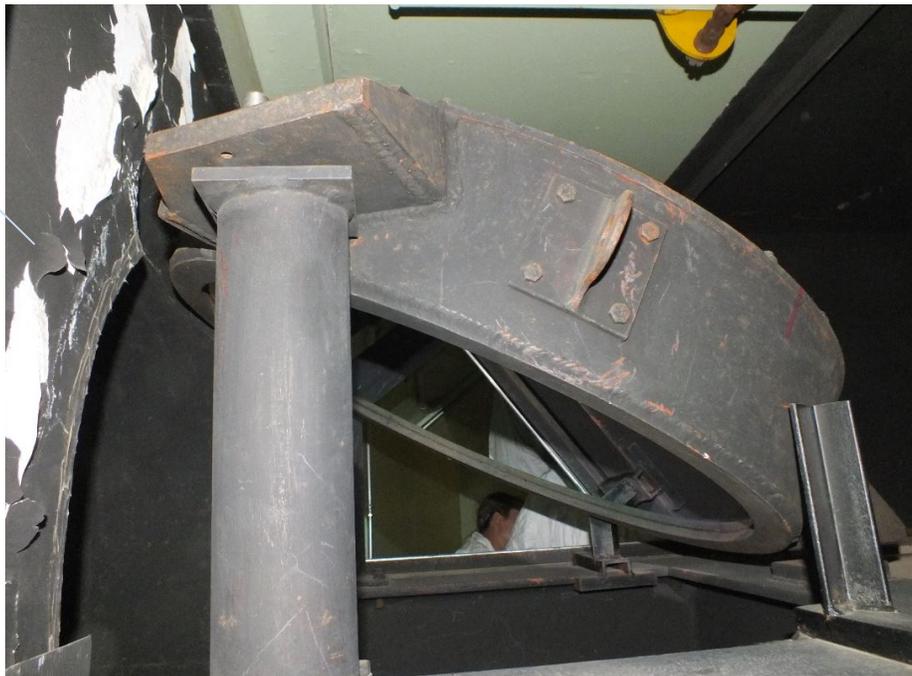
The next CAT mirror, M2, faced downwards at a 45 degree angle, so it wasn't too dirty. Dave cleaned it and we measured 83% with the blue filter and 88% with the red. There is some severe paint chipping from the housing that can be seen in the photo; it could and probably does fall down from that level to the primary mirror below.

Paint  
chipping

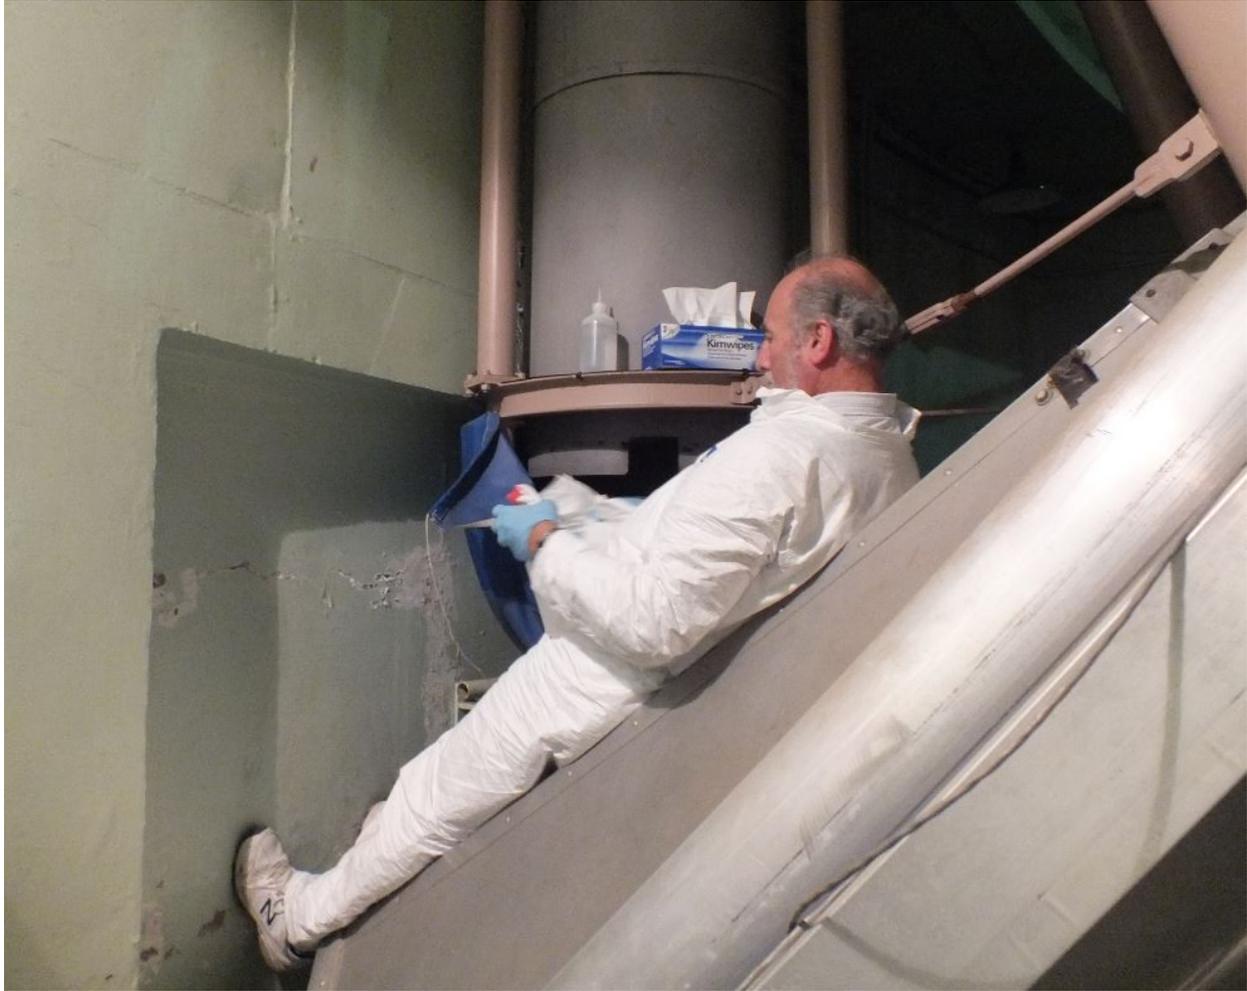
Dave cleaned the upward facing CAT primary mirror, M3, with air, then water, then ethanol. It is too risky to try to get the reflectometer into the tiny access hole in the surrounding shield.

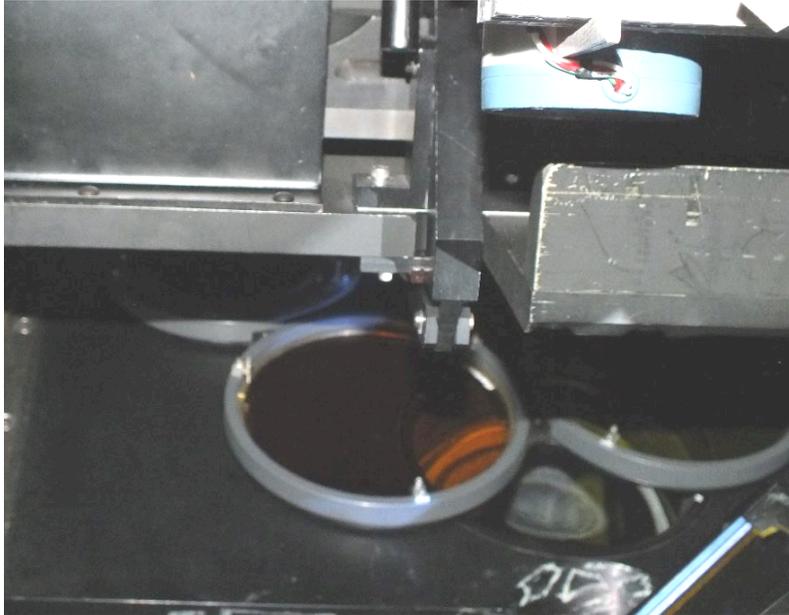
One of the filters (orange colored) had water spots that Dave was able to clean with de-ionized water (ethanol had no effect). Dave also cleaned the dichroic and a dusty mirror; the collimator didn't need to be cleaned.

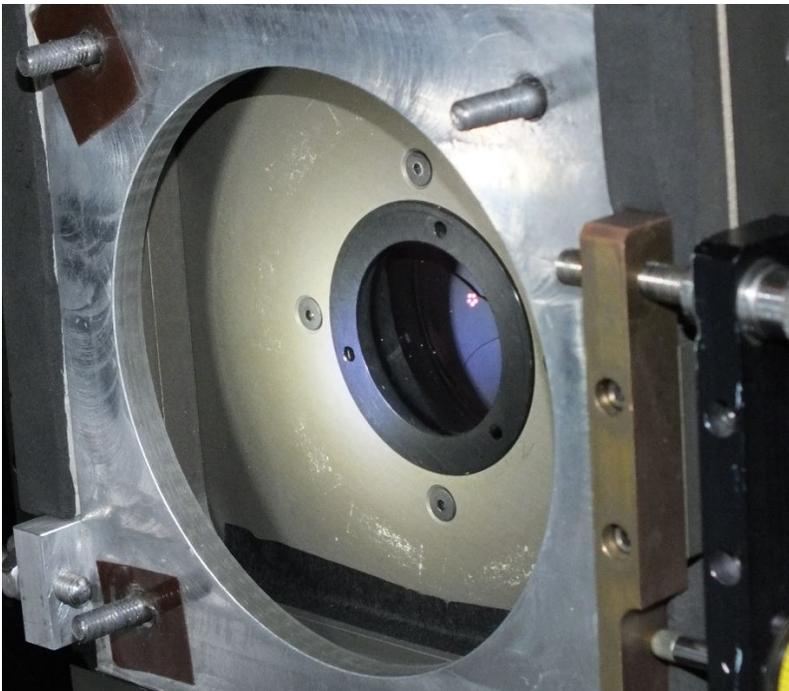
Dave removed the cover of the red side camera lens and cleaned the slightly dusty lens with air and ethanol.

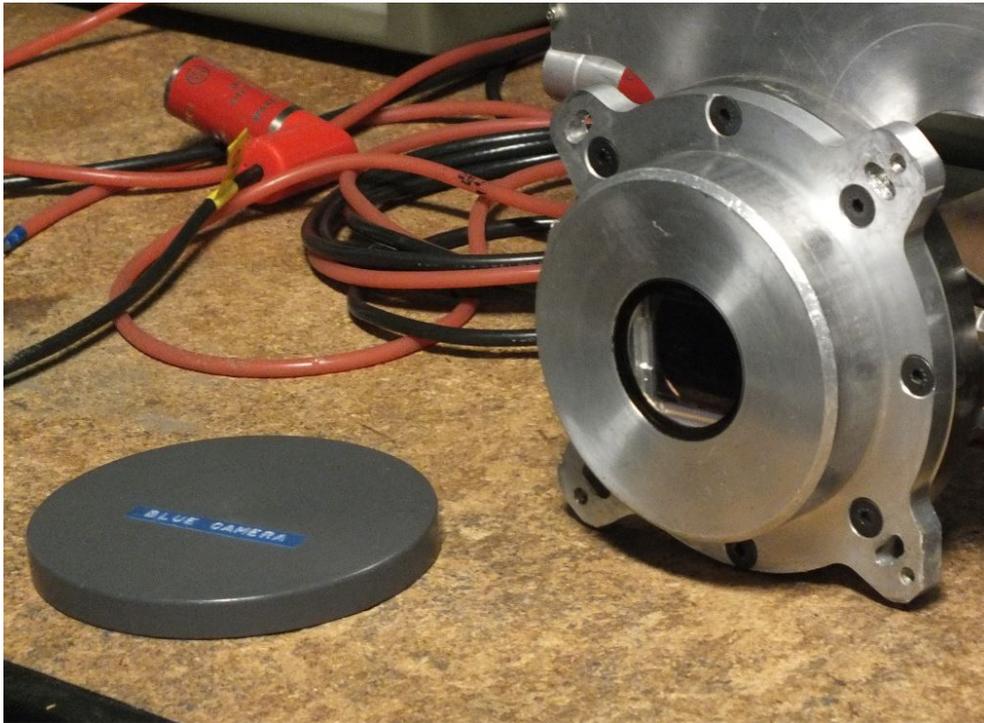
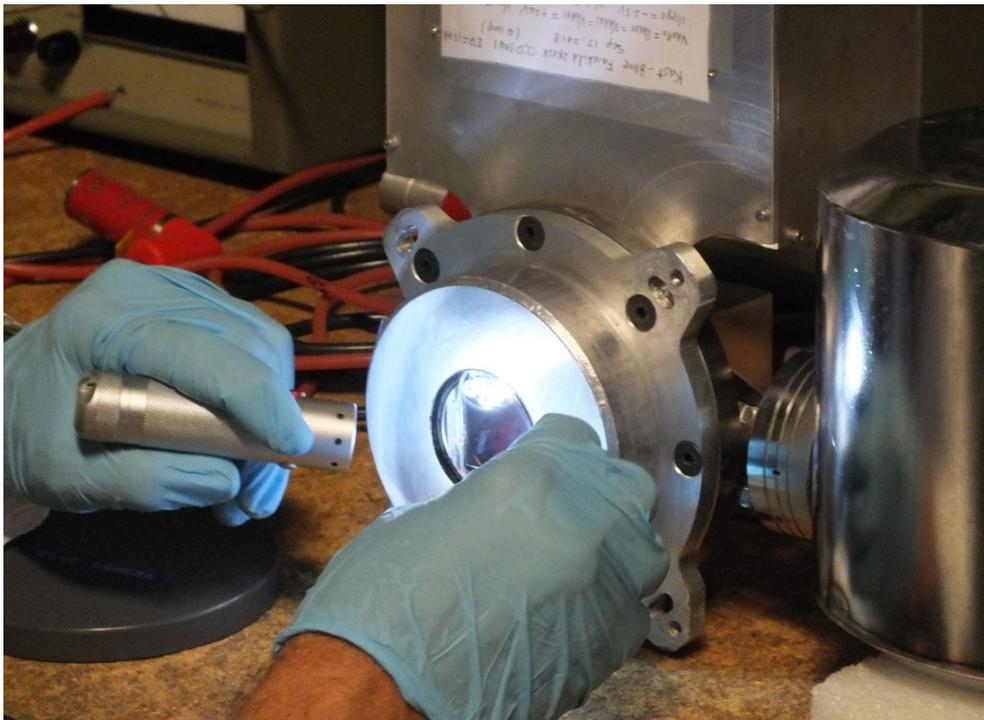
We visited the “nursery,” where Dave cleaned the KAST blue camera Dewar window.

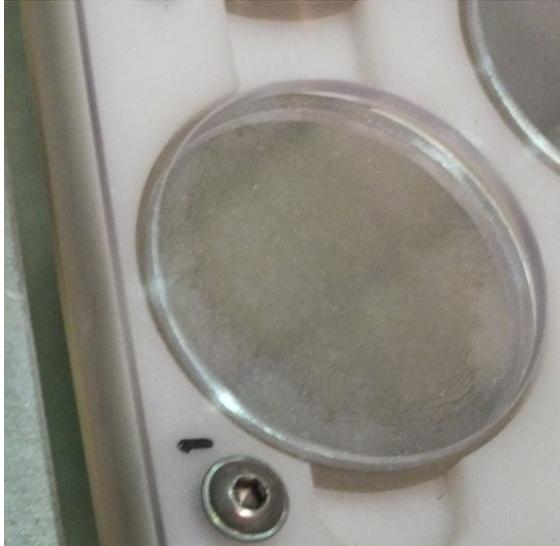
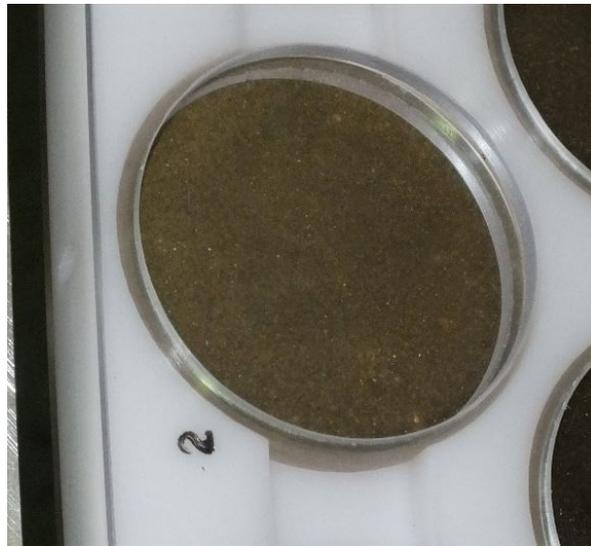
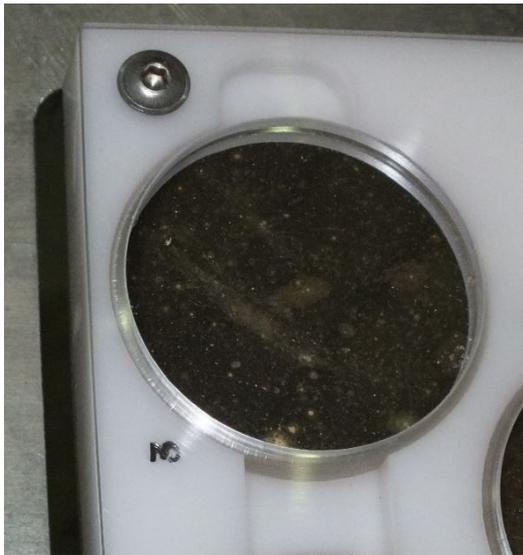
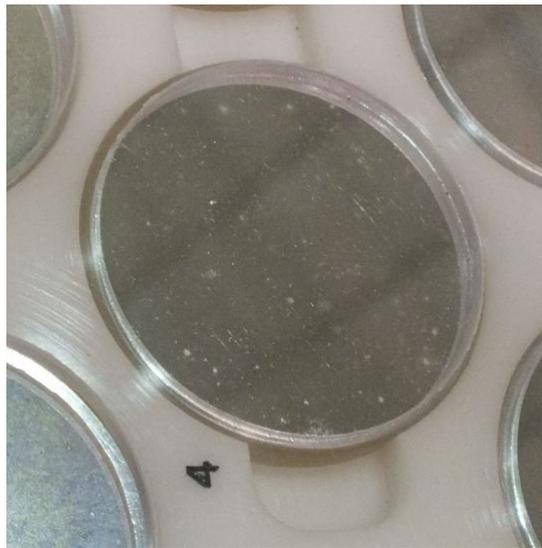
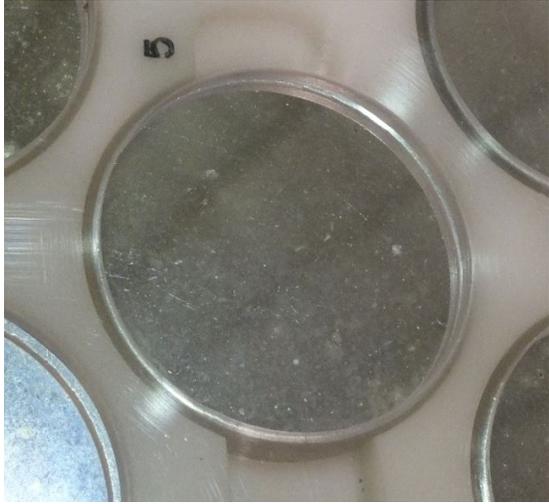
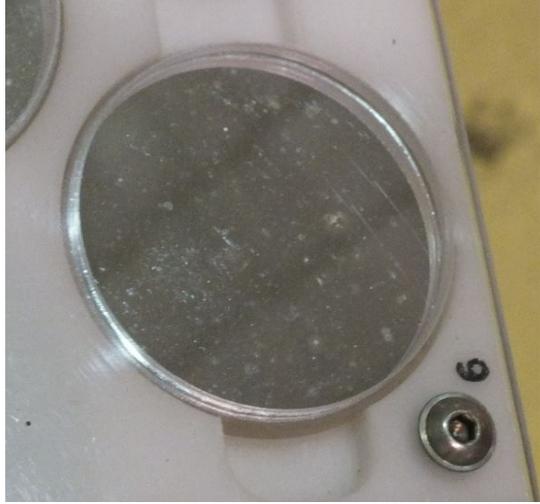
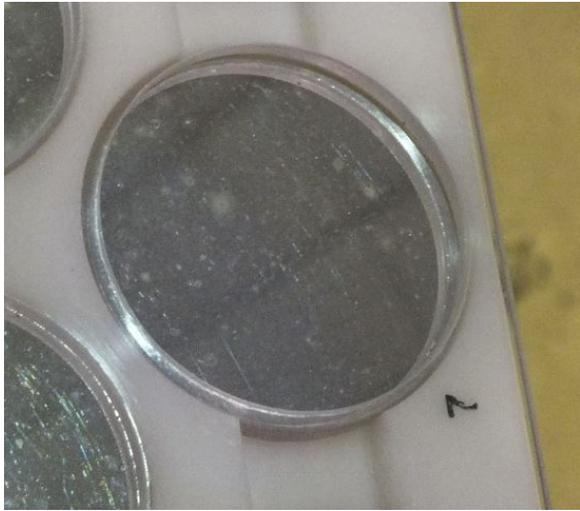
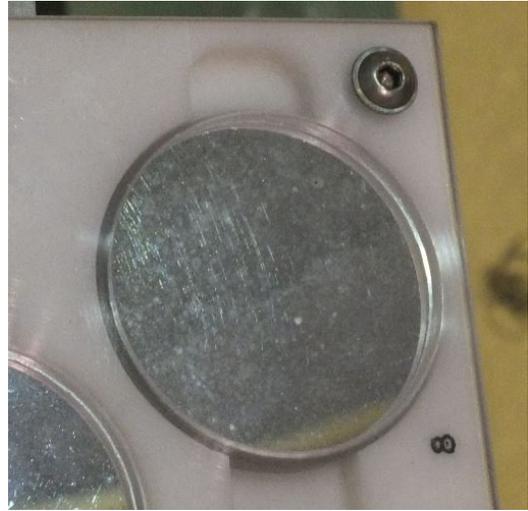
I took pictures of the 2" disks that have been exposed to the dome atmosphere for many months, now. Eight of them face upwards at an angle and eight face downward. I only took pictures of the up-facing ones. Of these, #4 and #6 appeared to have the best reflectivity. #3, #5 and #7 were specular but with nucleation sites of surface degradation. #1, #2 and #8 all had a gray scattering look.
