## Mt. Hamilton Optics Cleaning Trip 6/5/14

David Hilyard and Brian DuPraw

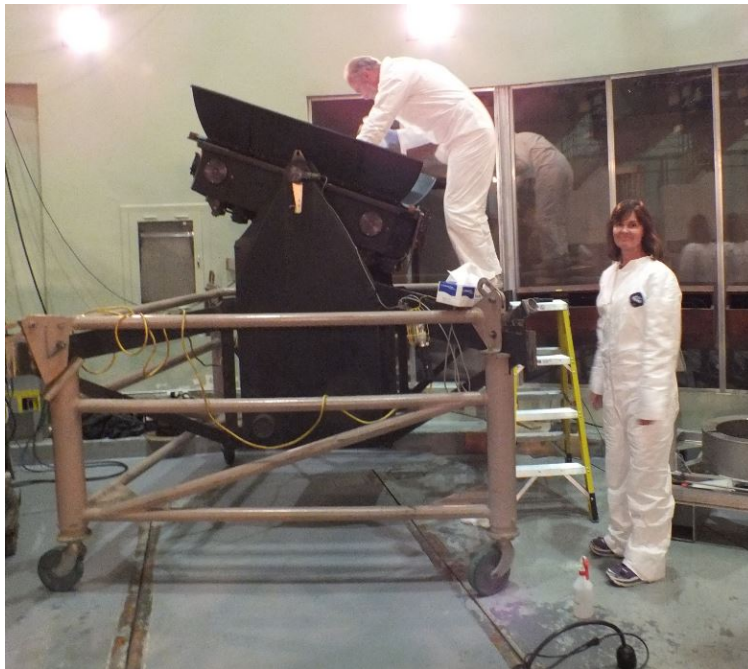
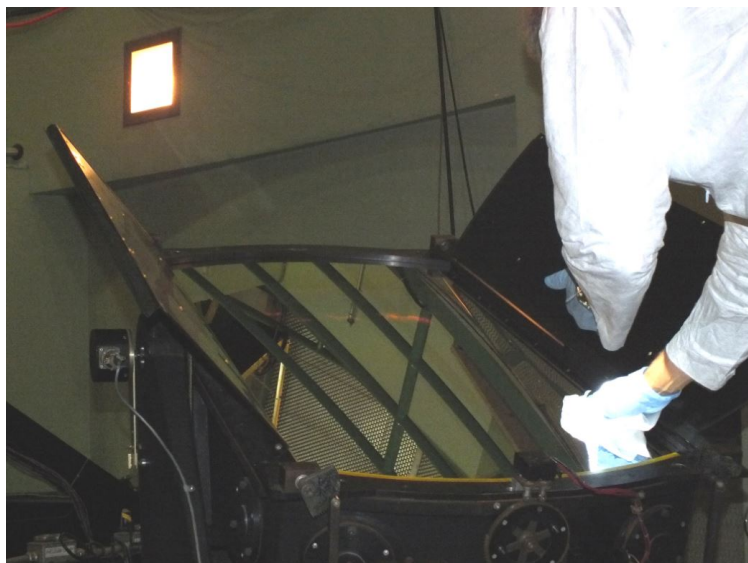
The first mirror cleaned was the 120" telescope's Coude M3, which was in its stand on the dome floor. We measured the reflectivity before cleaning and found it was 92% with the red filter, compared to the reference mirror, and 87% with the blue filter. Dave washed the mirror by spraying de-ionized water on it and dabbing it off, followed by an Orvus/acetone/H<sub>2</sub>O mix, more water, then ethanol. The reflectivity after cleaning didn't show much change (92% red and 87% blue) however it appeared much better visually.

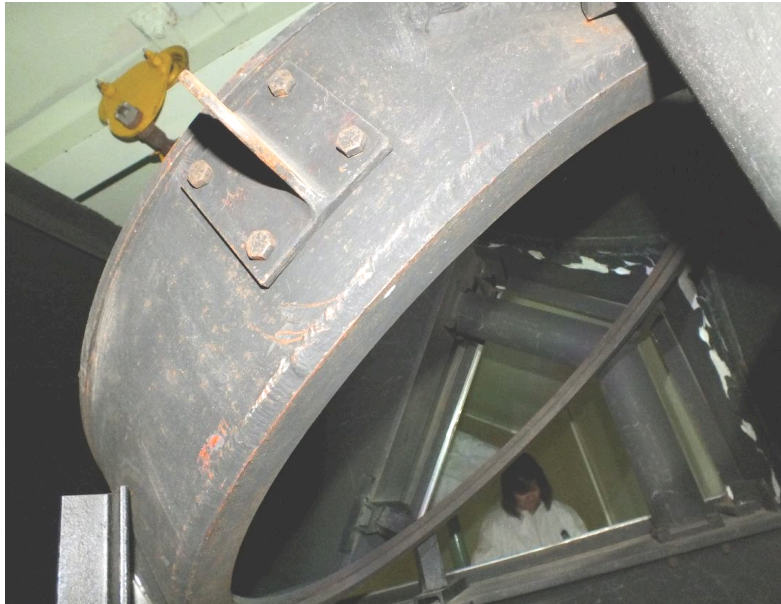
This mirror is the second in the Auxiliary Telescope set and faces downward at a 45 degree angle so doesn't get as dirty as the upward-facing primary. Dave tried cleaning a small area and it had no effect so he didn't clean the rest. We measured 84% relative reflectivity with both the red and blue filters.

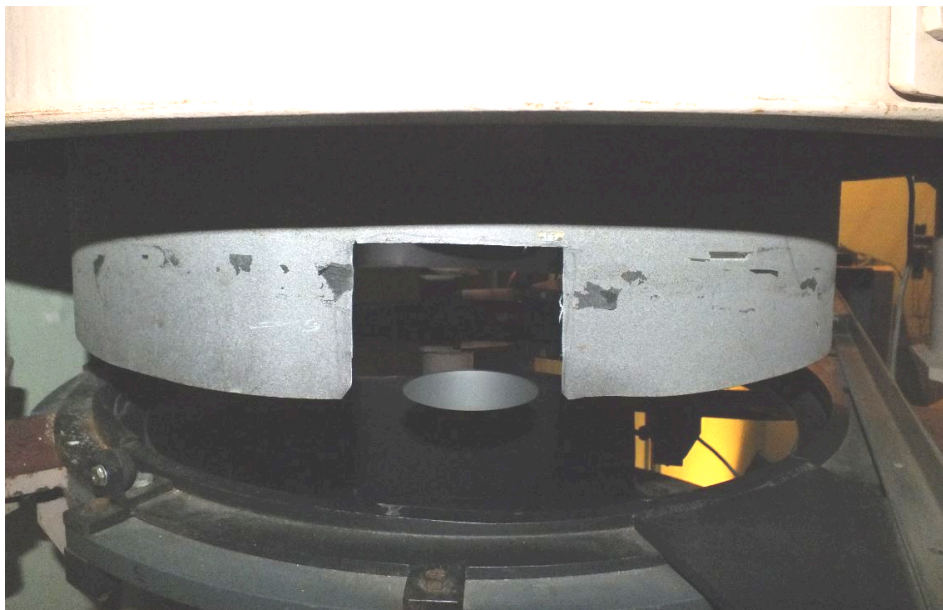
**CAT Primary Mirror After Cleaning (1)**

The third mirror in the Auxiliary Telescope set, the primary is known to get dirty quickly due to being upward-facing, and this trip was no exception. It was blown off with canned air then cleaned with water, followed by Orvus/acetone/H<sub>2</sub>O then ethanol. The small access hole doesn't allow room for our bulky reflectometer to be used without excessive risk to the mirror, so no measurements were made.

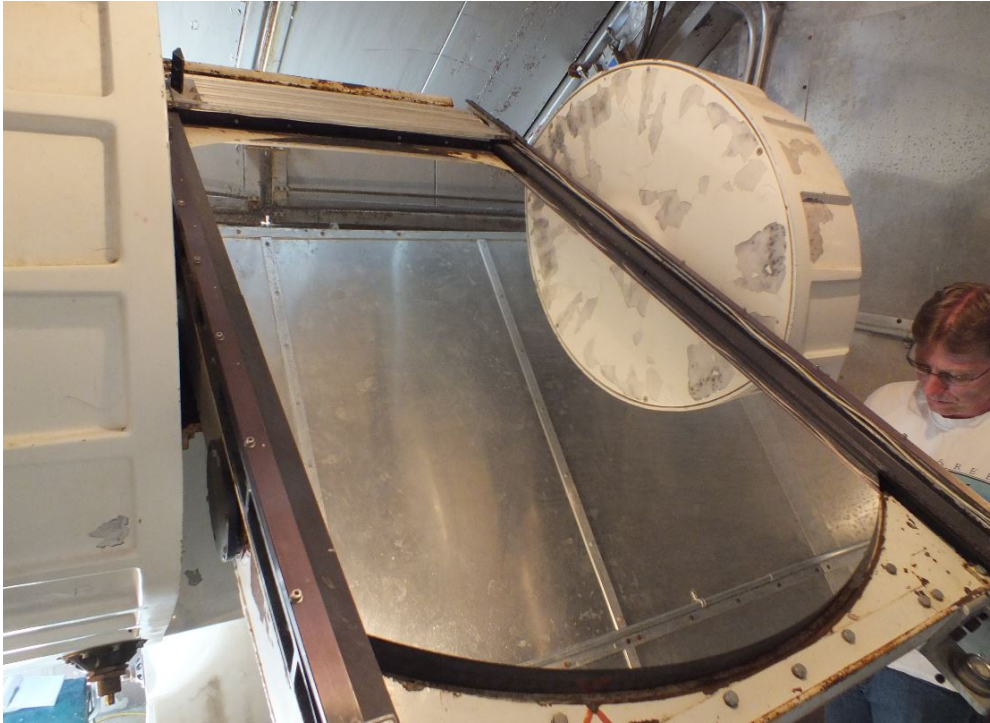
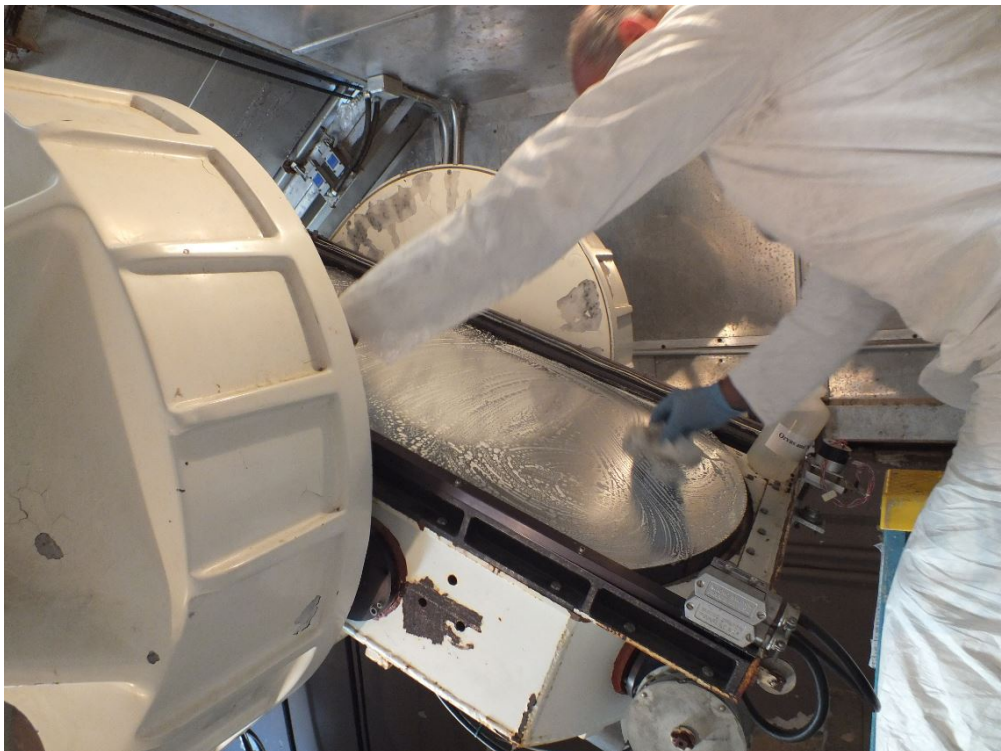
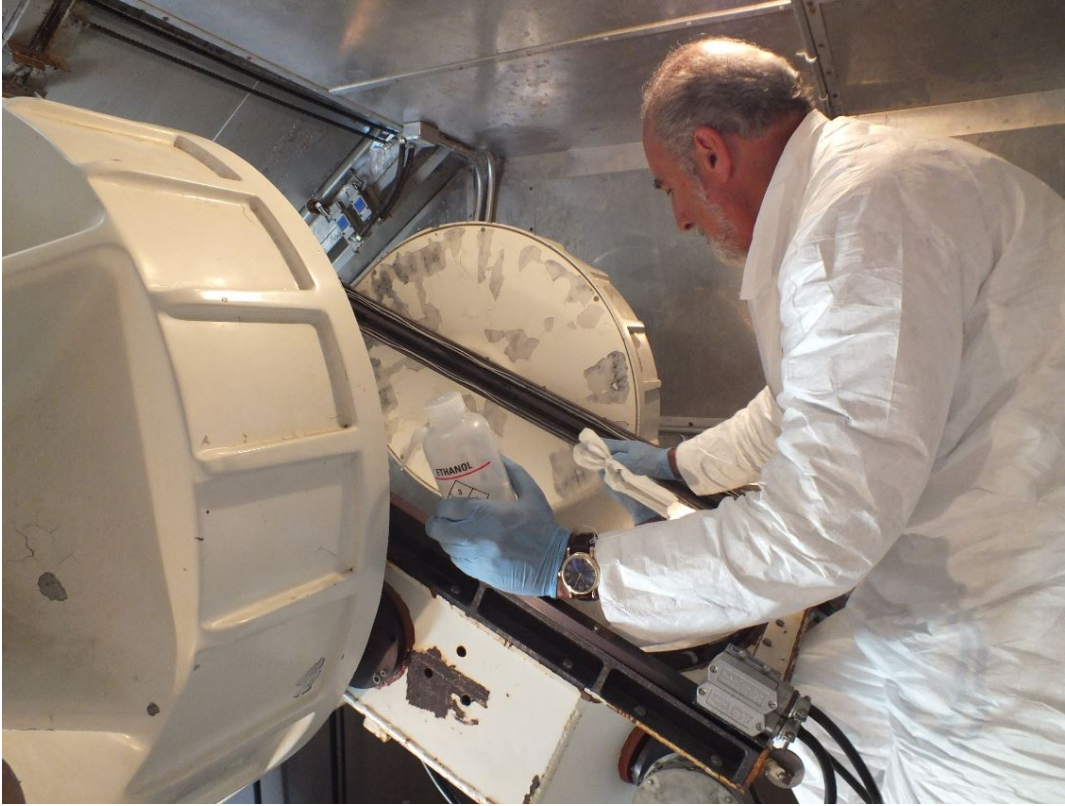
The first Coude Auxiliary Telescope mirror is housed in a shed-like structure outside the 120" dome. It has a robust coated surface so is cleanable. We measured 84% reflectivity in the red before cleaning and 86% in the blue. After cleaning it was measured to be 87% red and 90% blue. It was cleaned by blowing it off with canned air, then using sprayed-on de-ionized water followed by Orvus/H<sub>2</sub>O (without acetone), more water, then ethanol.

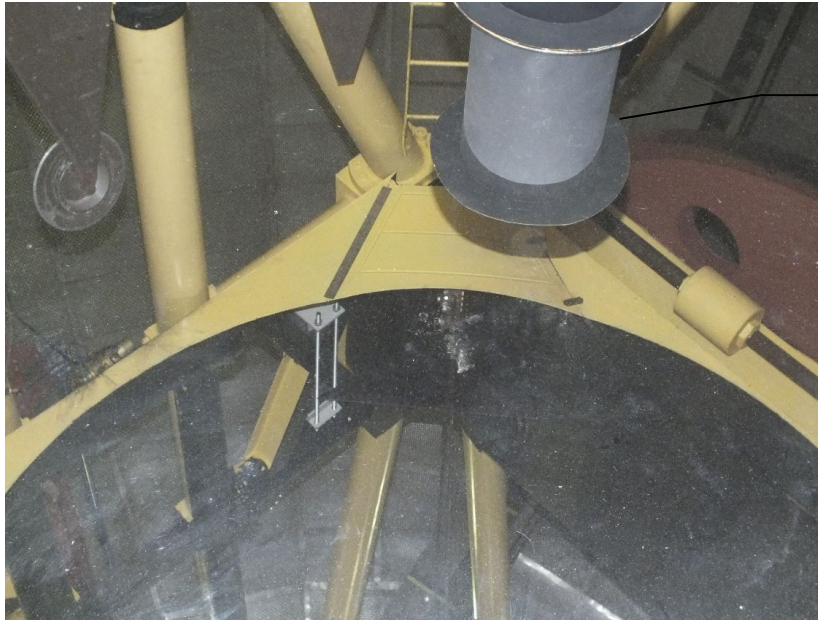
Top Hat in center of mirror

The 120" primary was a little dusty but not too bad. It could probably stand to be CO2-cleaned. There were no notable oil spots since we last washed it in February.

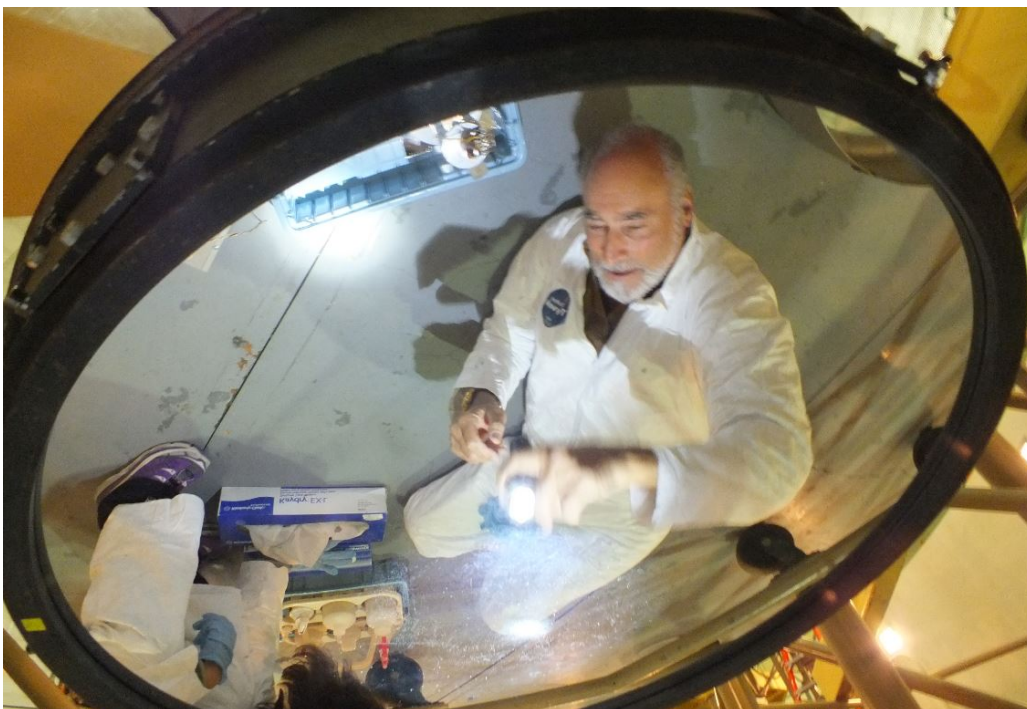
This secondary mirror for the Shane 120" telescope was on the dome floor. It is known to have a fragile coating that is not safely cleanable. The coating is also pitted. We measured 90% reflectivity with both the red and blue filters.

**Coude Secondary Mirror Pitting Example**

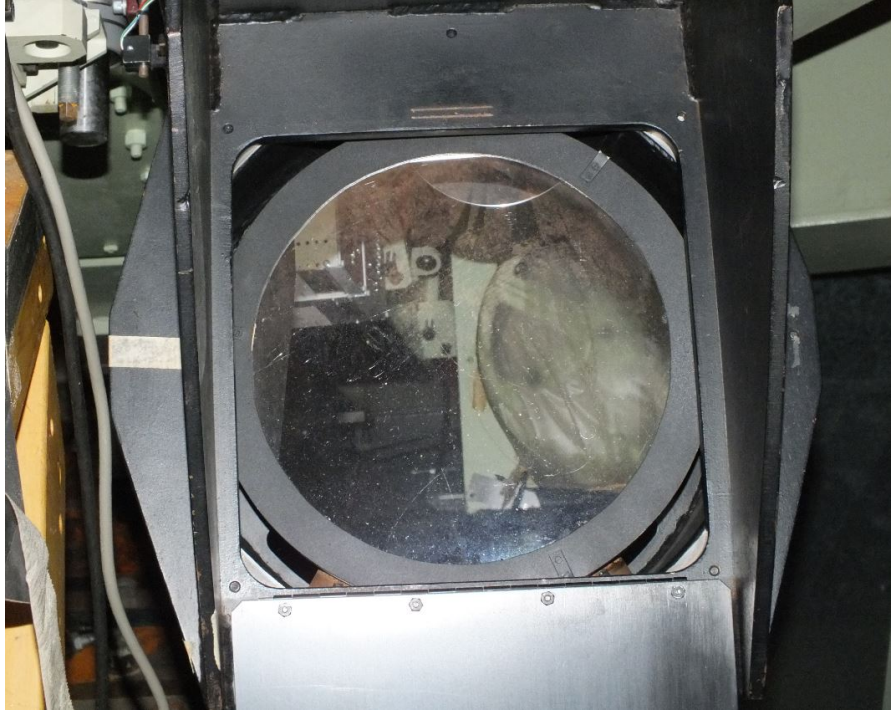
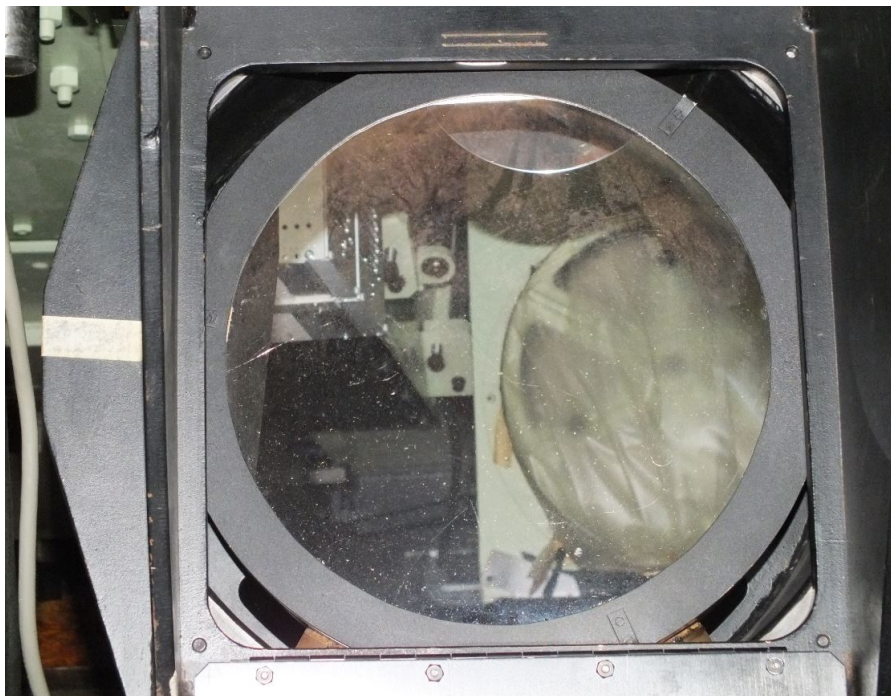
This mirror is behind a magnetically-closed cover. It has a known bad surface that has been seen to return to its poor condition even after re-coating. Note the brownish discoloration at the top of the mirror in the photo. The coating is also too fragile to clean.

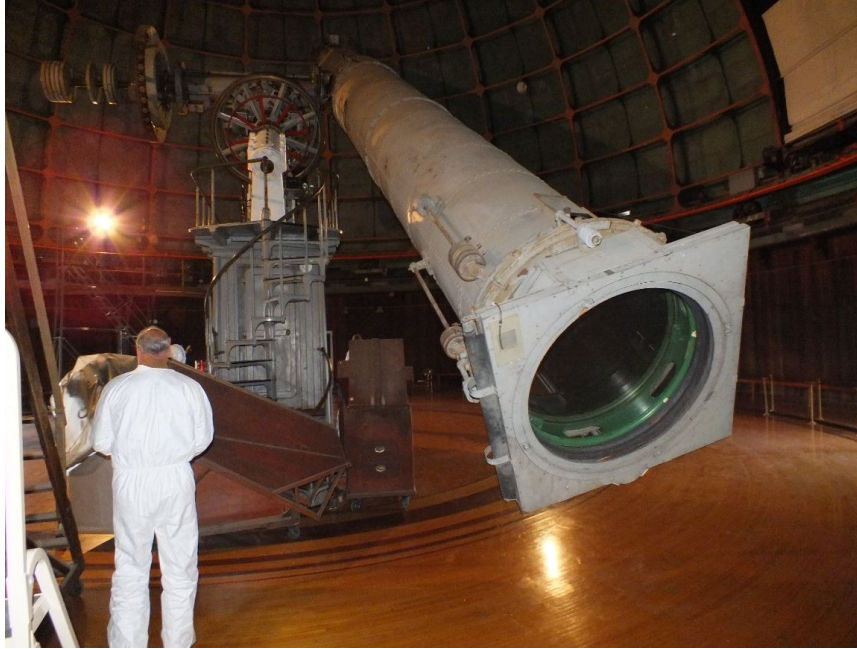
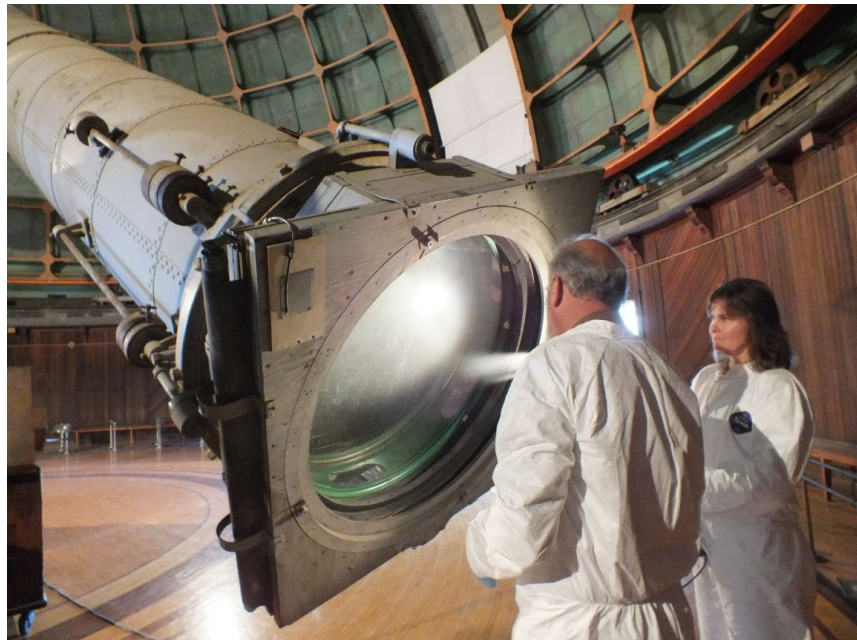
The 36" refractor's objective lens had been lowered to a reachable height and the lens access holes had been opened before our arrival. Dave inspected them and blew the dust off the outermost surface with canned air.

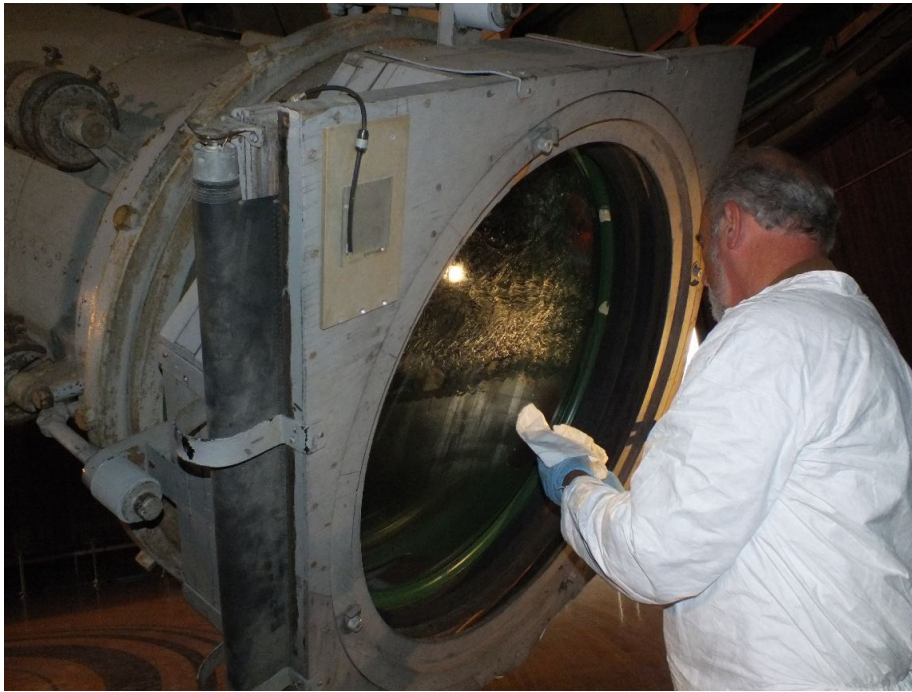
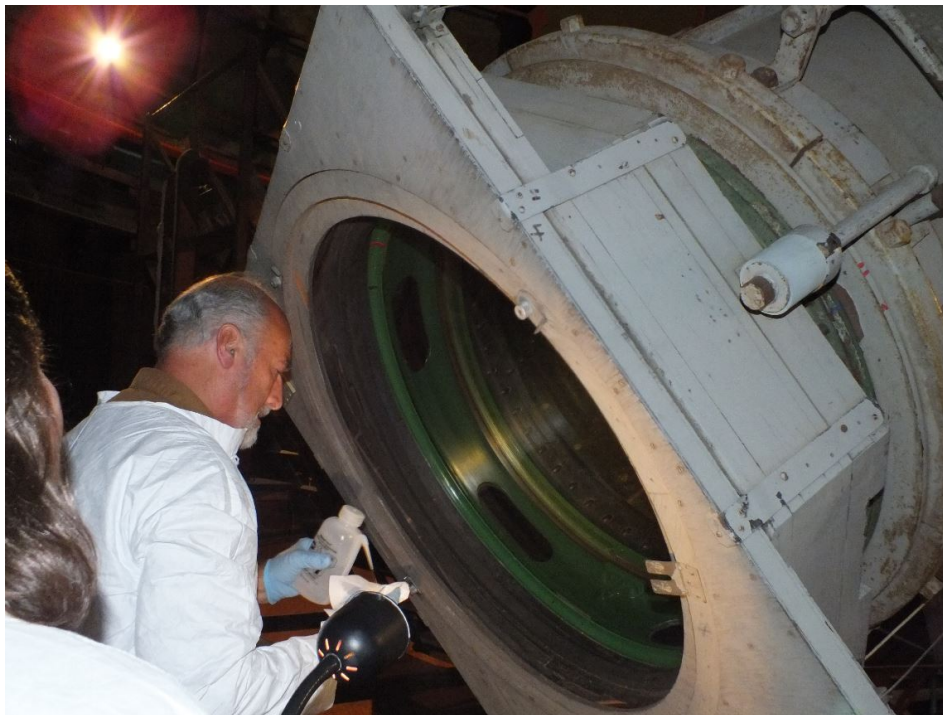
Then he sprayed on de-ionized water and dabbed the dust off. Following that he used Orvus/H2O mix (without acetone) followed by a dry wipe to get rid of soap smears. The back surface was known to have started crizzling, but there was nothing to be done about it but observe its progression.

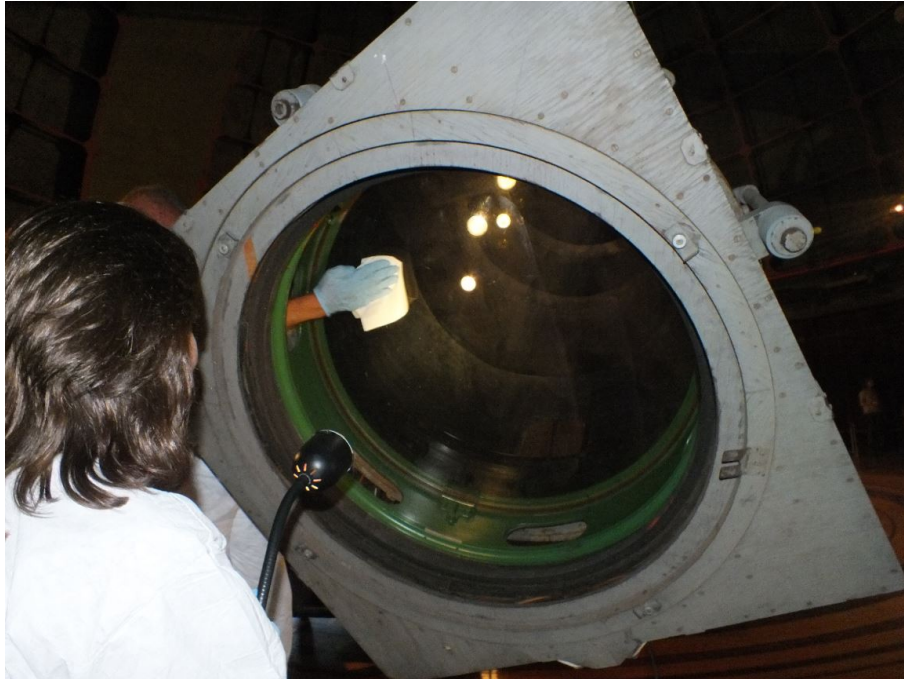
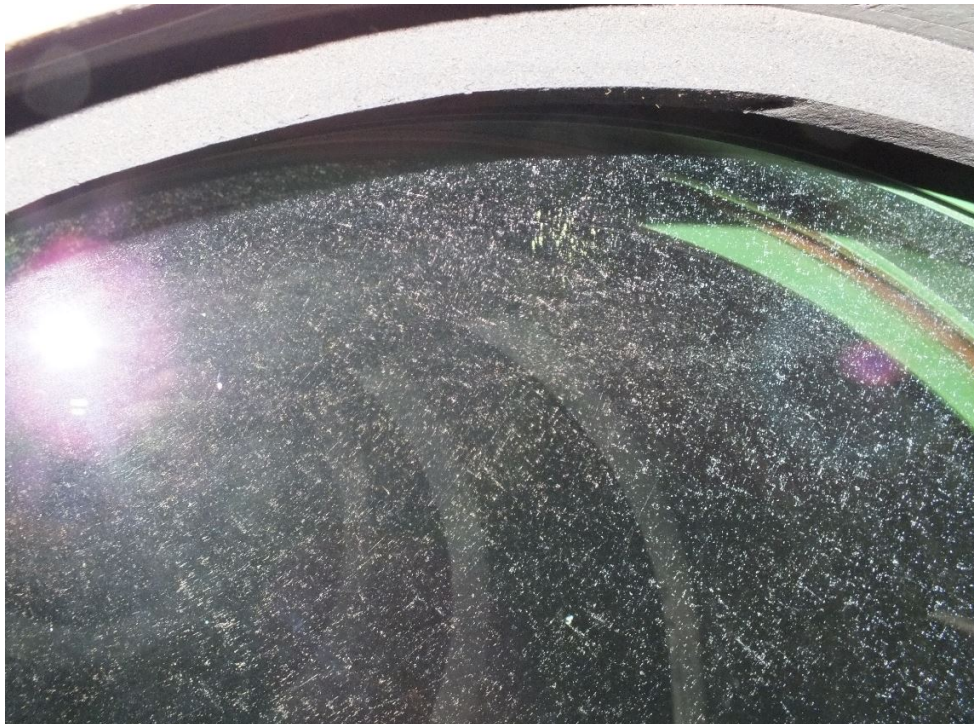
**Crizzling of the 36" Refractor**

He blew the dust off the inner surface and cleaned that with Orvus/H2O as well, reaching through the limited access holes.

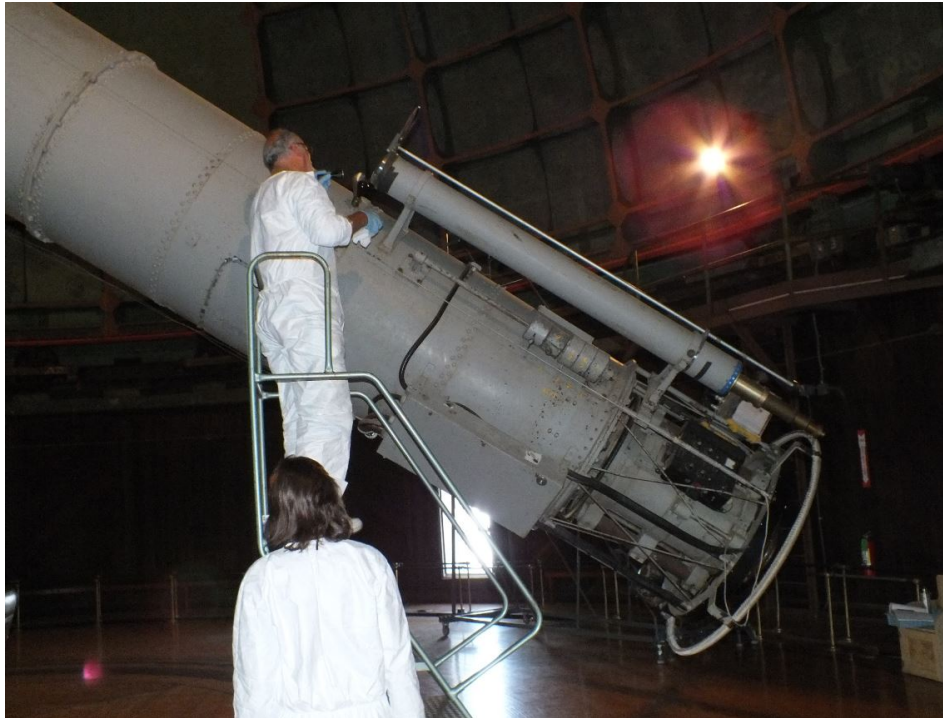
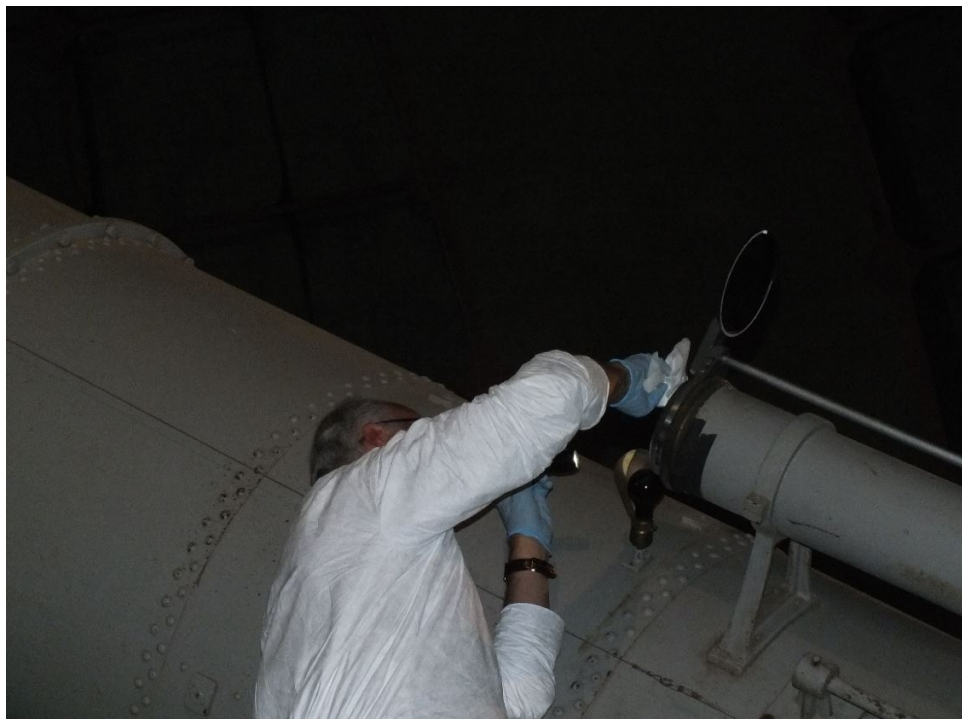
After the access holes were all closed Donny lowered the other end of the telescope to near the floor so that the eyepiece and spotting scope could be cleaned. Ellie removed the eyepiece and brought it to a desk at the base of the telescope's mount where Dave cleaned it by first putting Orvus/H<sub>2</sub>O on a tissue and the following up with a dry tissue.

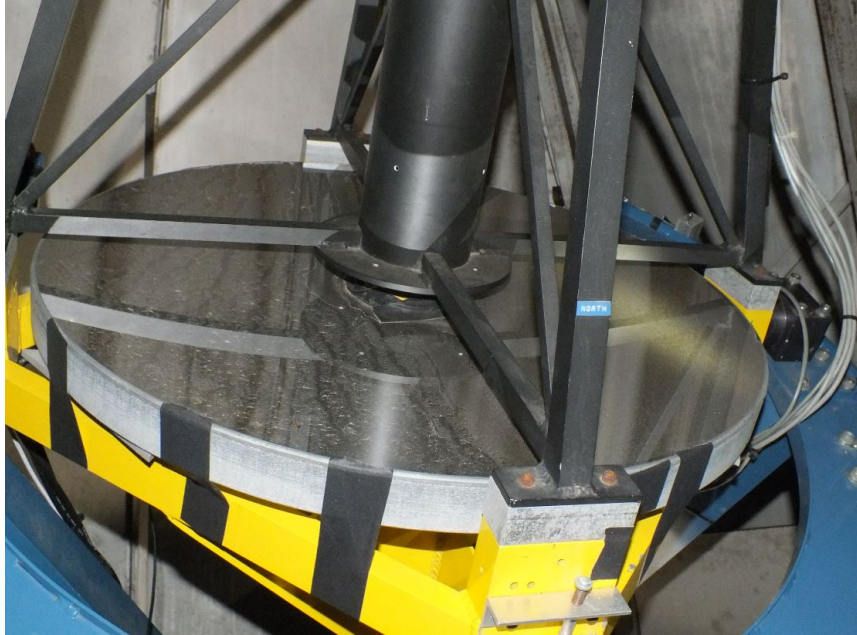
This telescope is in a separate dome that is off the main highway a little past the 120" telescope. It is operated remotely, from Berkeley if I'm not mistaken. Its primary mirror gets dirty relatively quickly and has a permanent stain from a water rivulet, located below a strut. Before cleaning we measured the reflectivity to be 90% with the red filter and 82% with the blue. After cleaning with water and Orvus/H<sub>2</sub>O it improved to 98% in the red (relative to the reference) and 85% in the blue.

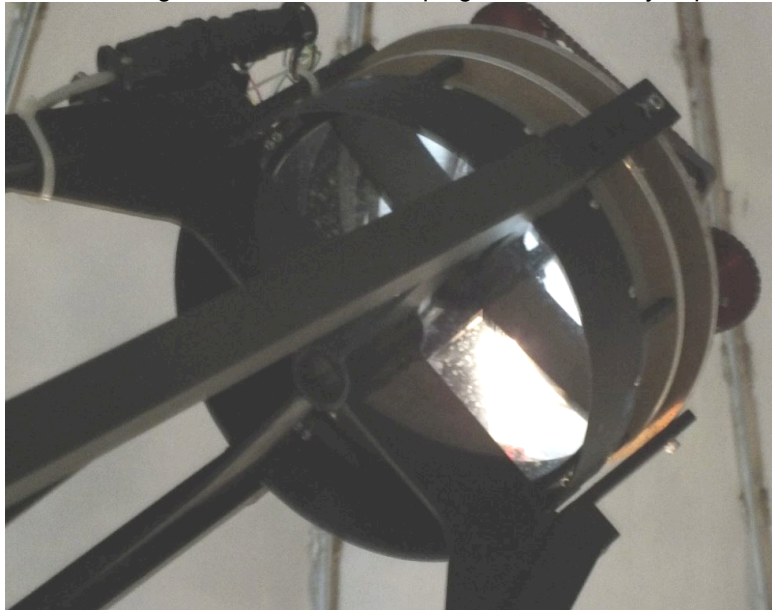
The secondary has spots that are permanent stains. Dave cleaned the surface as best he could by dabbing, given that struts crossing the mirror made a wiping motion virtually impossible.
