Mt. Hamilton Optics Cleaning Trip #7

David Hilyard and Brian DuPraw

5/17/11

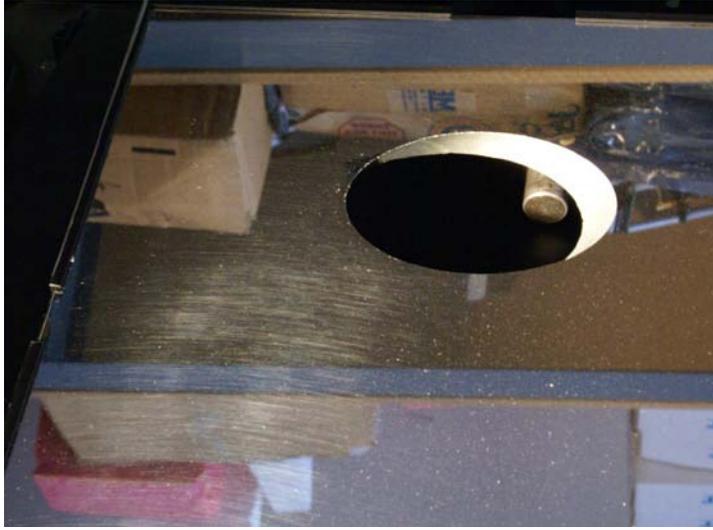
120" Telescope Diagonal Mirror with small hole

This diagonal mirror had a relatively small oblong hole, compared to a similar mirror with a large hole. This one is used for the KAST camera, primarily. It had light sleeves over much of its surface. Dave blew it off with canned air and cleaned it with ethanol, then acetone. After cleaning it was measured to have 78% reflectivity with both red and blue filters (relative to the standard witness kept with the reflectometer)

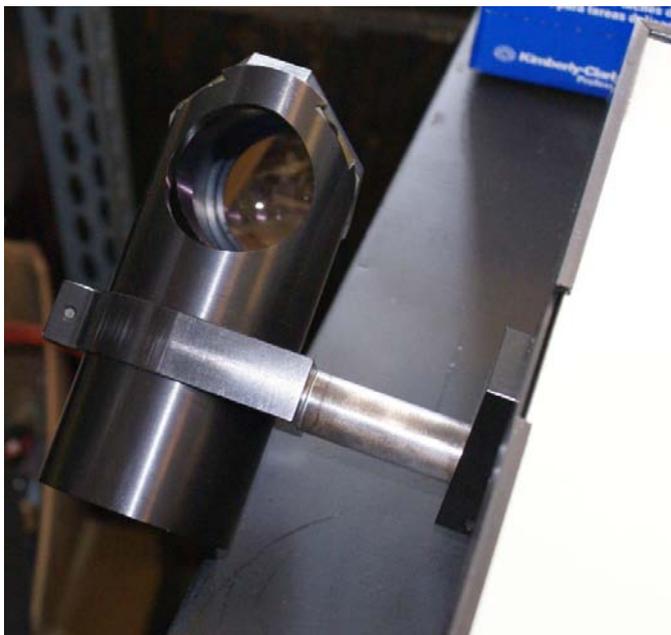
There was a periscope attached to the frame, and Dave cleaned it with acetone. He cleaned the outside of the lens, only, using ethanol (didn't remove it from the assembly).

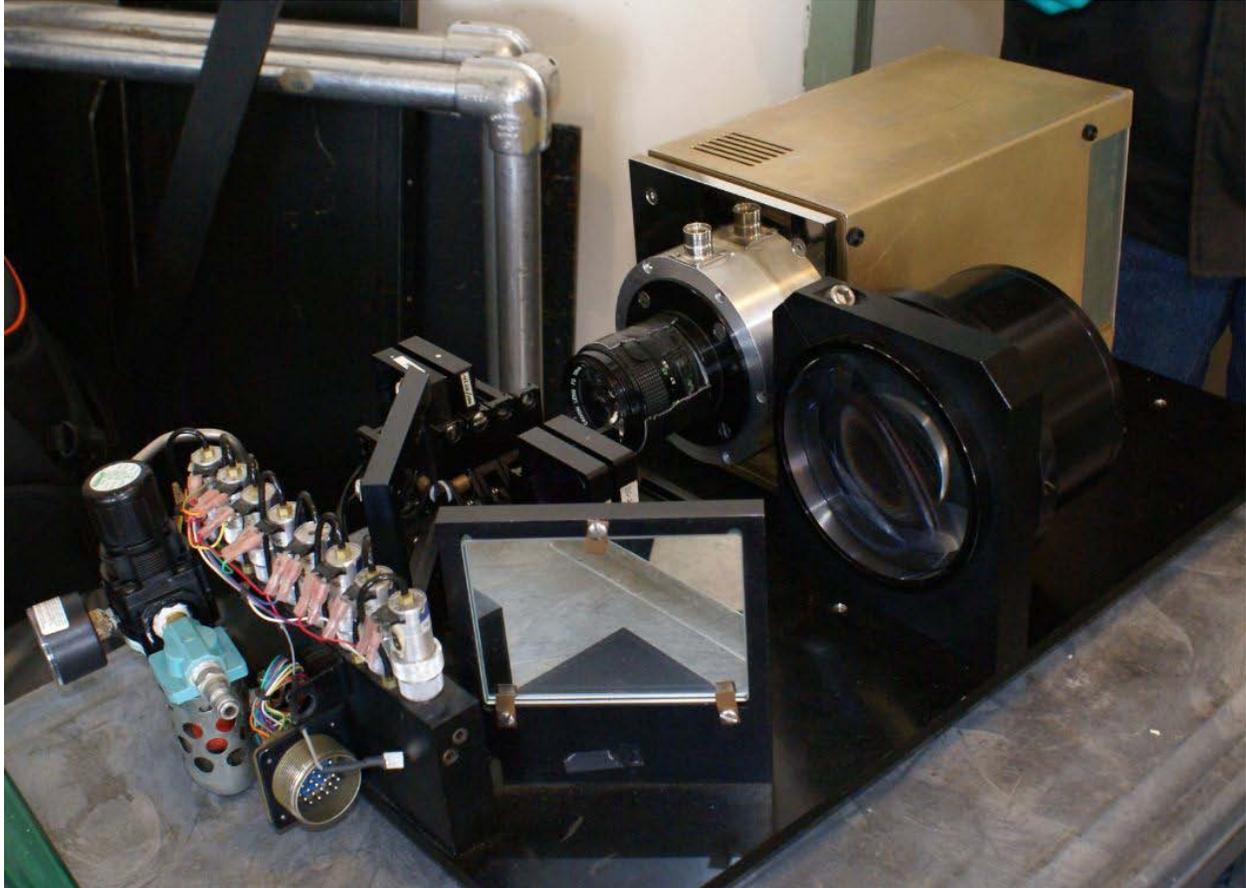
120" Telescope Guider Camera Assembly

The light from the 120" primary is brought in via the diagonal mirror, goes through the transfer optic (large lens on the side), then is folded back around to the camera by two flat mirrors. In front of the camera there are a number of filters and a focusing lens that can be flipped in or out.

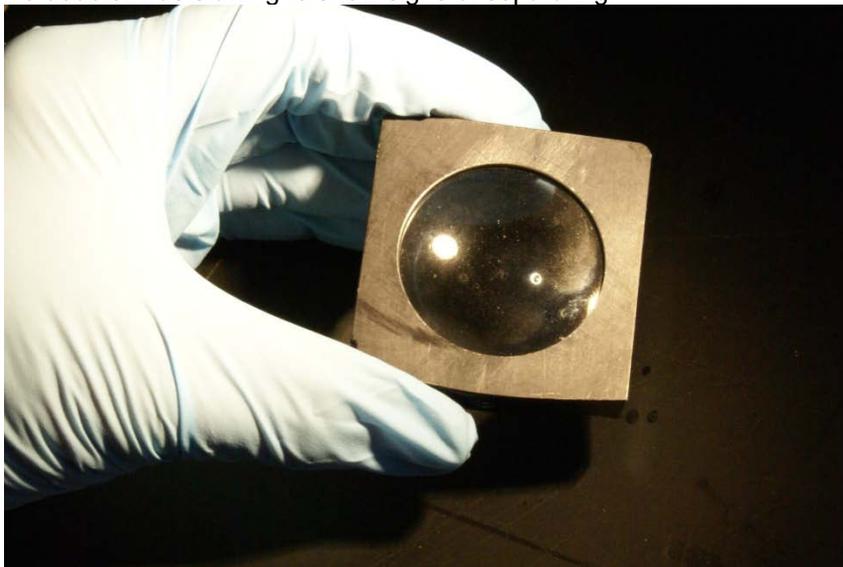
The focusing lens was dusty and had fingerprints. Dave took it out of its frame to clean it and found that the doublet was starting to show signs of separating.

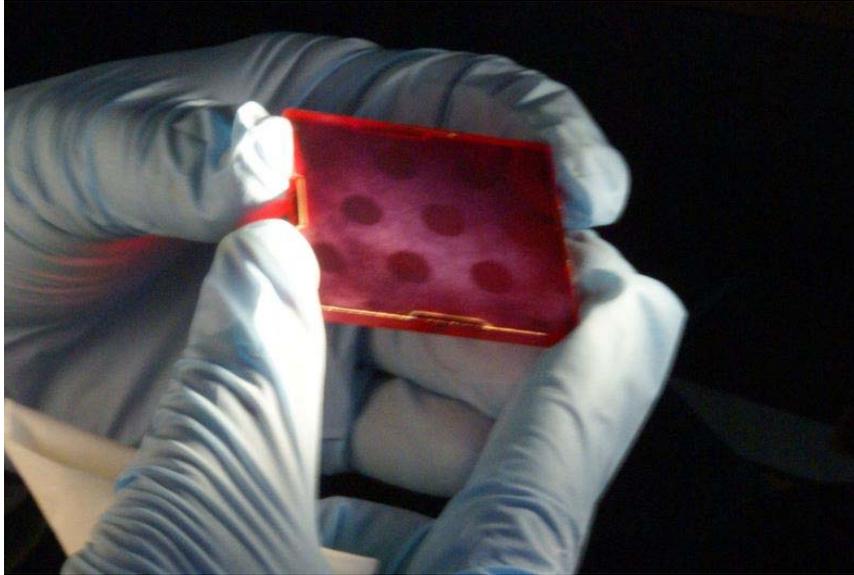
He cleaned the lens and the filters with breath and ethanol. The H-alpha filter had 7 weird dots about 5-10 mm diameter visible in it.

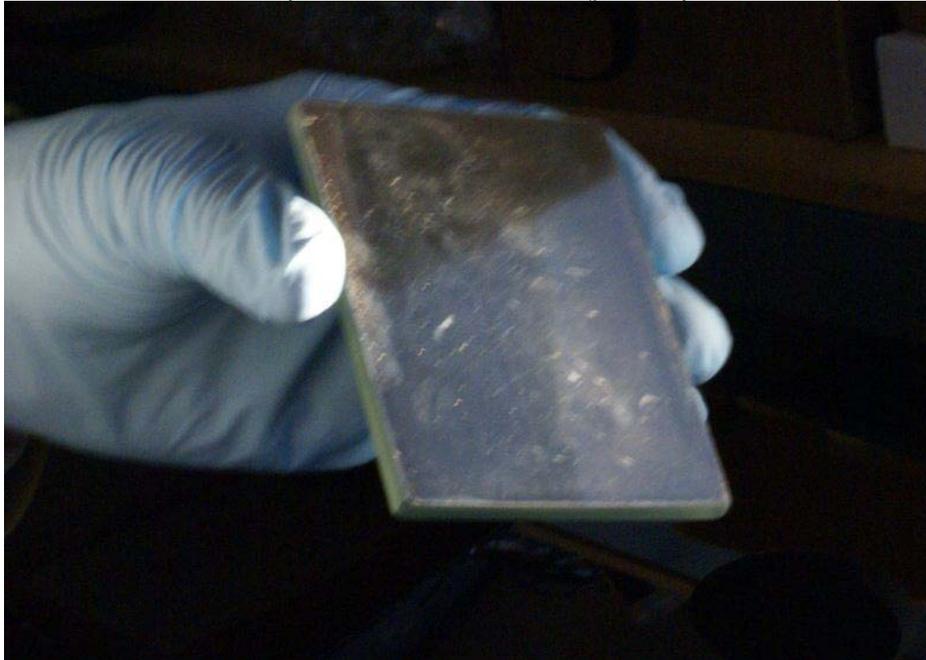
The flat mirrors were dirty and sleeked but robust (probably commercial) and cleaned up with breath.

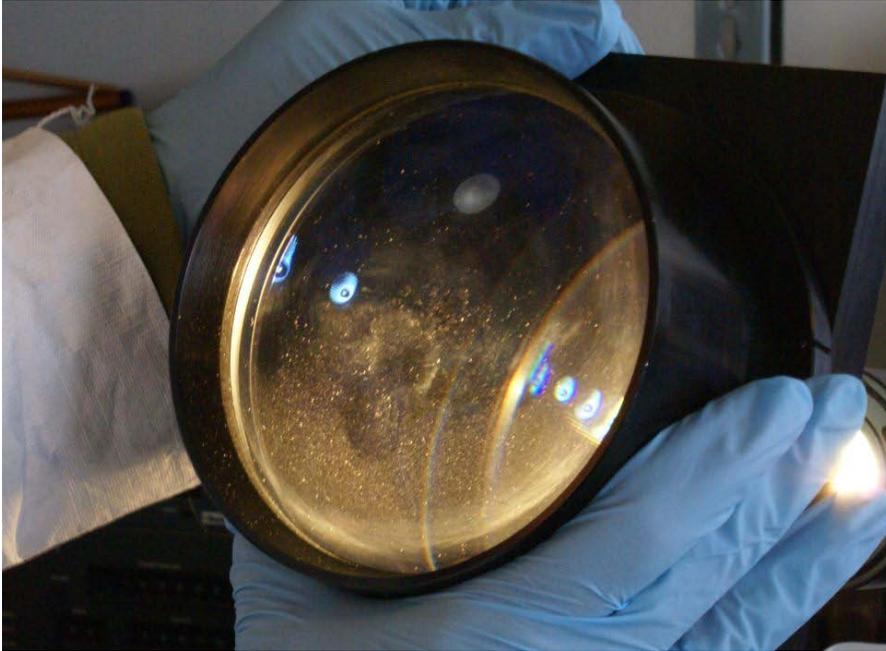
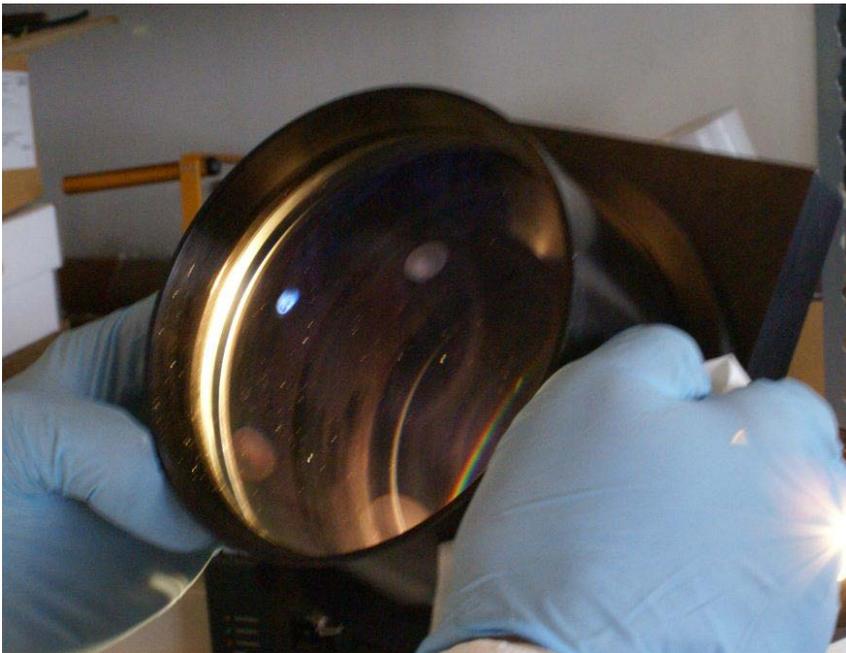
The transfer lens was removed by turning the entire camera assembly on its side and unscrewing it. Dave brushed off both the lens and the frame with a camel-hair brush, then he wiped the lens with acetone and breath, followed by ethanol.

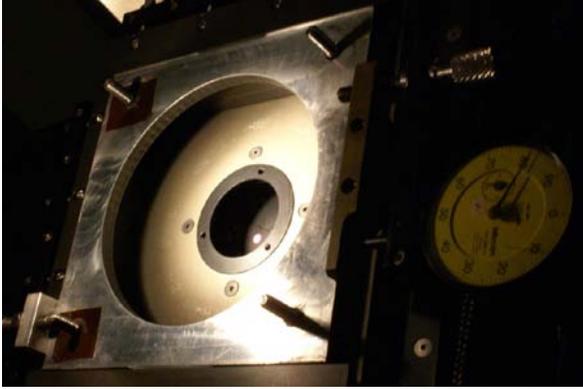
Dave cleaned both the red and the blue side KAST cameras. Kostas removed a cover on the red camera, mentioning that there were shims that needed to not get dropped or lost. Both lenses were slightly dusty before cleaning.

Blue camera after cleaning

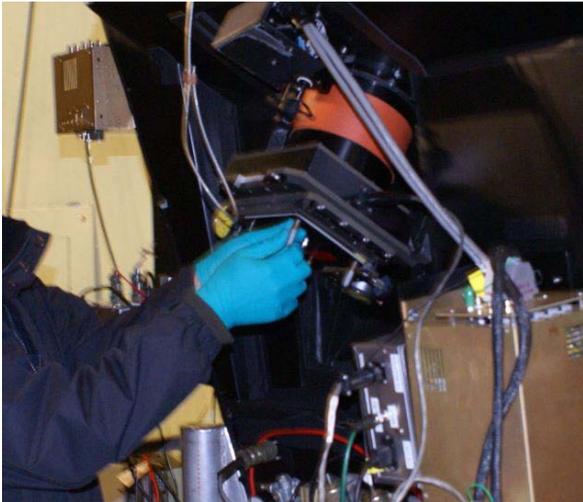
Red Camera cover removal

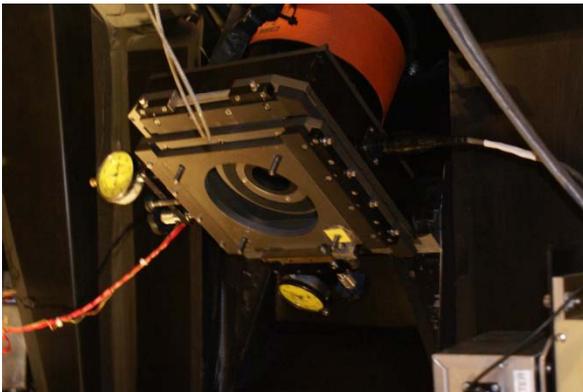
Red camera uncovered

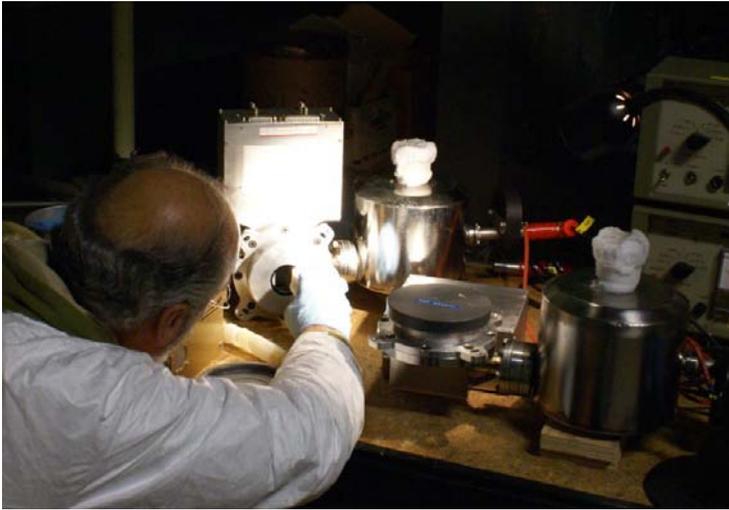
Dave cleaned the Red and Blue KAST Dewar windows. They weren't too bad beforehand but were even cleaner after.

Cleaning blue side Dewar

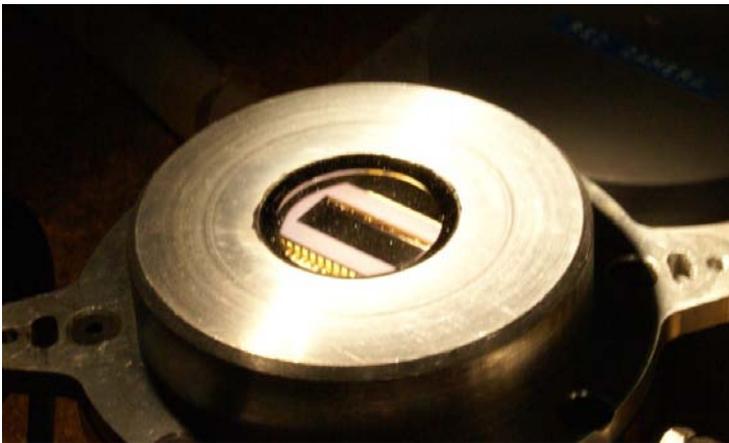
Red side Dewar window dusty

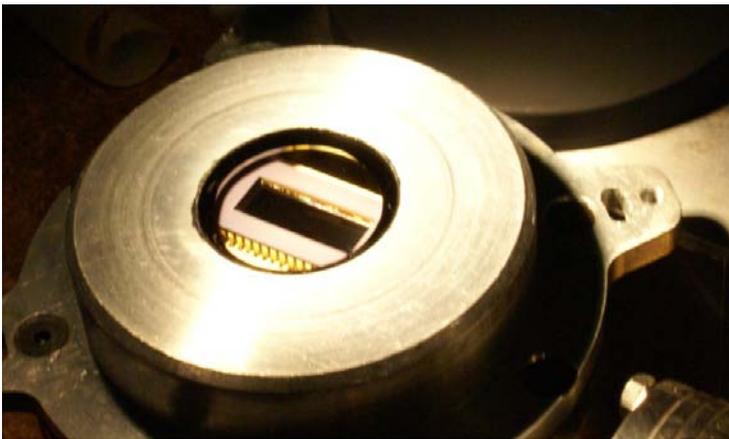
Red side Dewar after cleaning

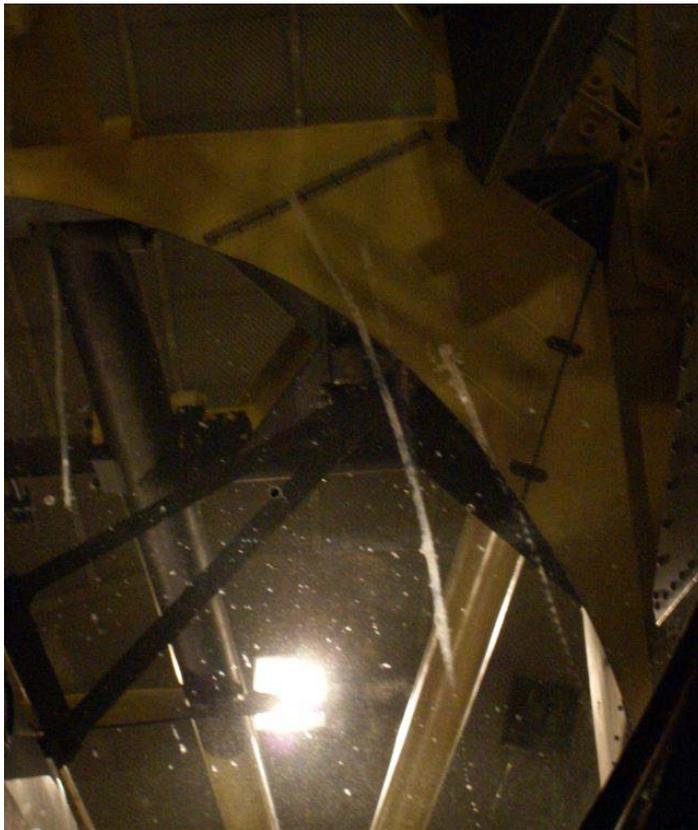
Water stain streaks (long curved lines)

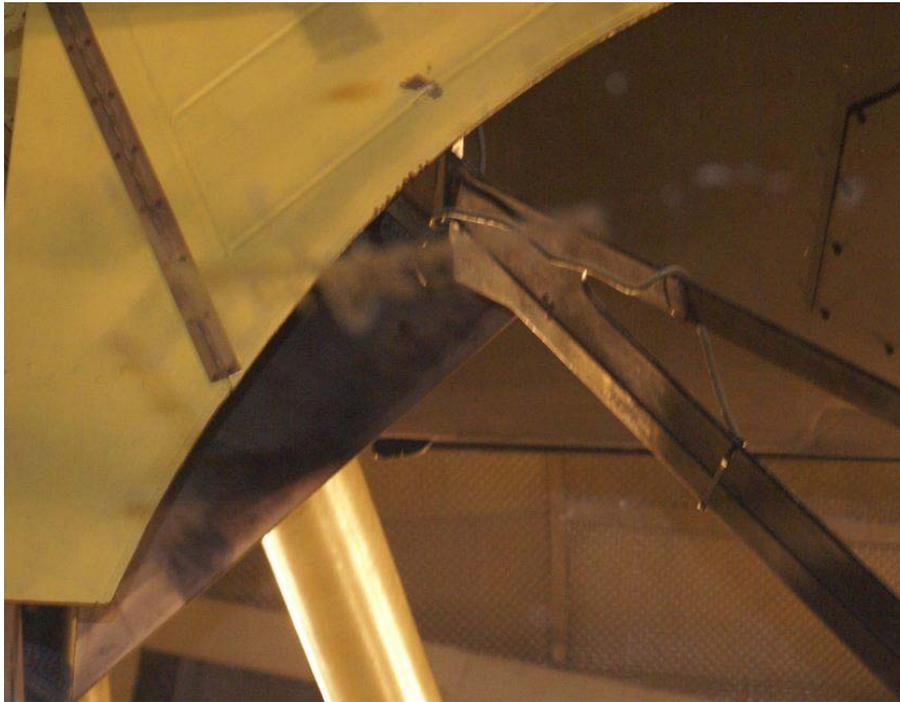
Dave was not able to reach much of the mirror surface, since the wedge-shaped cover pieces formed a formidable fence. The scaffold was not in place, since we weren't scheduled to wash it. Dave was able to reach one sizeable oil spot and clean it, though. It is the unfocused smudge in this photo.

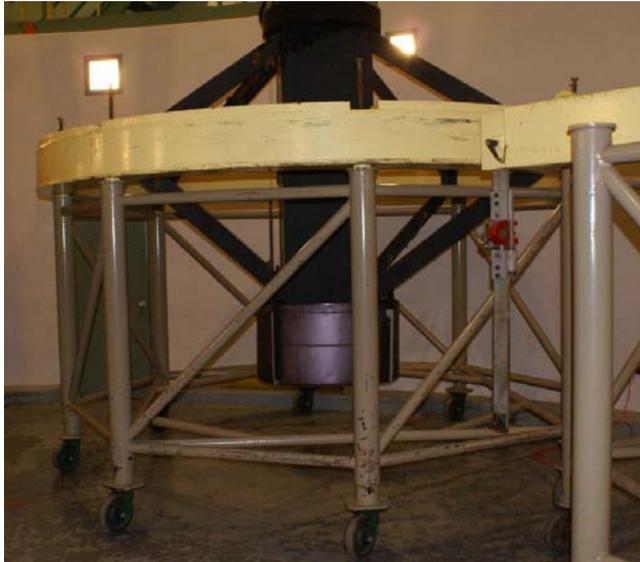
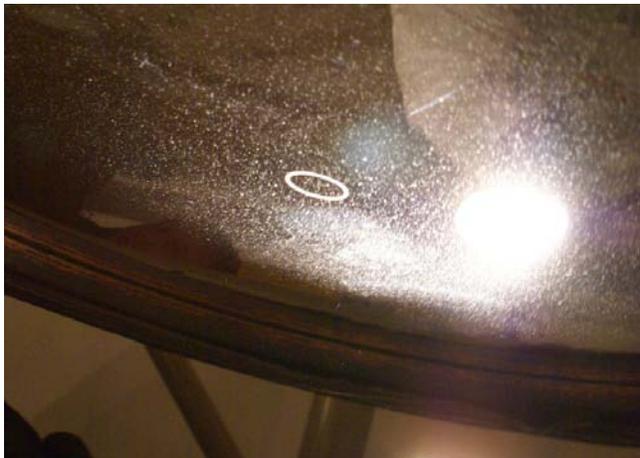
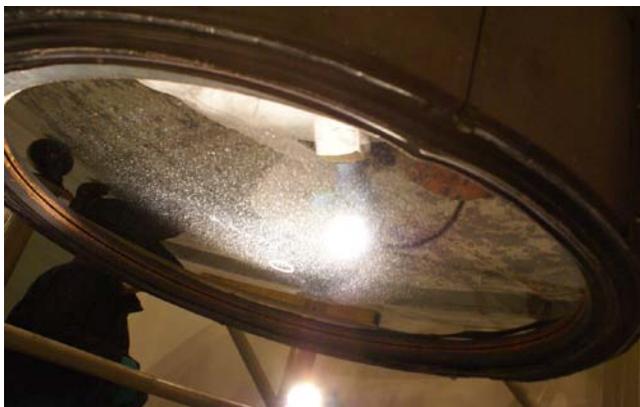
120" Telescope Cass Secondary

We had found on a previous trip that the Cass secondary was uniformly pitted. We were only able to take more pictures; couldn't clean it.

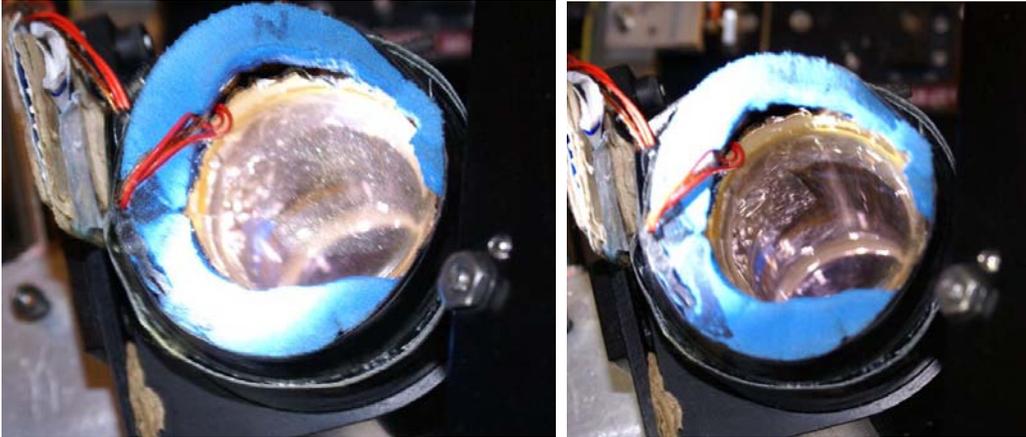
a) Iodine cell

Heated to 50 deg C.... Dave cleaned dusty outer surface with ethanol

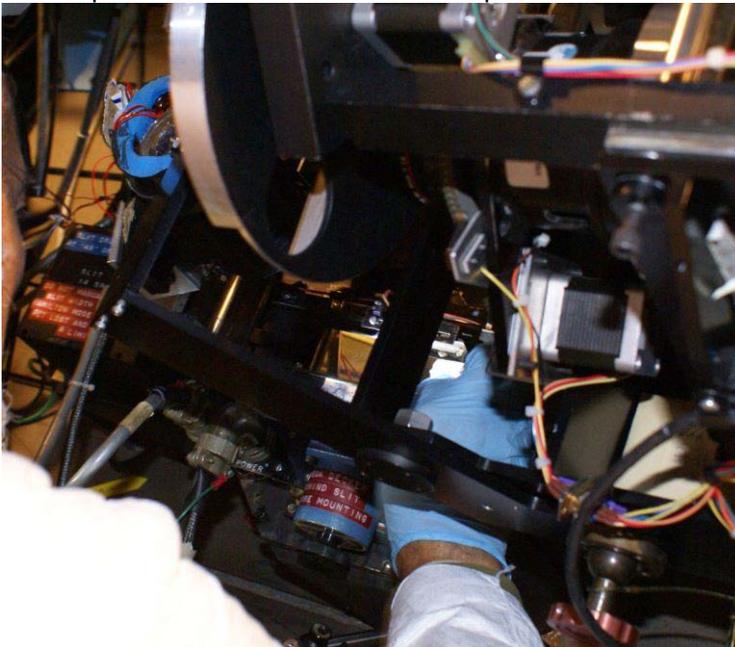
b) Decker Plate

Dave wiped off the surface of the Decker plate

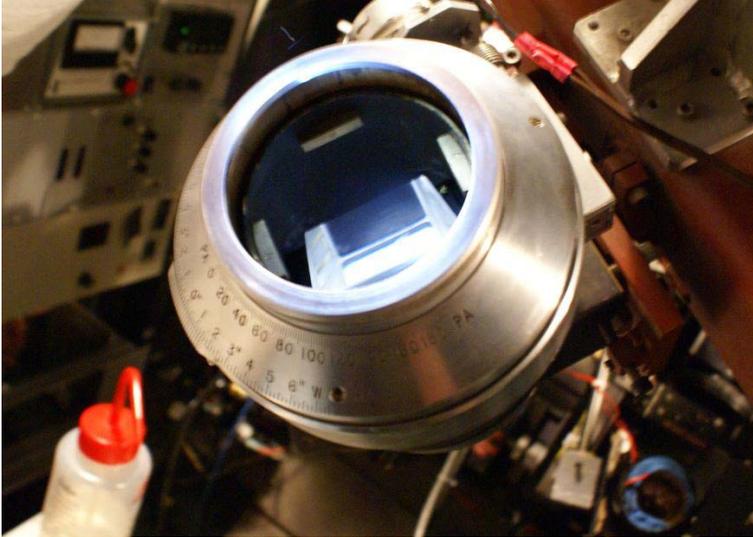
At first we couldn't find how to lower the image rotator to a more accessible position, so Dave did the initial assessment of the prism inside it via a stepladder. Then Kostas found the switch hidden behind some cabling on the side of an electrical panel in the slit room, and Dave cleaned the prism.

Prism in image rotator can

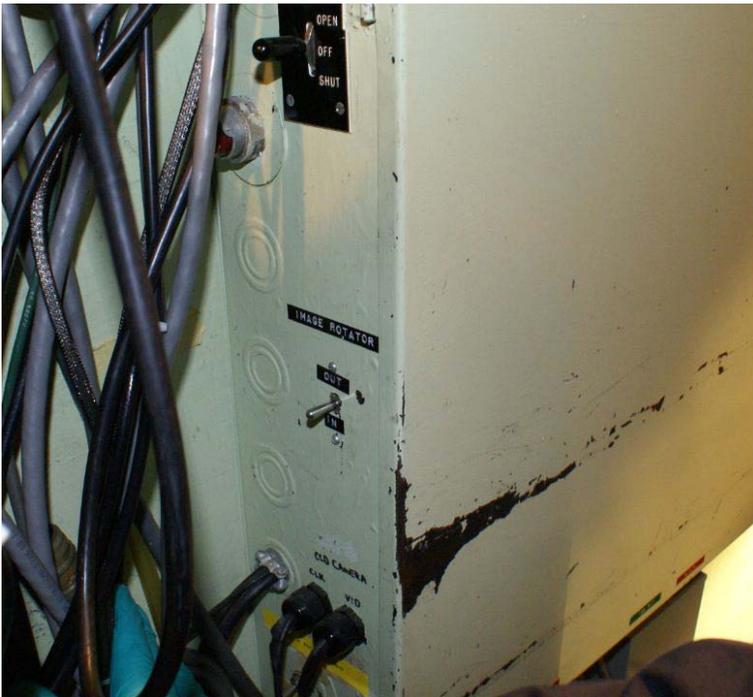
Rotator switch found

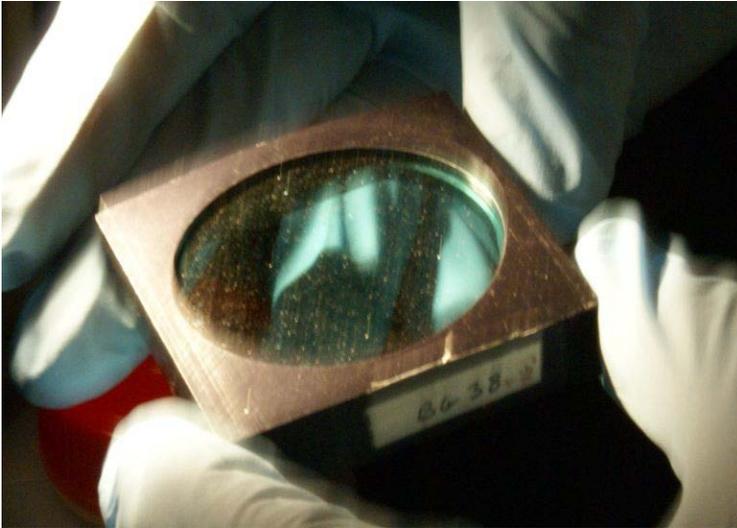
d) Filter Wheel

Dave cleaned several dirty filters from the filter wheel using breath and acetone, including this BG-38, an NG-4, and one labeled "BG-?"

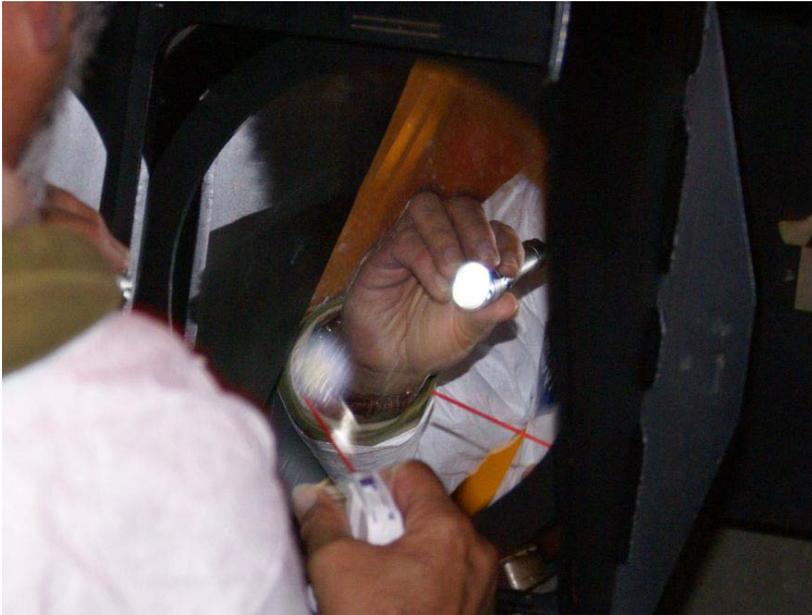
Dave used canned air to blow the dust off the Hamilton Collimator. It had the known defective area on the right side, and also appeared sleeky.

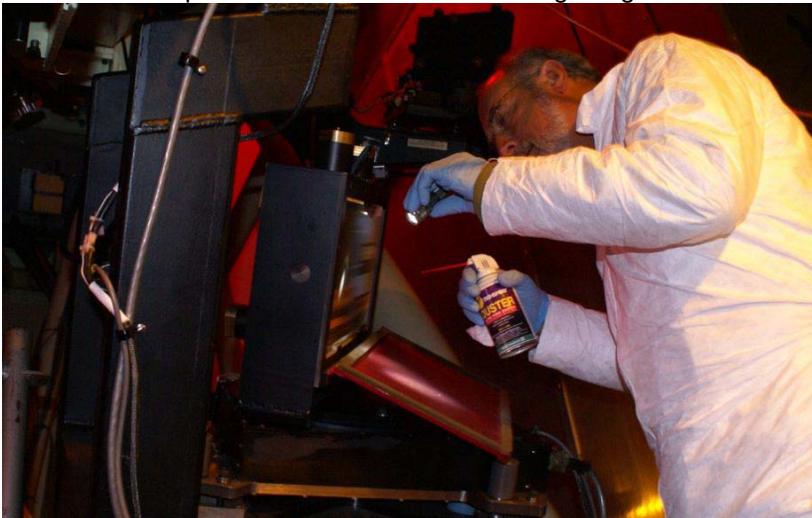
The prism access was open, so Dave wiped it with ethanol. That streaked, so he wiped it again with acetone. In this photo he blows the dust off the grating.
