## Mt. Hamilton Optics Cleaning Trip 10/31/13

David Hilyard and Brian DuPraw

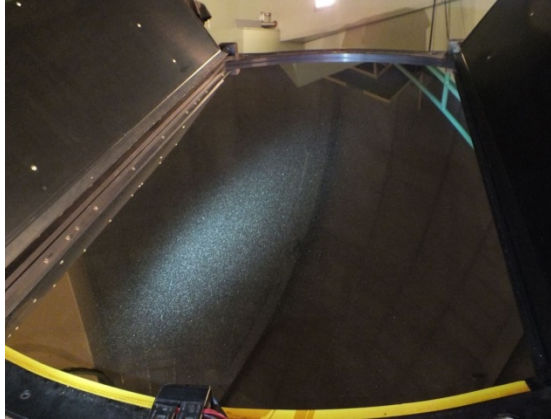
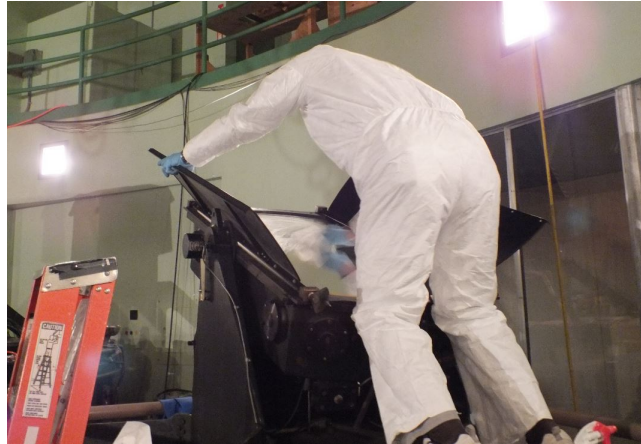
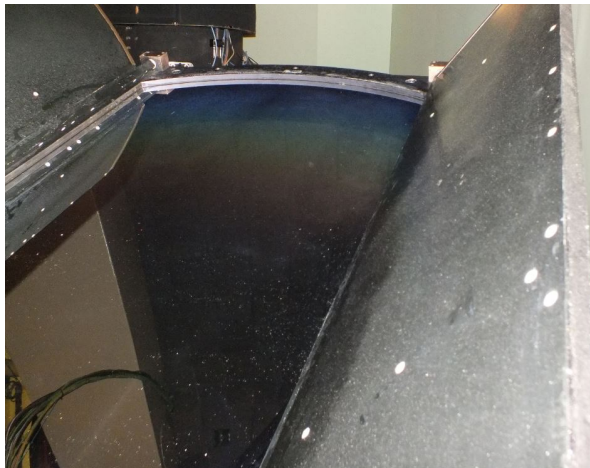
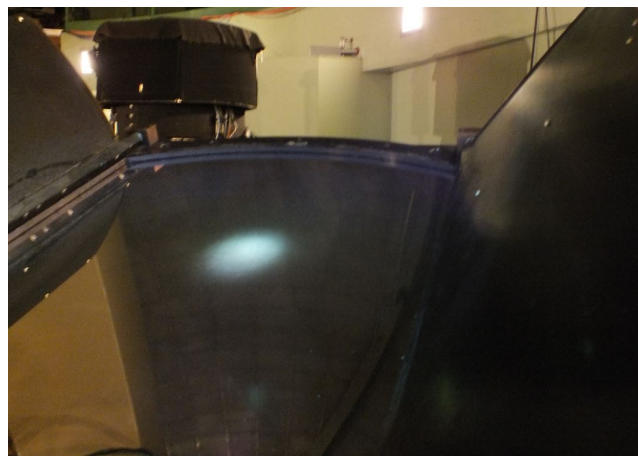
### Shane M3

This mirror was on the dome floor and was very dusty. Dave sprayed it with distilled water and squirted Orvus/acetone mix then dabbed that off. He followed up with ethanol and acetone. It cleaned up well but the surface showed a grayness, particularly at the top. After cleaning we measured the reflectivity to be 97% with the red filter and 88% with the blue.

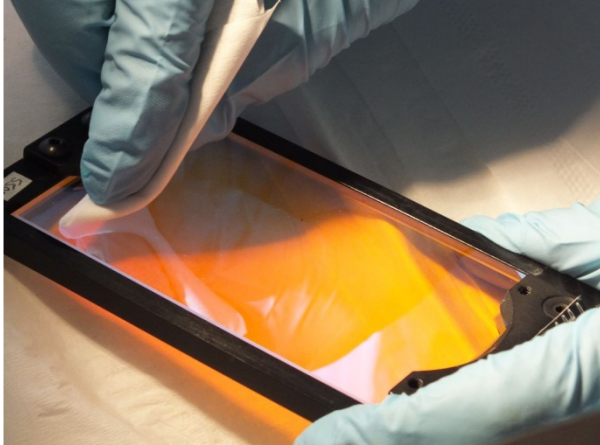
5500 A Filter

A box of filters and a filter wheel were had been brought to a side room off the dome floor. Three filter frames were empty and the others held a 4600 A and a 5500 A filter plus a flat mirror. They were cleaned by blowing the dust off with canned air and then wiping with ethanol on a TechWipe tissue. Except for a few stains on the 5500A filter they were pretty clean.

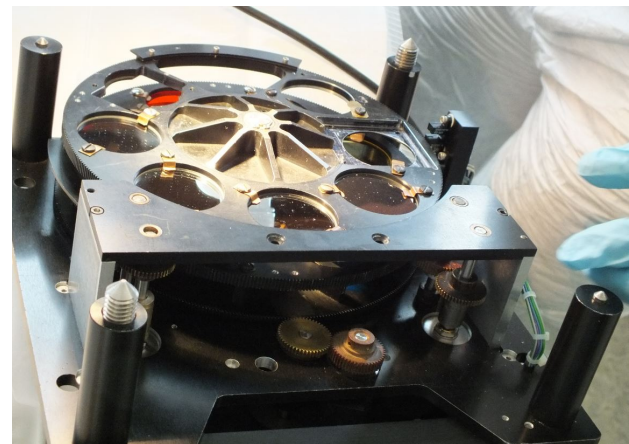
Filter Wheel

The filter wheel held four filters on the top wheel and 7 on the bottom. One filter had spots that ethanol didn't touch but they came off with distilled water.

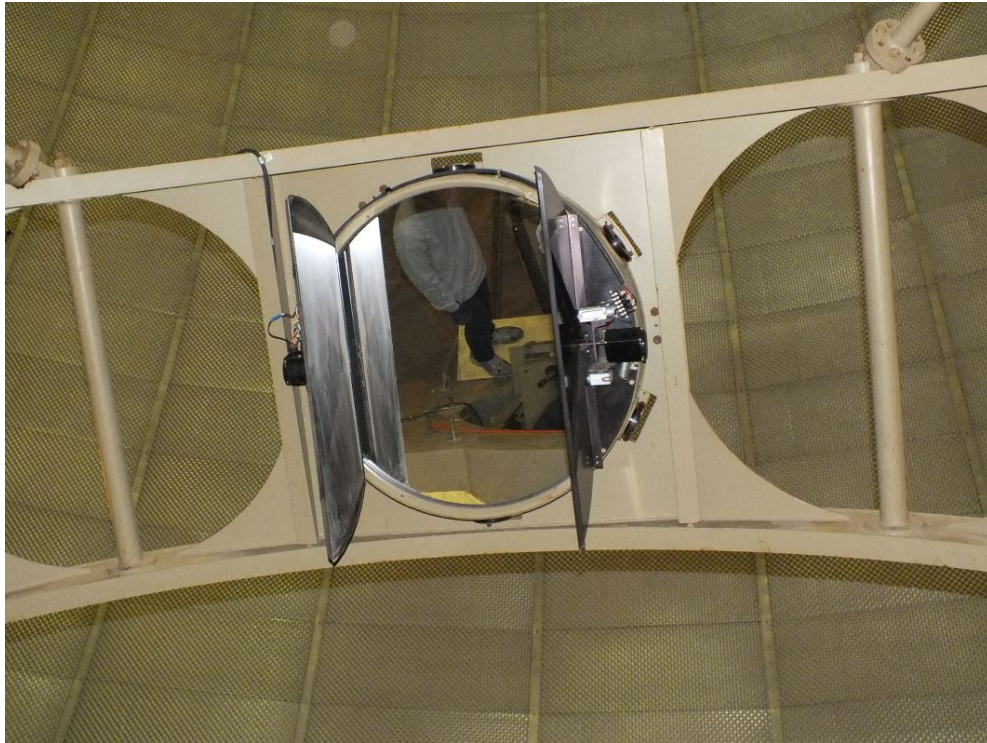
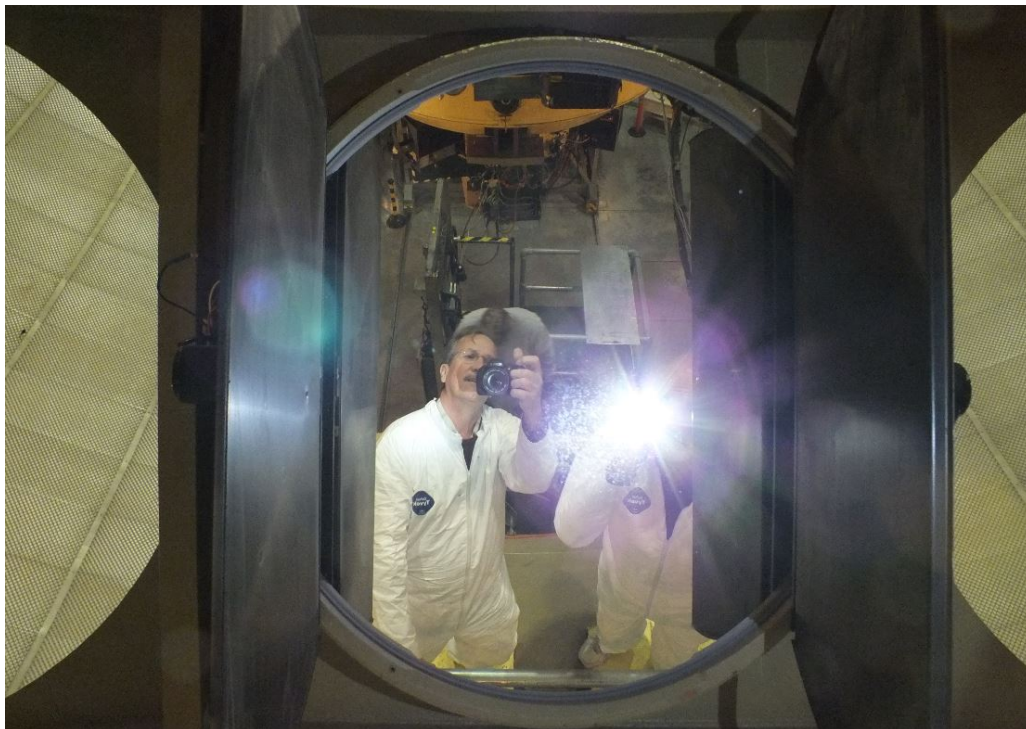
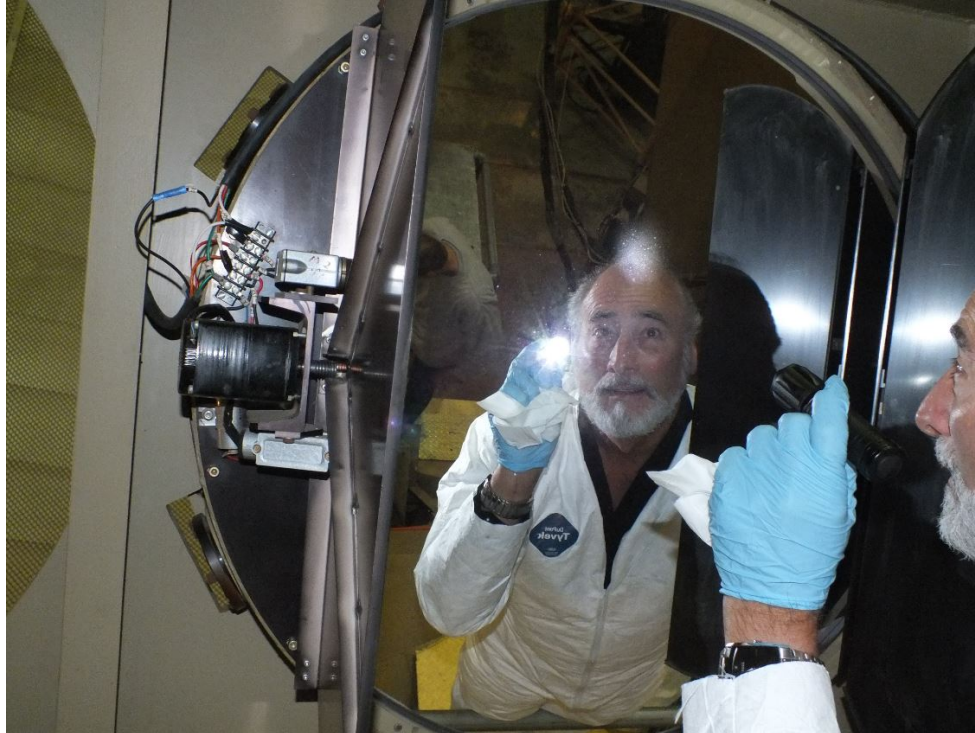
Coude #4 Mirror

This mirror was mounted to a moveable carriage spanning the forks of the 120" telescope mount. The surface was not dirty but had an overall grayness to it that ethanol in a test area did not remove. We measured 94% reflectivity with the blue filter and 93% with the red.

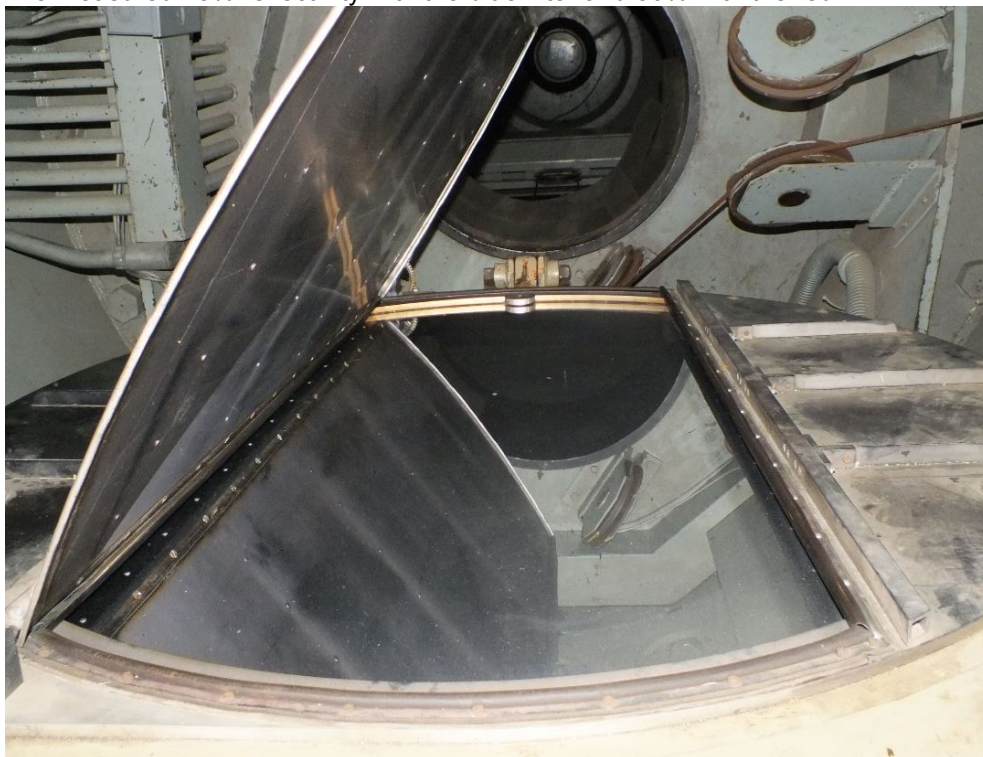
Coude #5 Mirror

This mirror was in a large hole between the forks of the 120" telescope mount. Ethanol in a test area had little effect. We measured 78% reflectivity with the blue filter and 80% with the red.

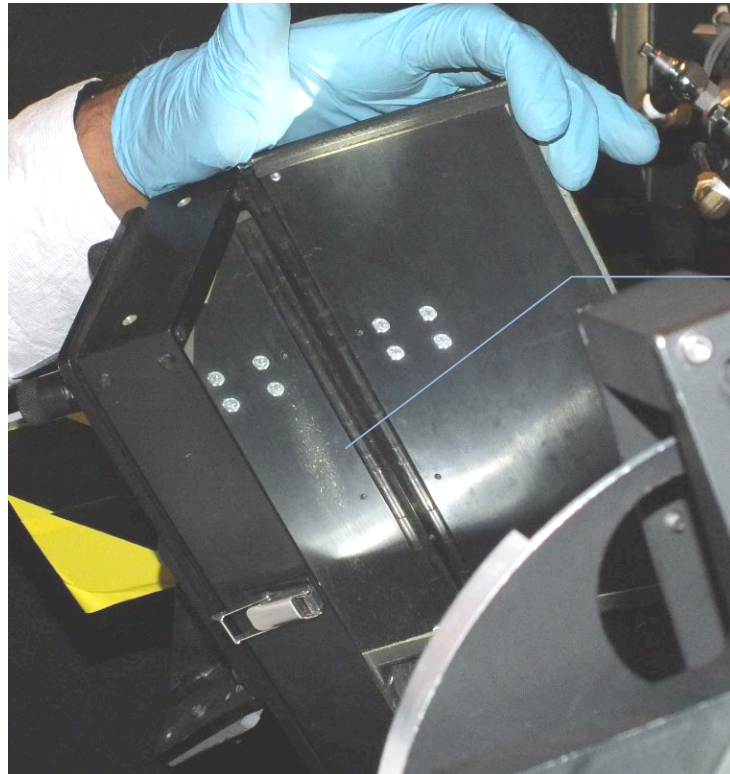
Pick-Off Mirror

In the Slit Room below the dome floor of the 120" telescope we inspected a number of items. First Dave looked at the pick-off mirror. He blew the dust off but knew from past experience it was too fragile to wipe without sleeing.

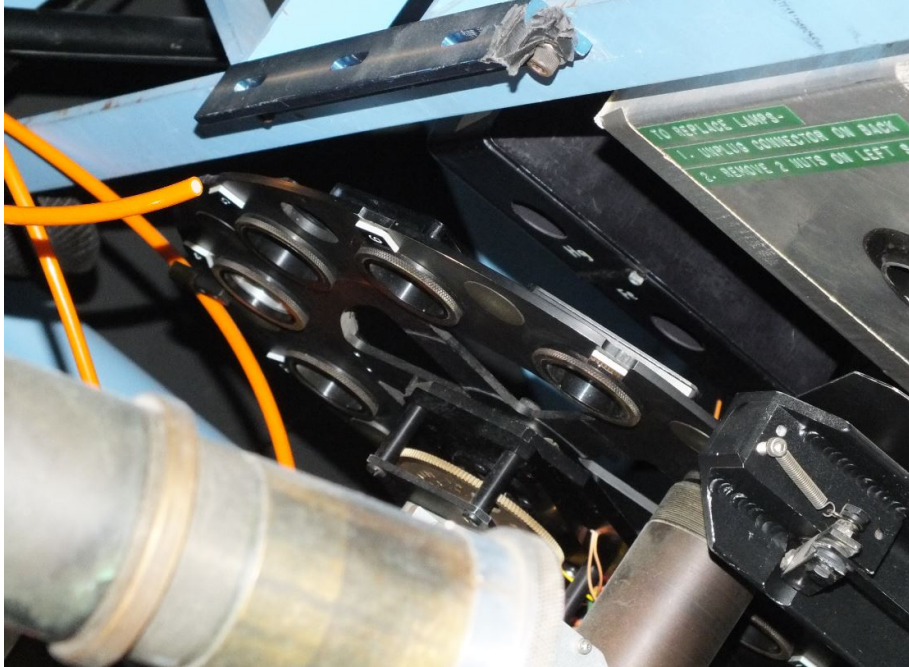
Back Filter Wheel

Dave reached back behind the aperture plate area to clean the #6 filter on the other wheel. Filters #2 and #10 couldn't be reached.

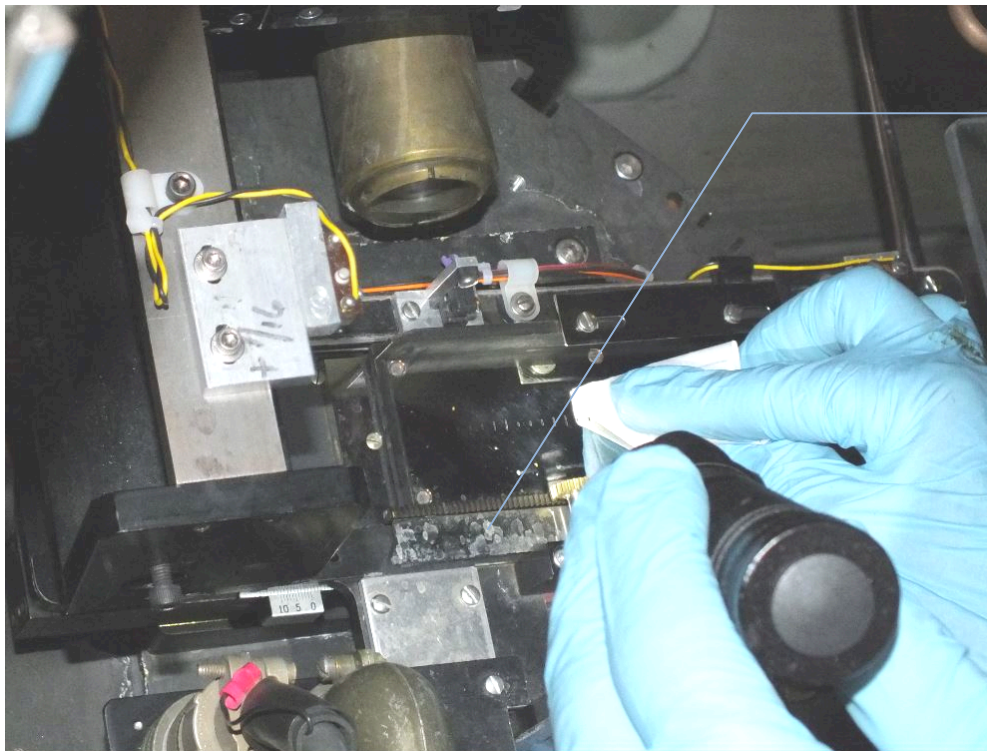
The Aperture Plate was cleaned with ethanol on a tissue. It has water spots from a long-ago leak that will not come off.

Permanent water spots

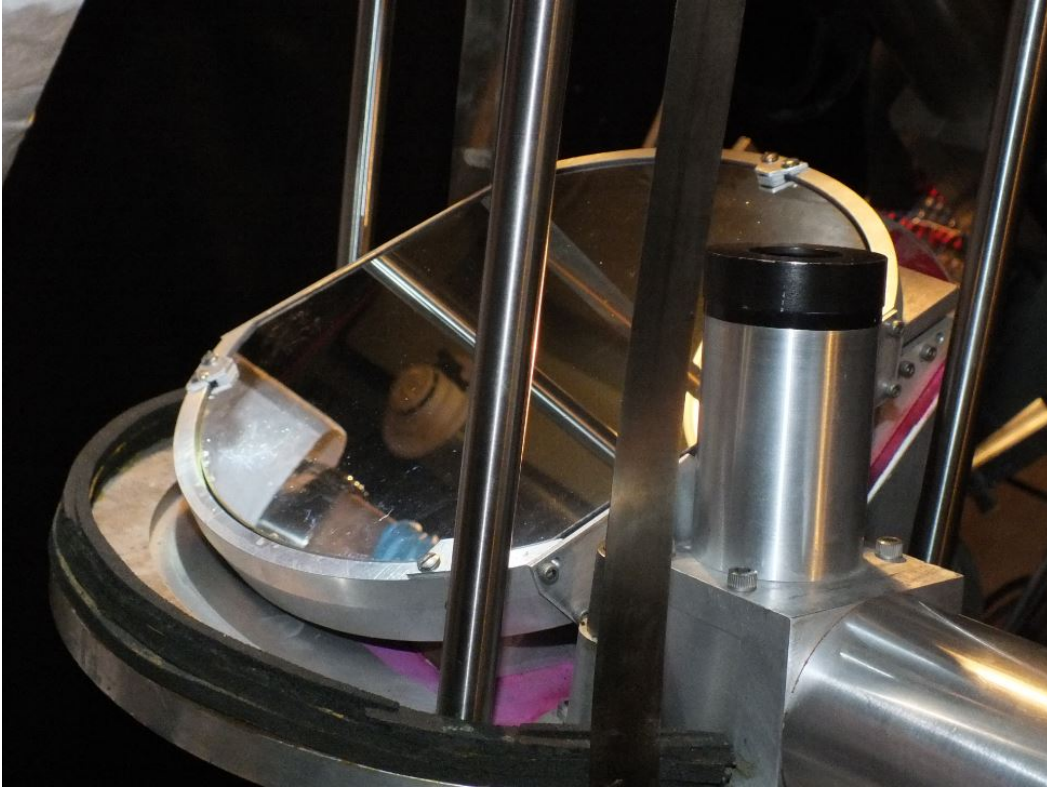
The periscope was lowered and the mirror checked. Dave tested cleaning it in a small area and found it too fragile for wiping, so he just blew it off with canned air.

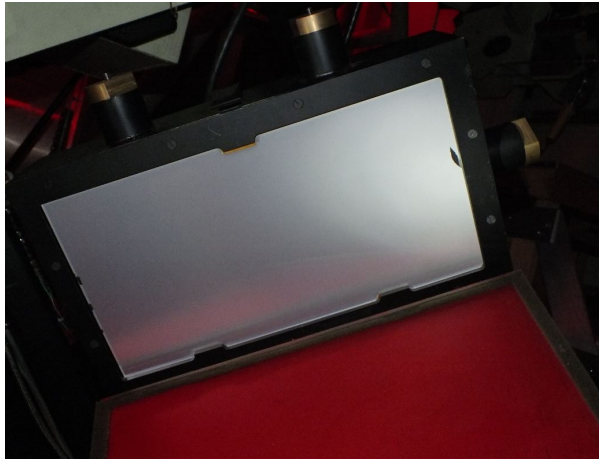
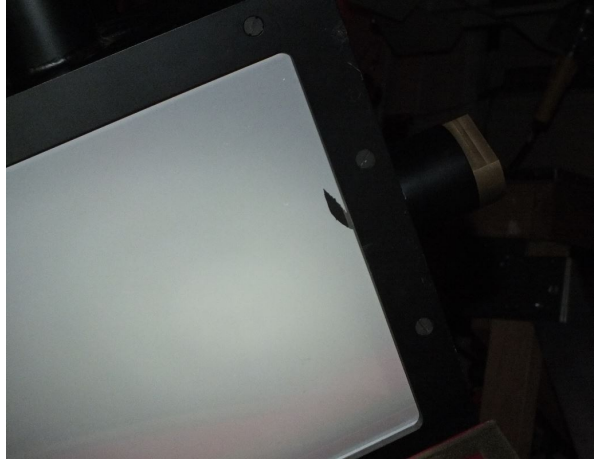
In the Hamilton Spectrograph room under the 120" telescope Dave cleaned the prism faces with ethanol. He used canned air to blow off the grating and a mirror. The grating had an existing tear and the mirror showed signs that it had been sleeted in cleaning sometime in the past.

Hamilton Spectrograph Grating with Tear

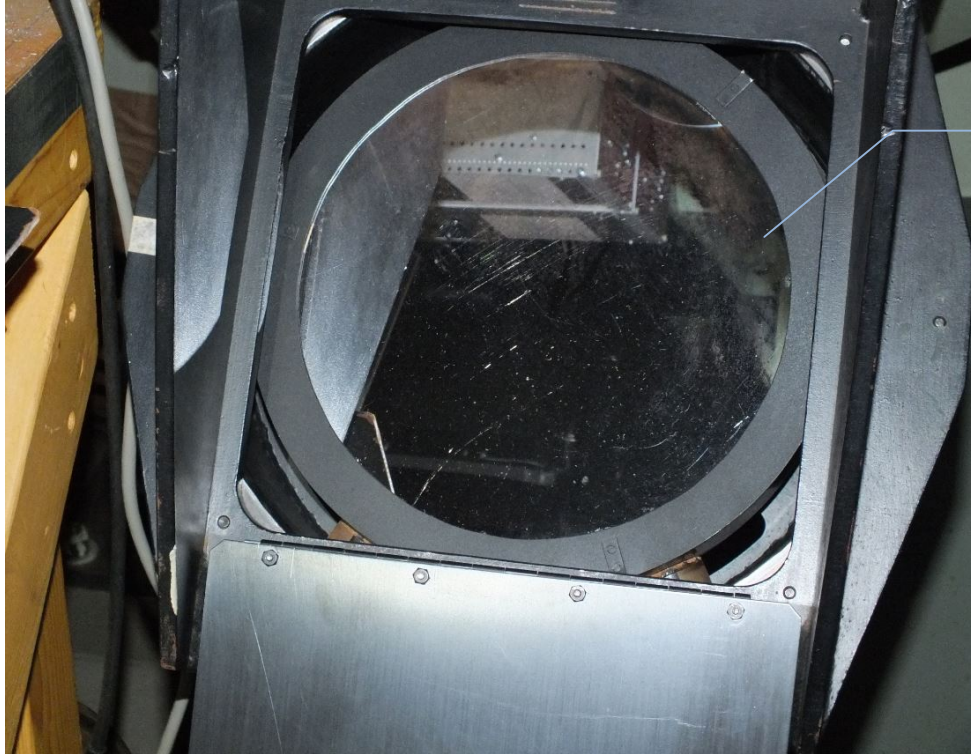
Collimator mirror with fragile coating and degradation at top and right side

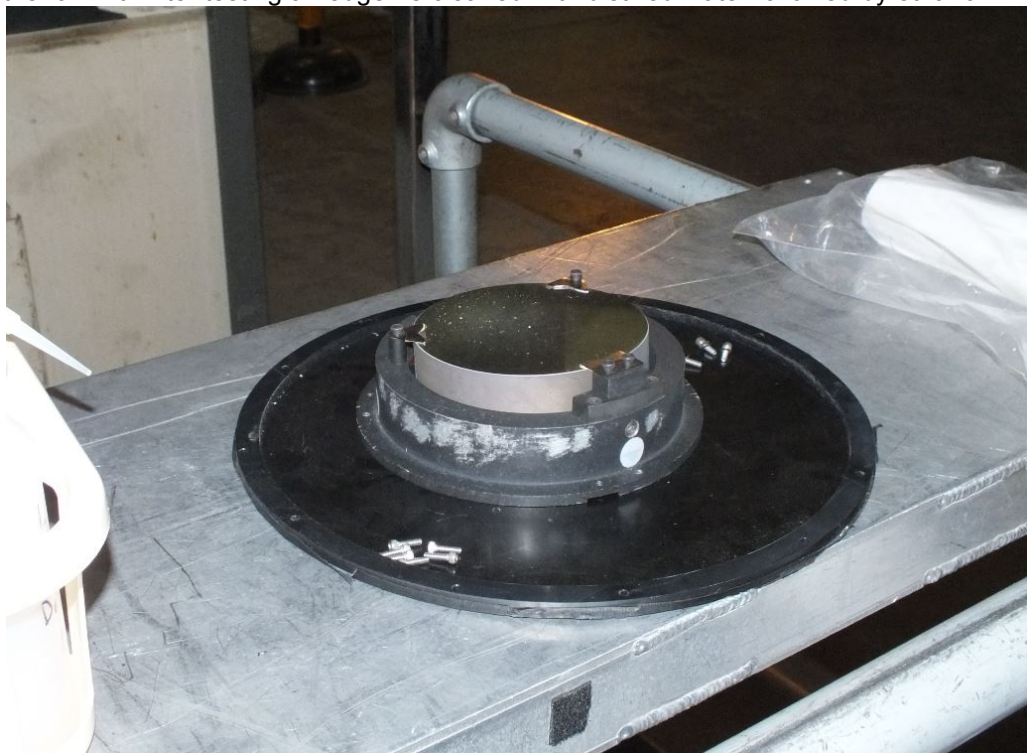
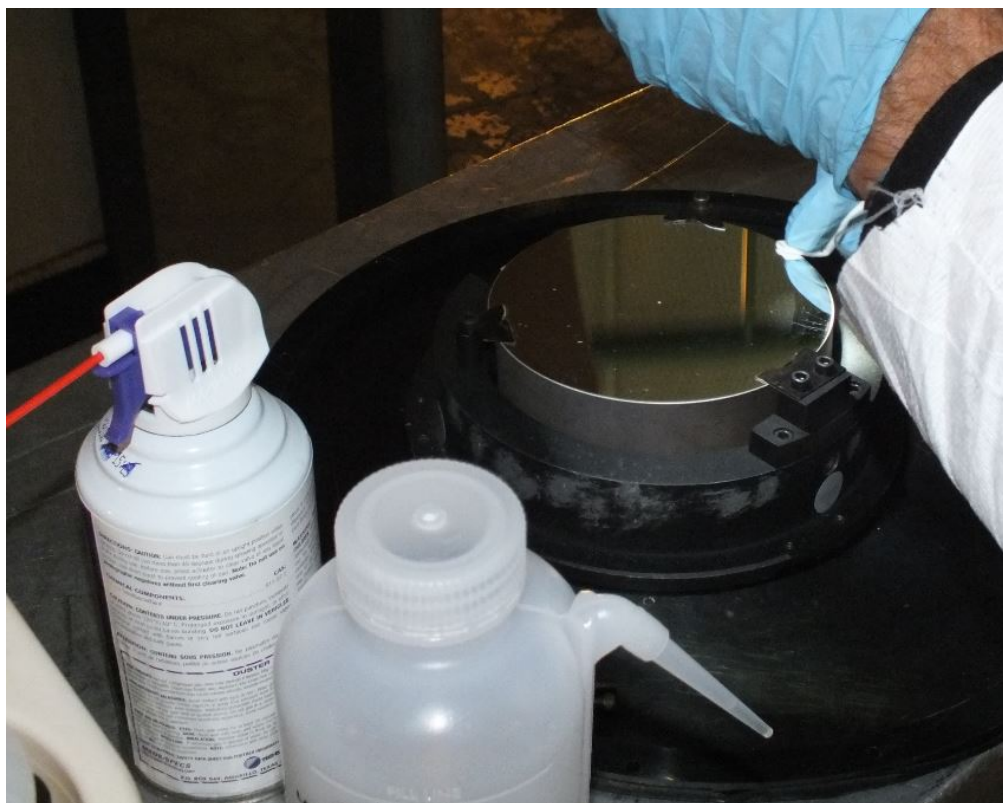
## KAST Red Collimator Mirror

This mirror was removed from the tub while we were there and Dave cleaned it on the shelf attached to the fork lift. After testing an edge he cleaned with distilled water followed by ethanol.

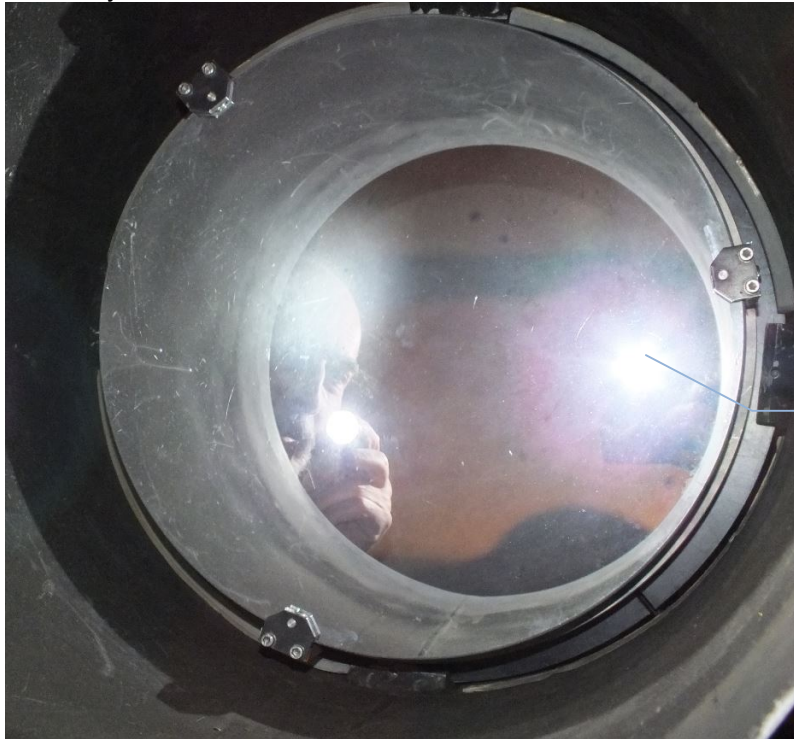
The secondary mirror was not dirty, although the coating was hazy. It and the primary were inspected only. The primary has a known large water spot. For the secondary mirror we measured 84% reflectivity with the blue filter and 76% with the red. For the primary we measured 76% with the blue filter and 78% reflectivity with the red.

Hazy coating surface on secondary

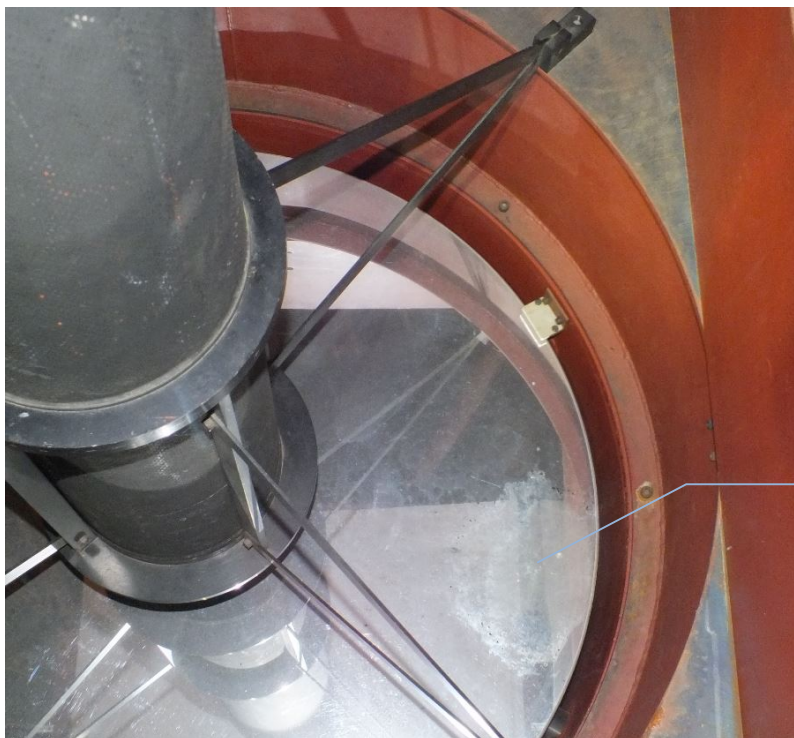
Large water spot on primary

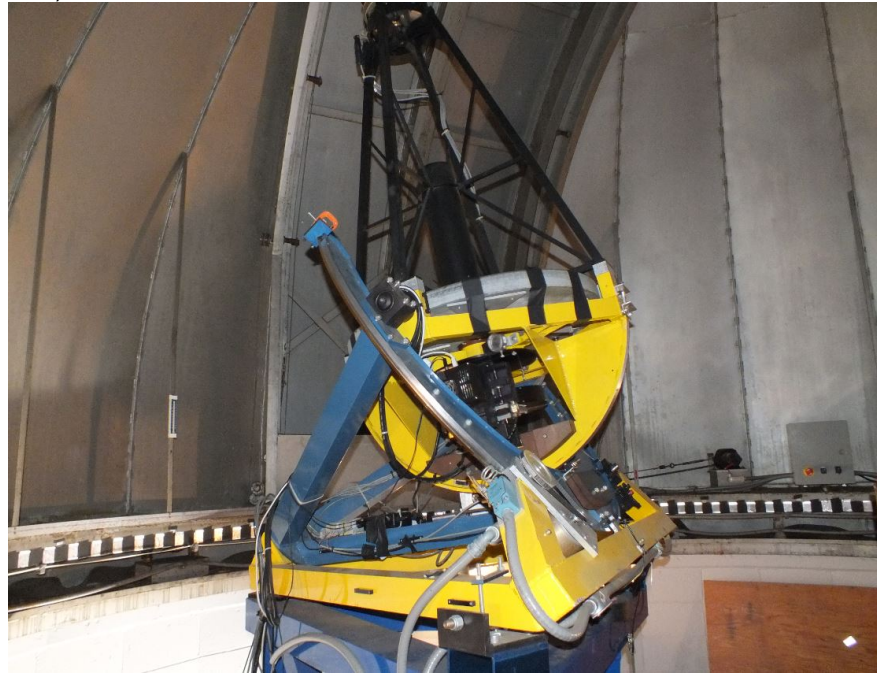
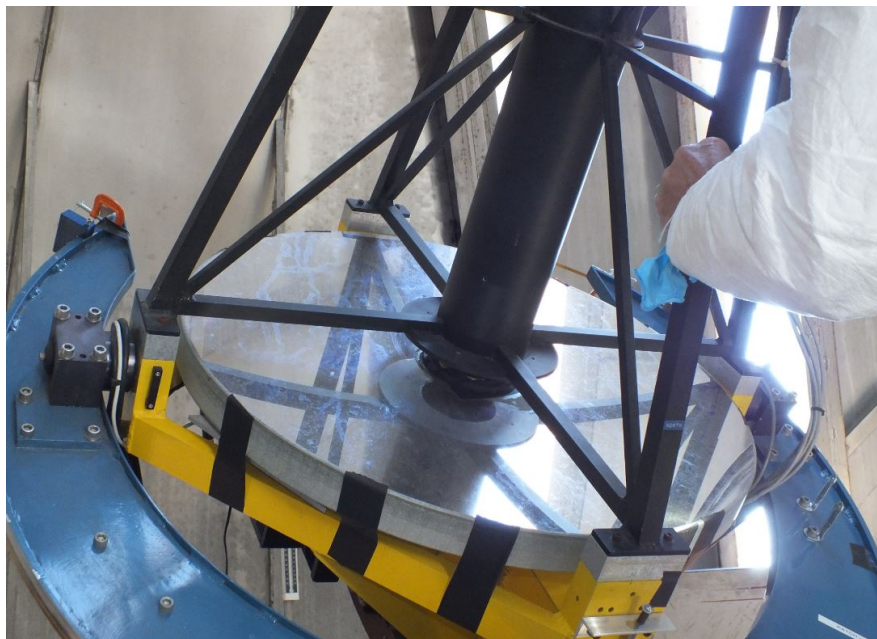
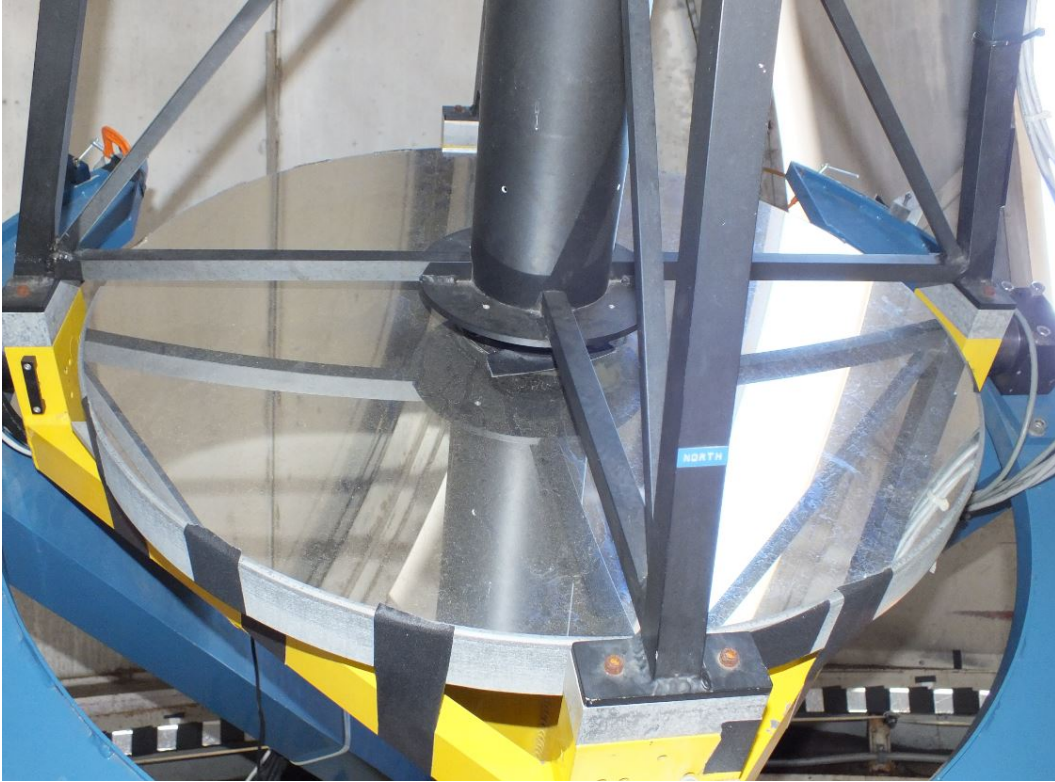
This telescope is in its own dome just up the road from the 120" dome. A gate pass-code is required to enter the private drive to get to it. The primary mirror of this telescope was quite dirty with evidence of water condensation rivulets. Before cleaning we measured 76% reflectivity with the blue filter (relative to the reference mirror) and 86% with the red.

Dave cleaned the primary by dabbing it with Orvus/actenoe/H<sub>2</sub>O mix and distilled water spray. He soaked it that way a couple of times, then followed up with ethanol.

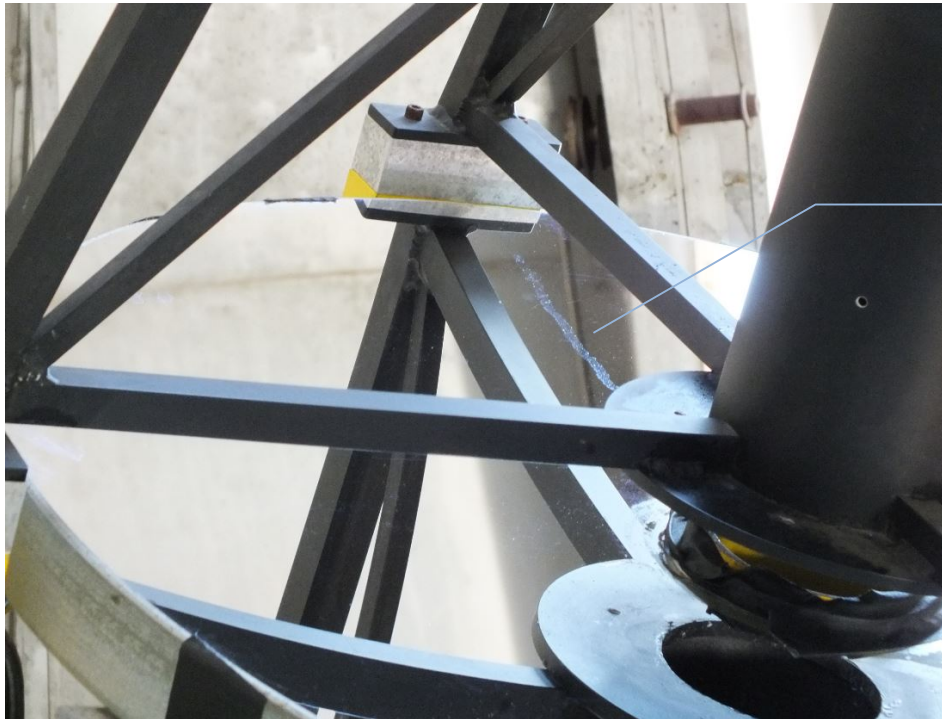
There was a water-etched streak directly under one of the structural elements of the mirror that will not come out until the mirror is recoated.

Permanently etched water streak

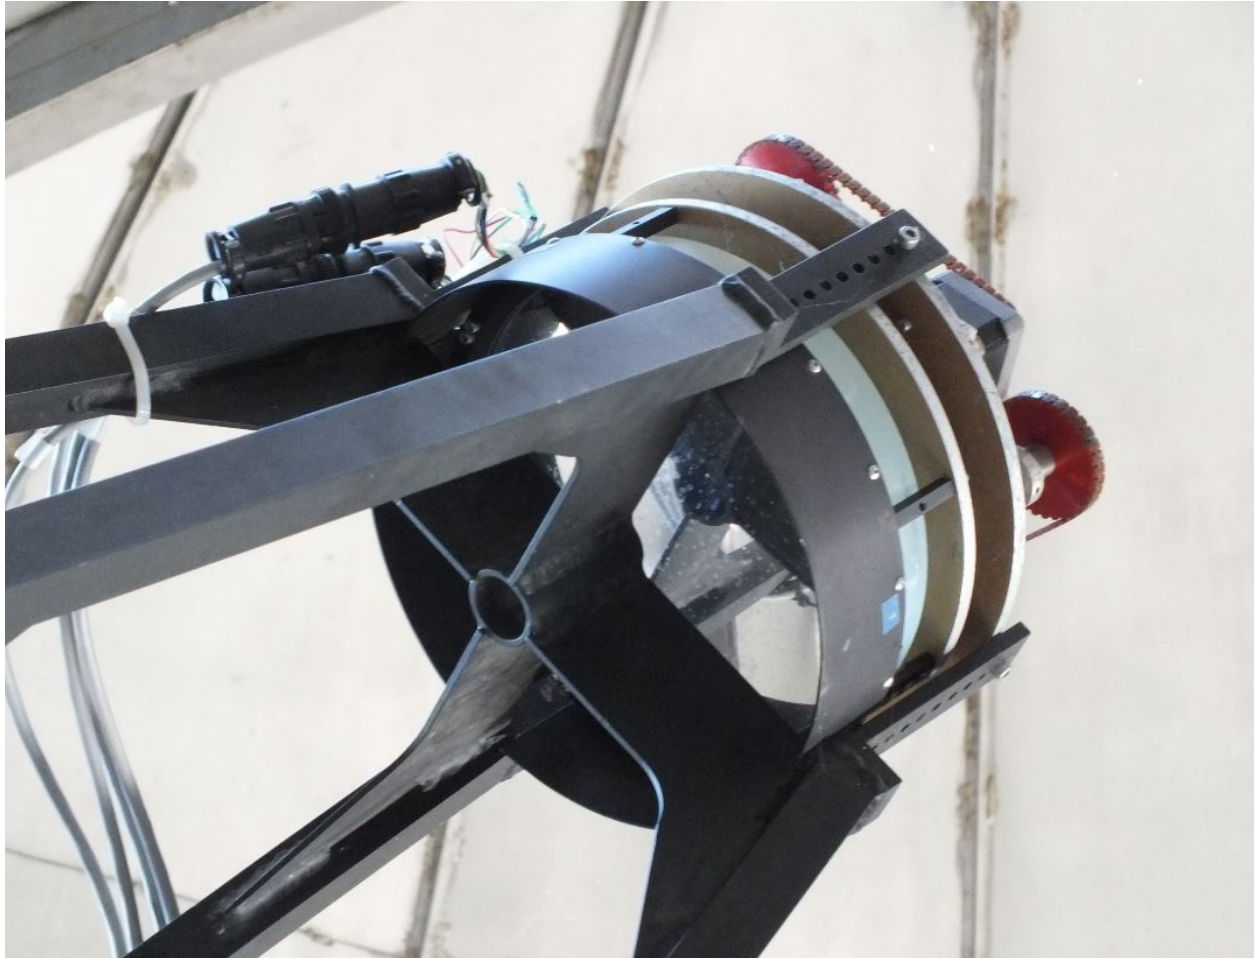
The KAIT secondary mirror had water spots that may be in the surface. It was fairly inaccessible and we didn't attempt to clean it.
