Mt. Hamilton Optics Cleaning Trip

David Hilyard and Brian DuPraw
11/27/12

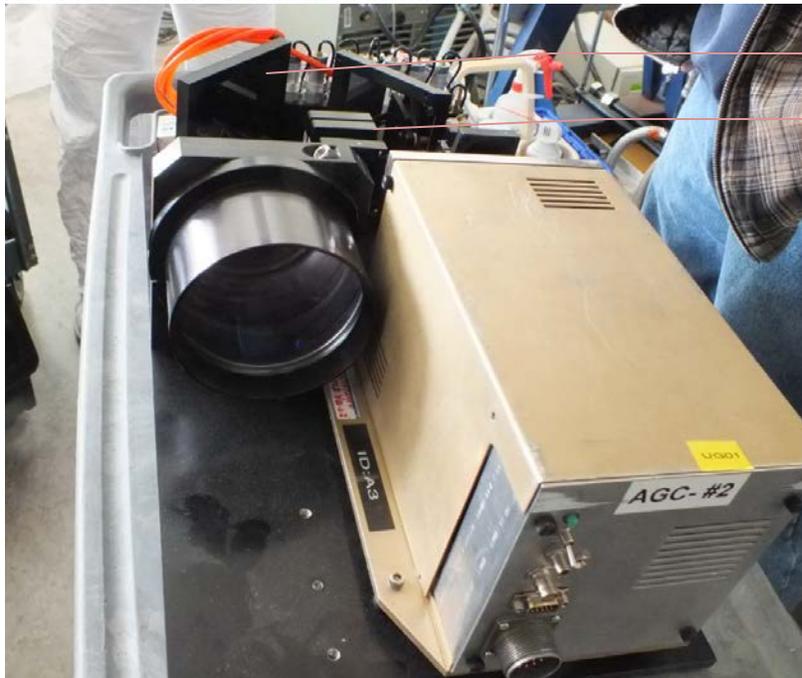
Folding Mirrors

The Cassegrain Guider camera was brought into the Gemini room where we had set up our cleaning supplies. All the exposed optics were quite dusty. In addition, light from a high-intensity lamp could be seen through pinholes and scratches on the two 1/4" thick folding mirrors. We measured their dimensions in case the decision is made to replace them... one was 4.0" x 3.0" and the other was 4.625" x 3.5". For the time being, Dave removed them and cleaned them.

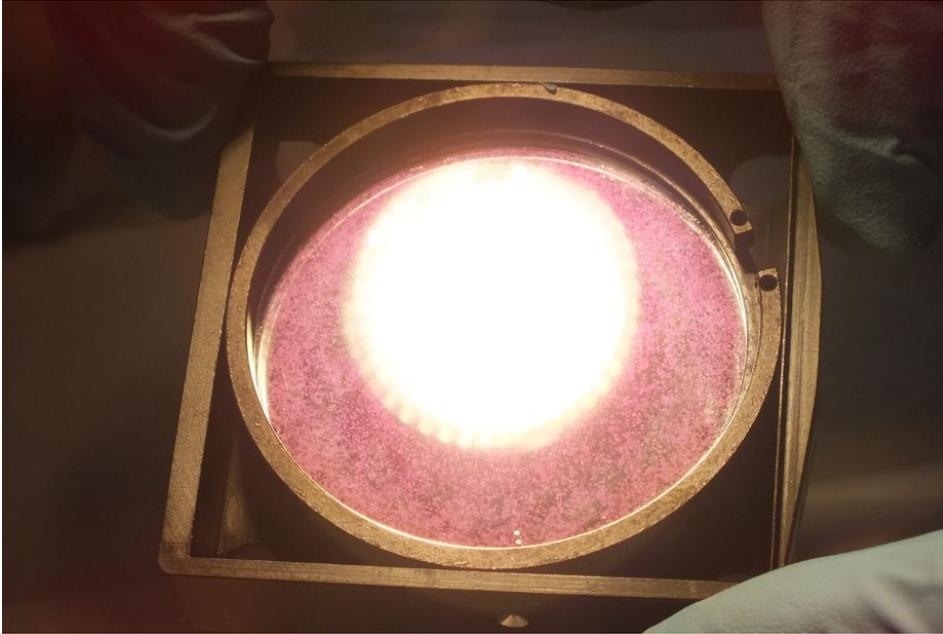
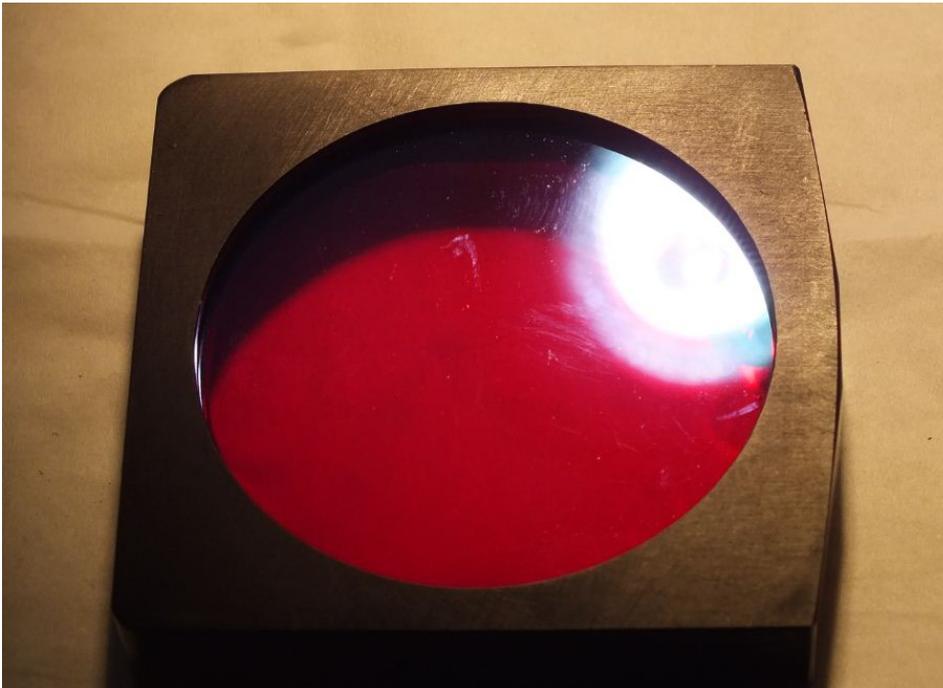
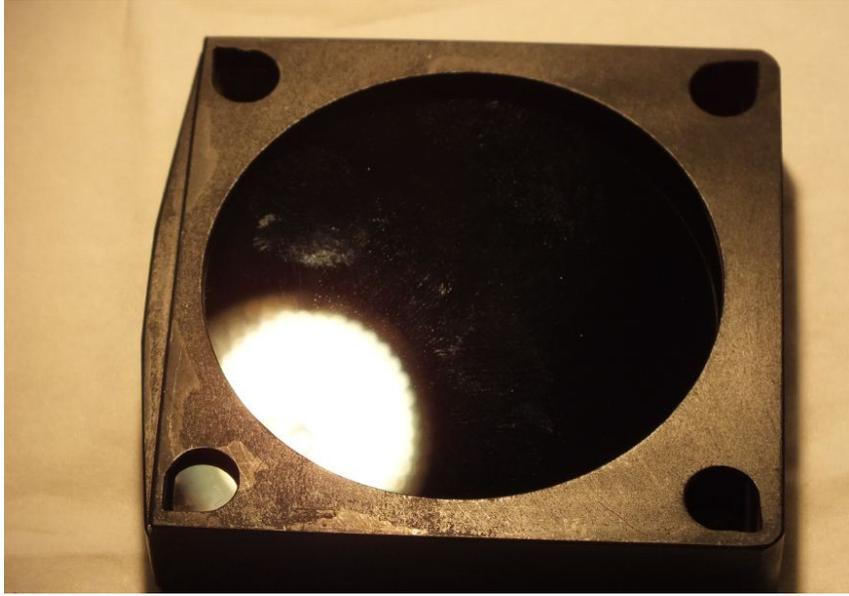
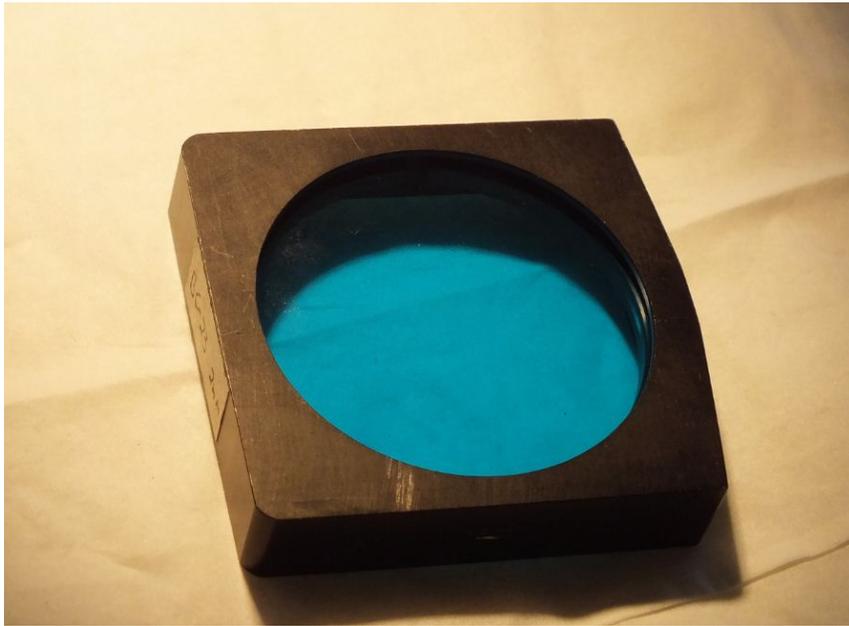
Filters

Dave also unscrewed, one at a time, the handful of filters from the holders that flipped them into position and cleaned those, as well. One in particular (4625/100 HES) showed degradation. The others weren't too bad, but each still had one or two lightly scratched areas.

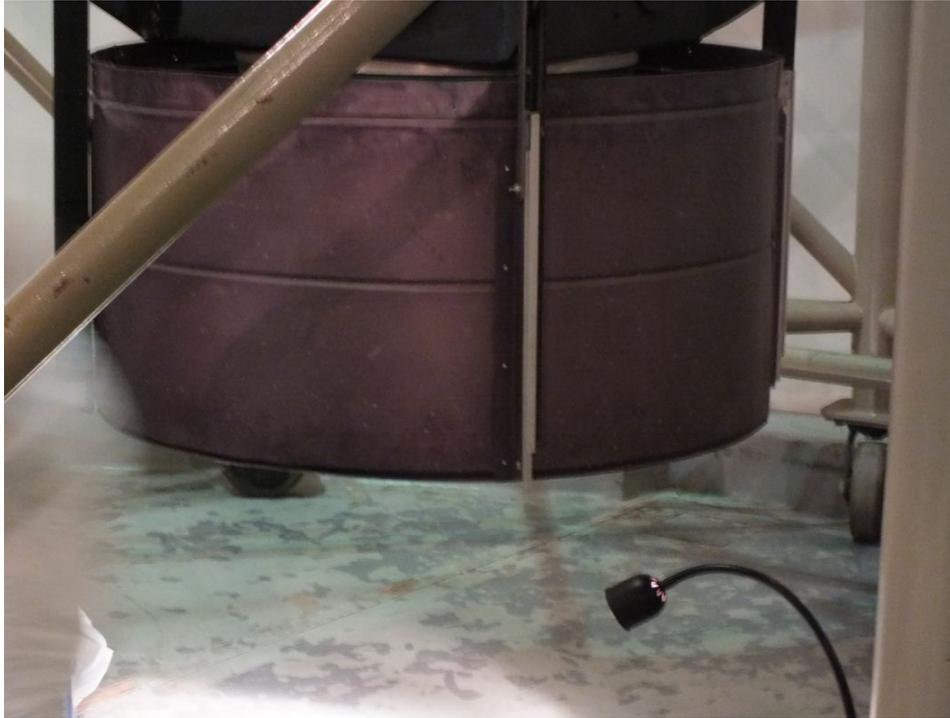
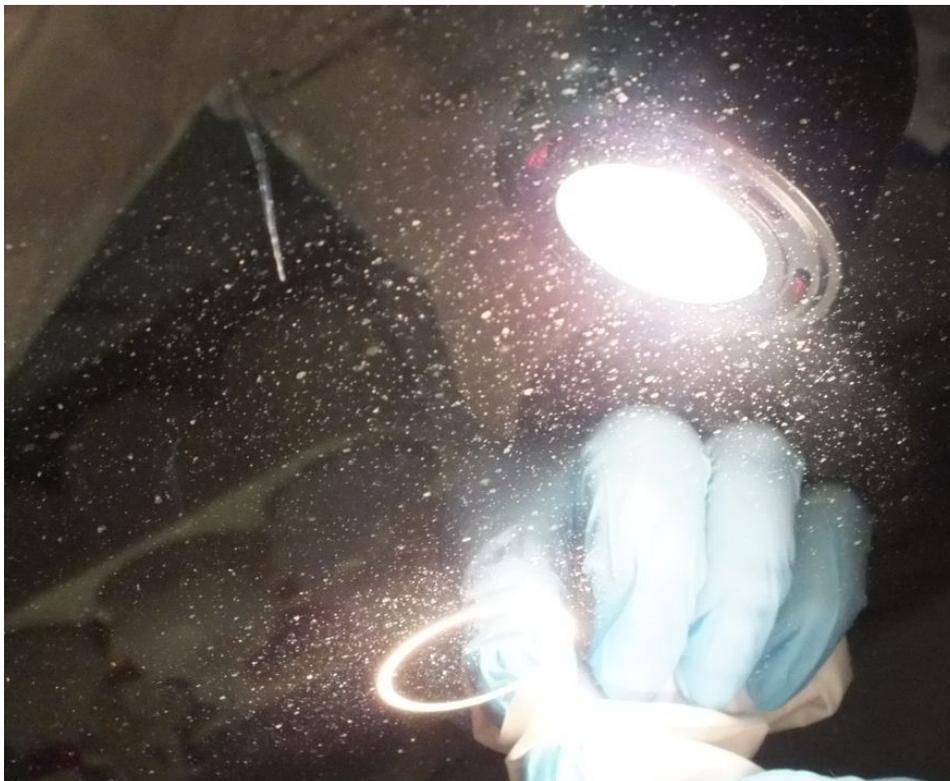
Cassegrain Secondary

The 120" telescope's Cassegrain secondary mirror was examined and found to still have a large number of spots in its coating, as well as a few scratches. The surface was not cleanable, although Dave wiped a small area to ascertain that. At least it was found not to sleek easily.

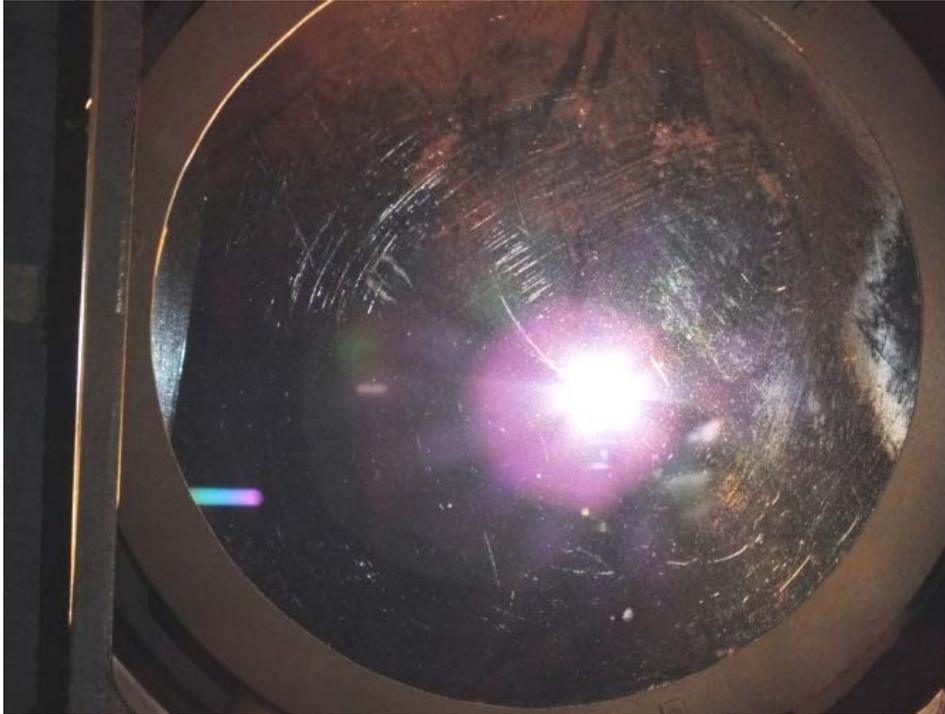
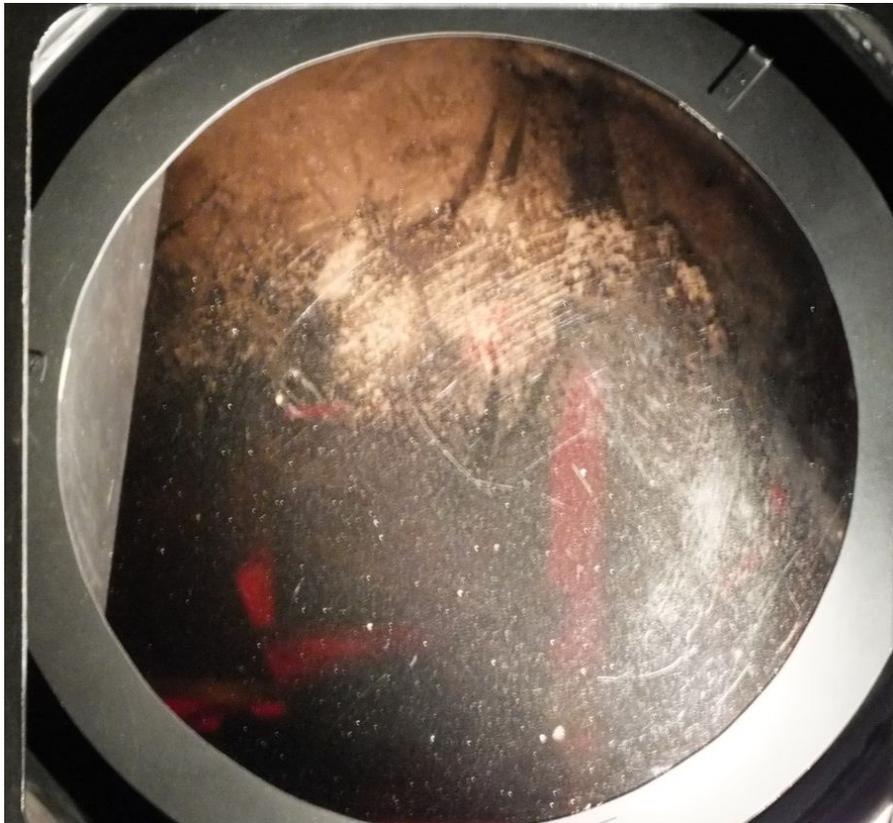
The Hamilton collimator mirror was examined and found to have a large brown-looking area covering the top third of the optic, in addition to the known bad patch on the right side. When lit from behind we could see pinholes through the brown area.

Dave blew the optic off with canned air but decided the coating was too fragile to safely clean. What was surprising was that the bottom part of the optic didn't look too bad, considering we had seen what looked like degradation on a previous trip. It turns out the optic with the degradation on the bottom was a different mirror that had been positioned in front of the Hamilton Collimator at that time (August).

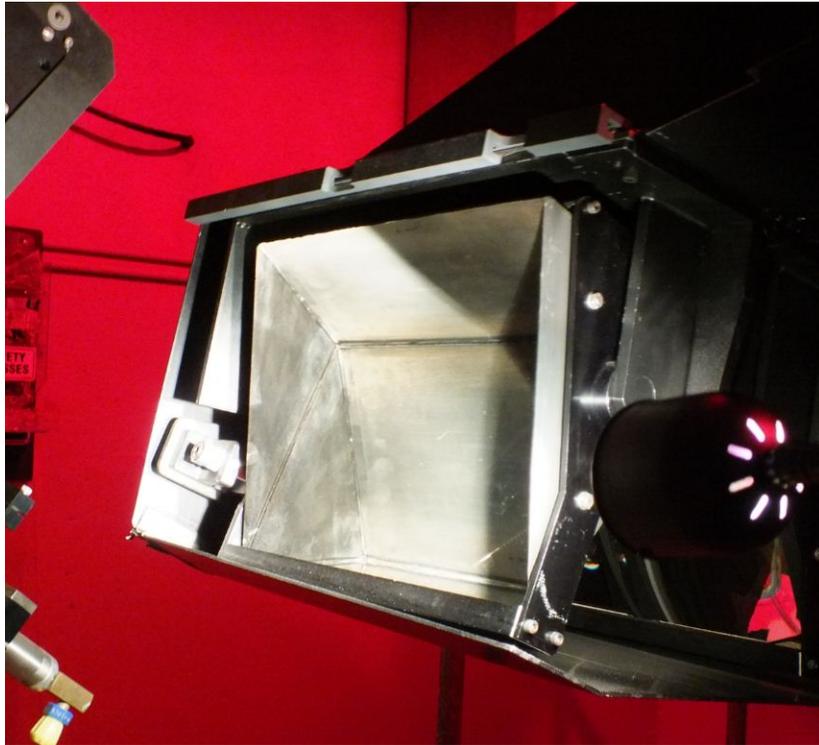
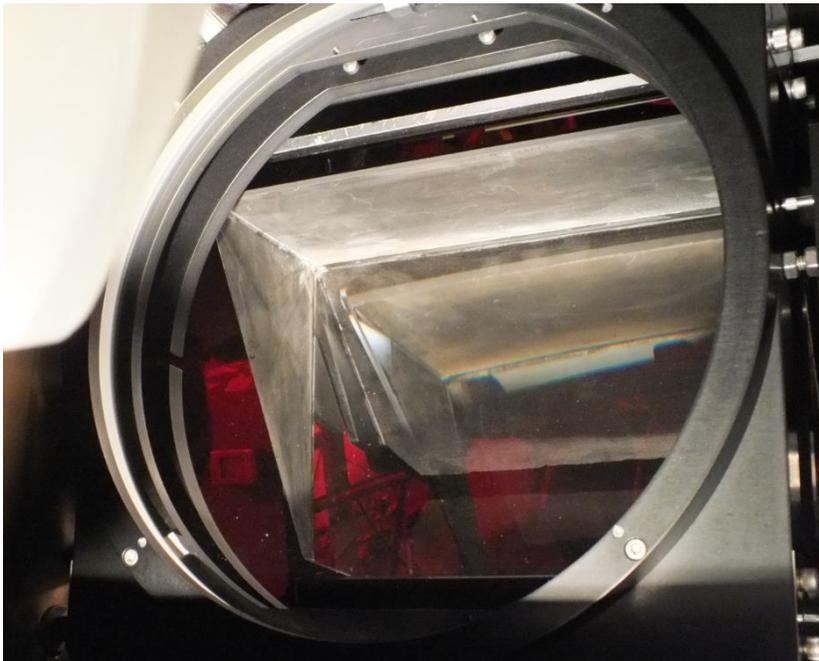
We also examined the prism and the lens in the housing nearby and found they looked good.

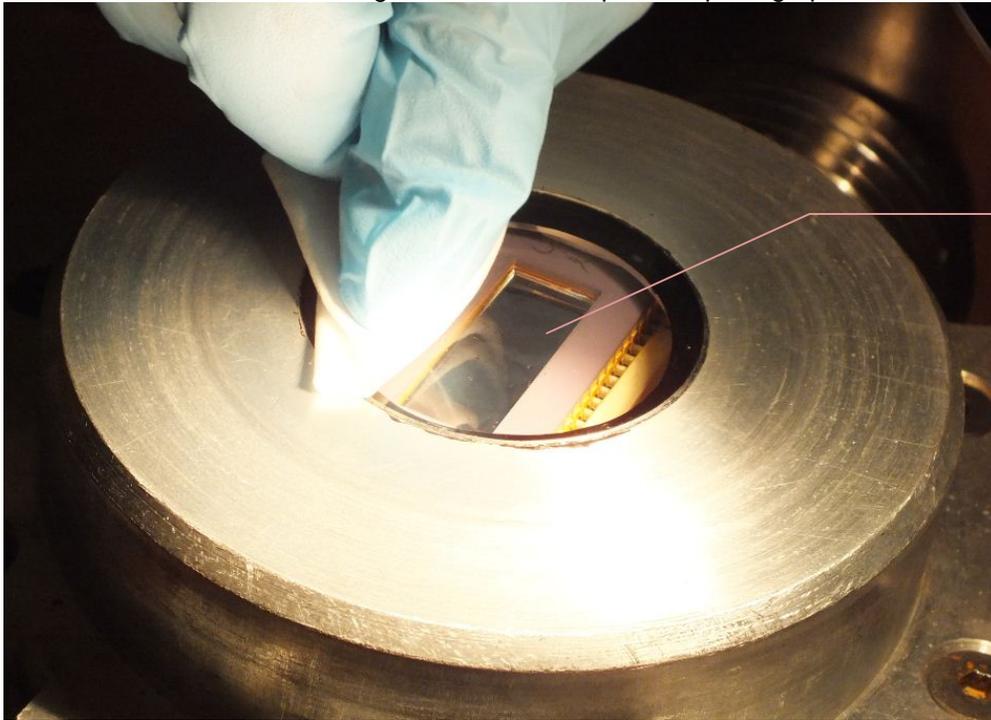
Red CCD

The CCDs for the KAST red and blue cameras were in the “nursery.” Dave cleaned their glass covers. The previously-noted stain on the inside of the red CCD’s cover did not appear any worse, but was still there, since it was unreachable for cleaning. It doesn’t show up well in photographs.

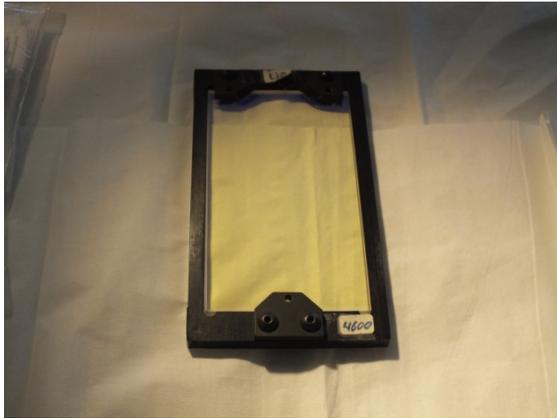
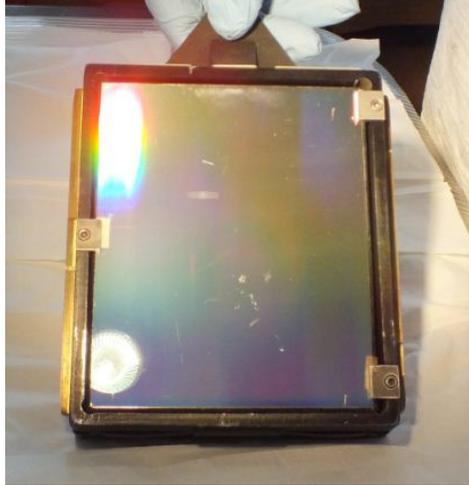
We had been asked to measure the dimensions of the KAST gratings and filters, for eventual replacement. I didn't take any new photos, but these old ones are included for a visual aid:

Dichroics (optic): 2.5" x 4.4"

Optic: 4.4" x 5.3"

Holder ID: 4.44" x 5.38"

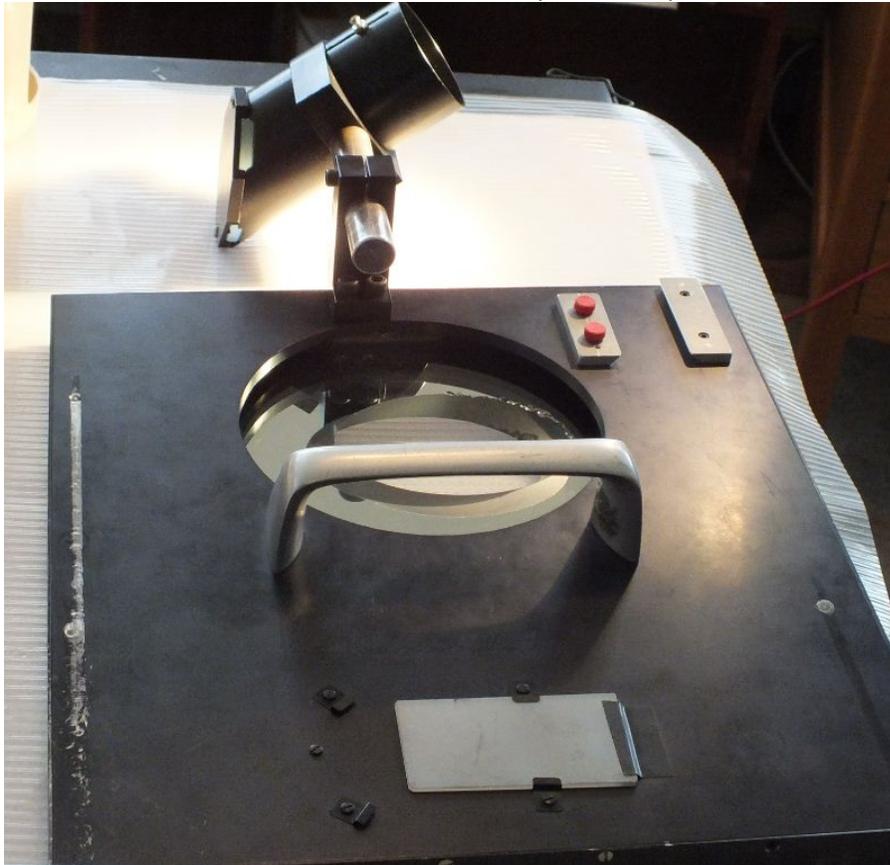
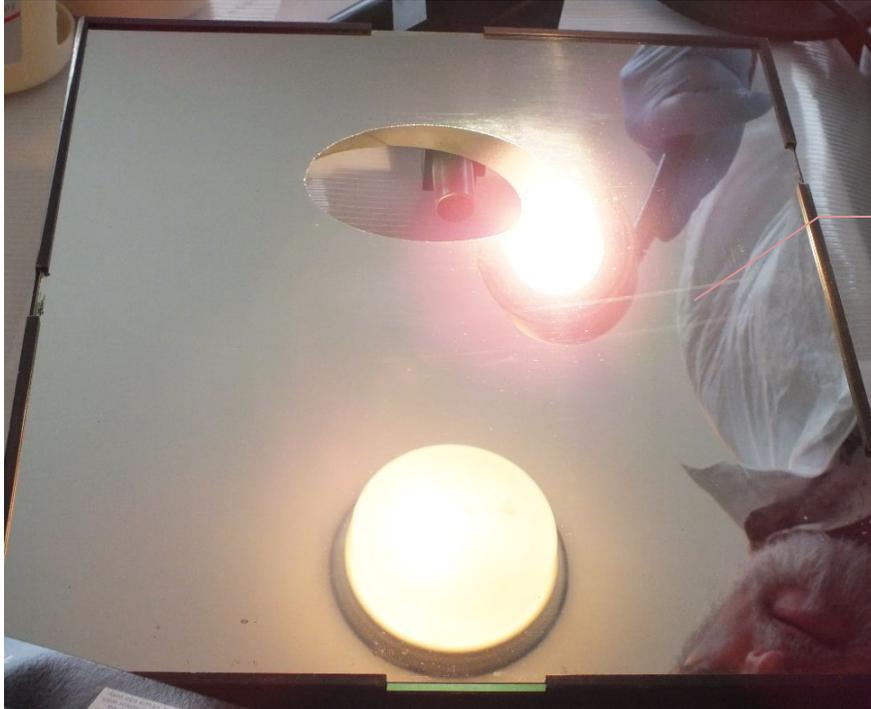
Lines on mirror surface

This mirror was cleaned on a recent trip, including the periscope attached to it. This time we just blew it off and measured it in case it ever gets replaced. It was $\frac{1}{2}$ " thick and 12.0" x 13.375" in size. Oh yes, and it has a large oval-shaped hole in it, so is not an off-the-shelf item. There were two thick lines in the middle of the mirror that had been noted on a previous trip.

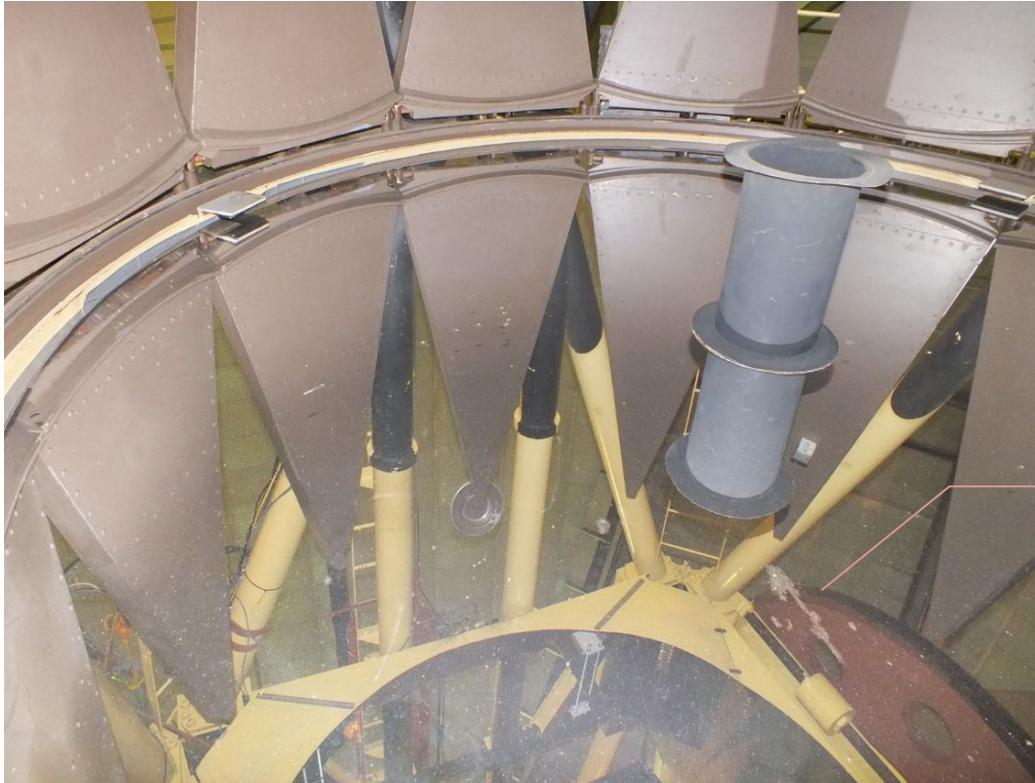
Oil Spot

The 120" primary did not look too bad. There was one oil spot of note, visible in the picture below, that was too far in to reach while standing on the mirror's edge, outside the fence formed by the cover pieces. Unless CO2 can help, it may have to wait until the next time the scaffold is used for a full cleaning.

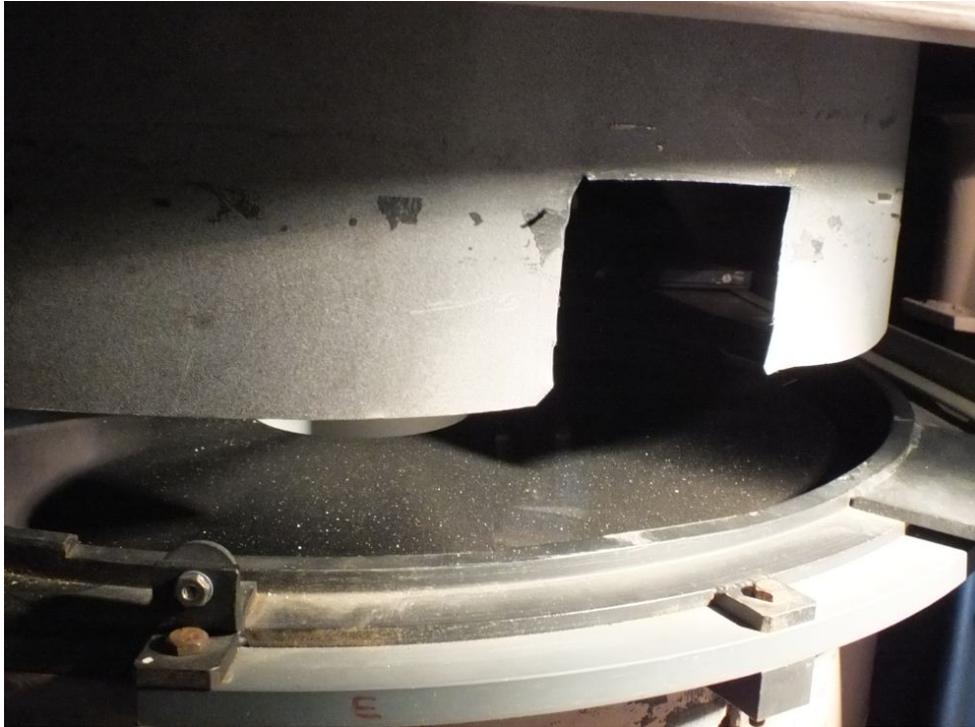
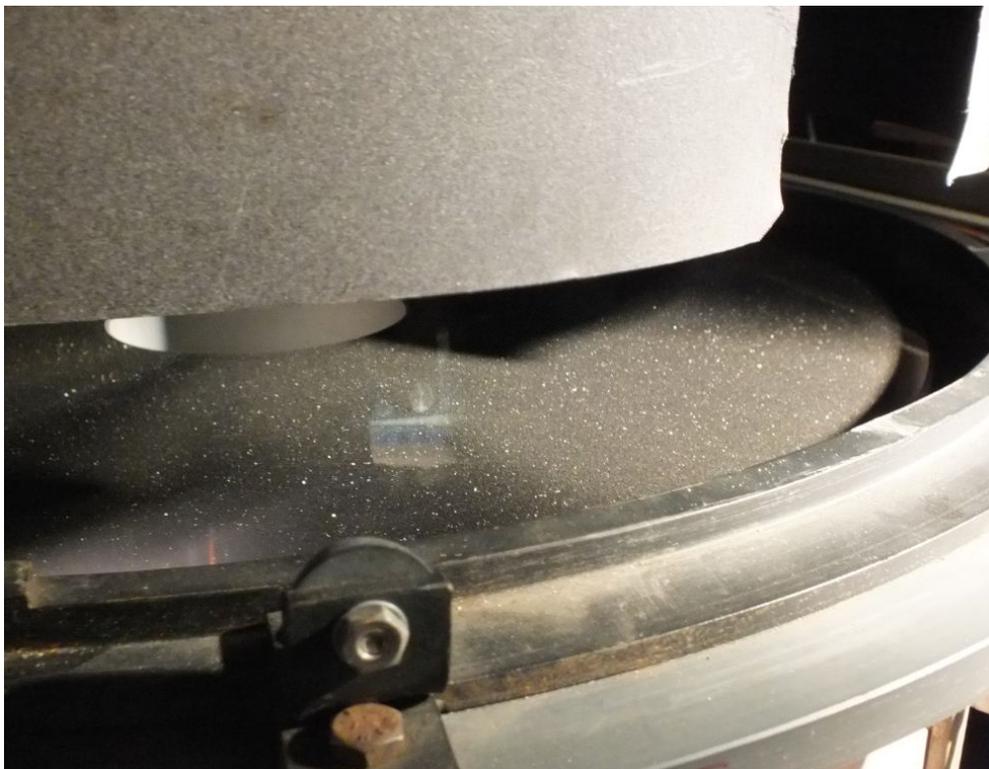
CAT Primary

The Coude Auxiliary telescope's up-facing primary is almost always dusty, and this trip was no exception. Dave cleaned it with sprayed on de-ionized water, followed by ethanol or acetone.

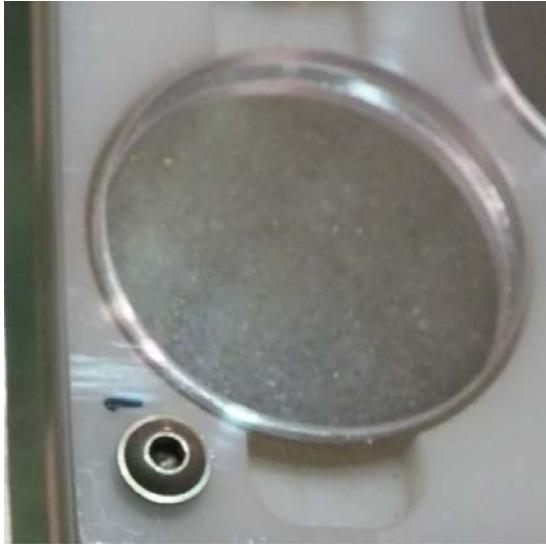
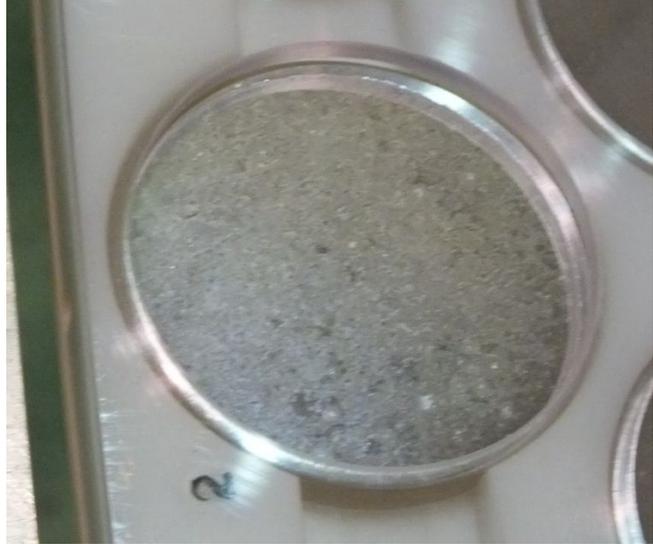
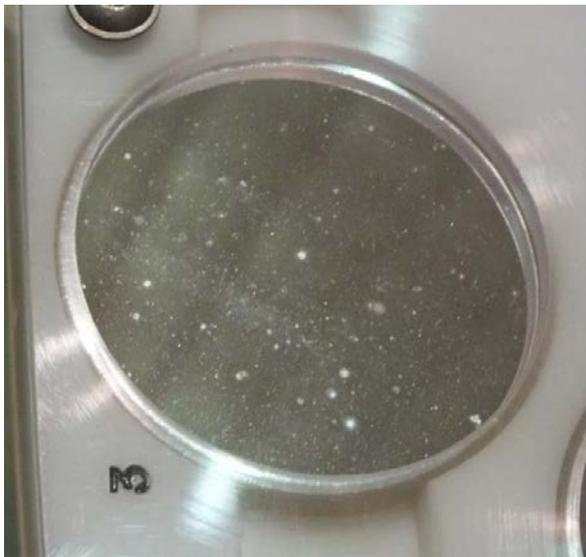
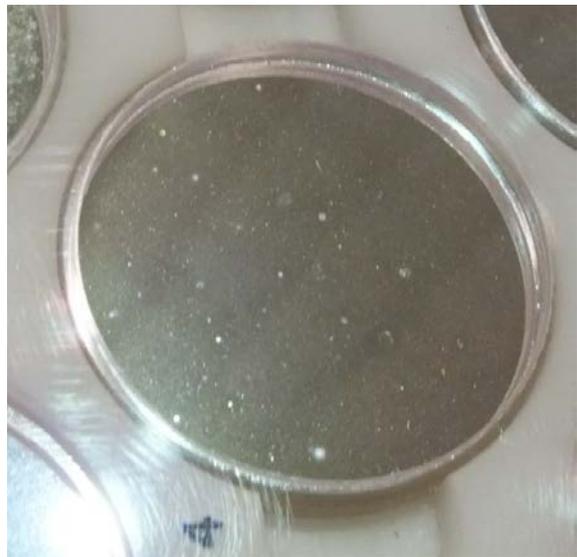
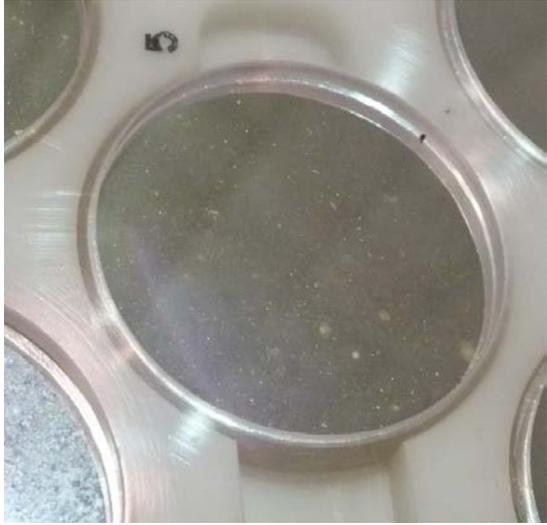
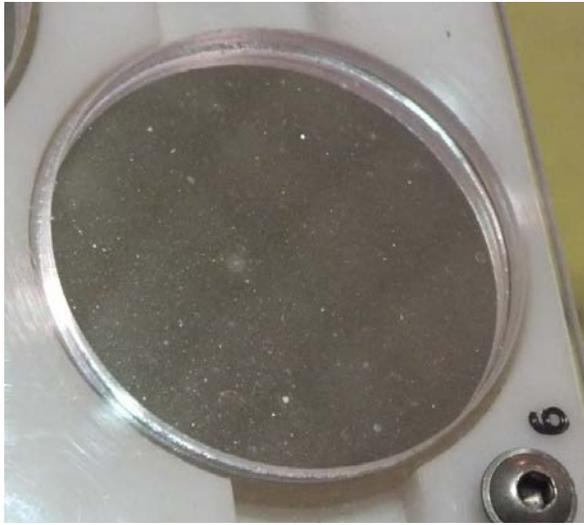
Dome Samples

Here are some pictures of the upward-facing 2" Zerodur disks undergoing long-term environmental testing in the dome. The downward-facing ones were not photographed because, without removing the rack the angle makes it difficult to get a decent shot.
