Re-Coating 120" Mirror February 13 – 16, 2006

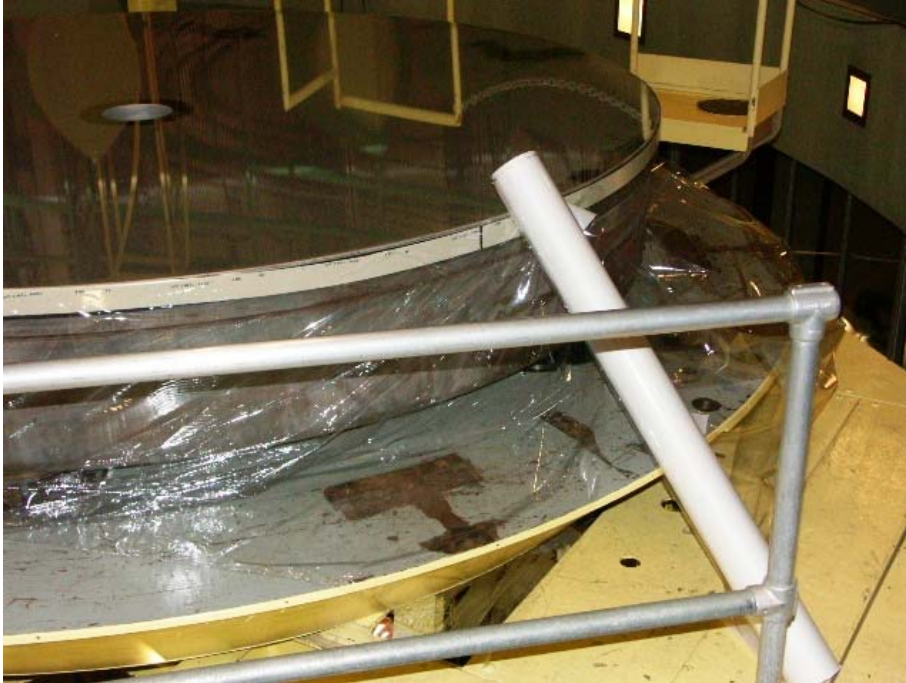
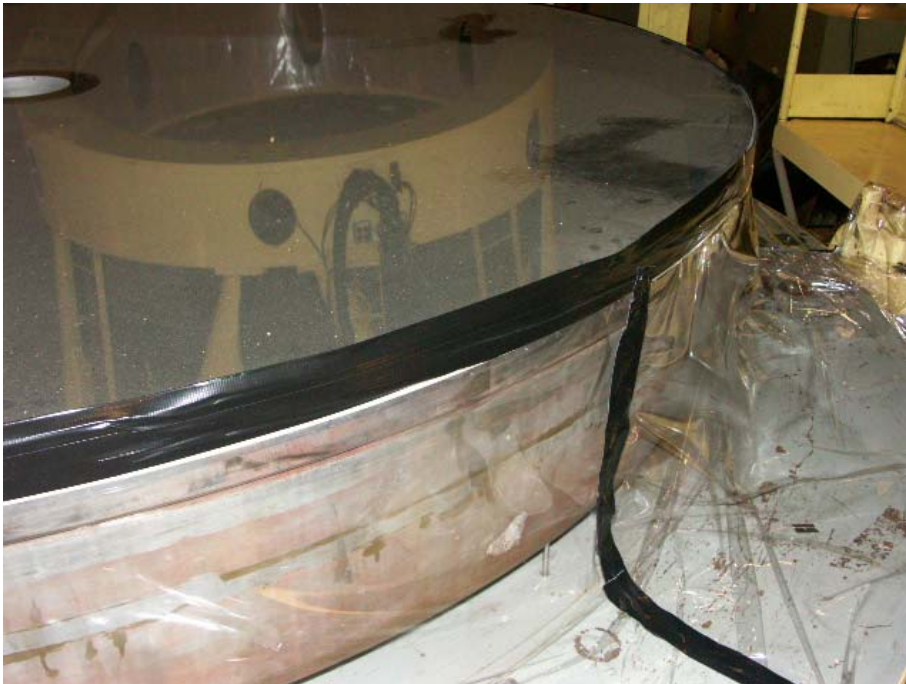
We then used a layer of masking tape and a layer of double-sided tape to attach a 3' or 4' wide skirt of vinyl to the mirror, draping it down to protect the painted surfaces and the people working below from the fluids we were preparing to use. We had to put the vinyl on in several sections, and we were careful to overlap the sections with more vinyl and to seal the joints with duct tape.

On top of the vinyl we made a ½" dam around the circumference by folding a piece of 2" duct tape over on itself and sticking the unfolded portion down on the vinyl. The result was designed to keep the fluids on the mirror, flowing into the central hole, and not off the edges and onto surfaces and people below. The central hole was connected to a drain line that was held in place by an inflatable tube (not shown)...it drained to the darkroom sink. For future re-coats we recommend a pre-formed dam, possibly of plastic.

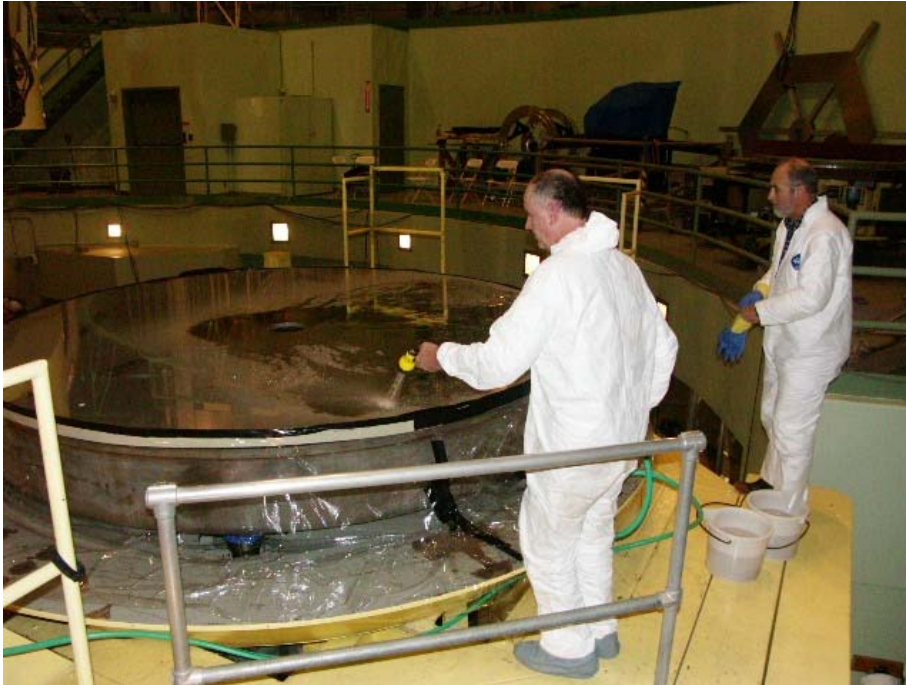
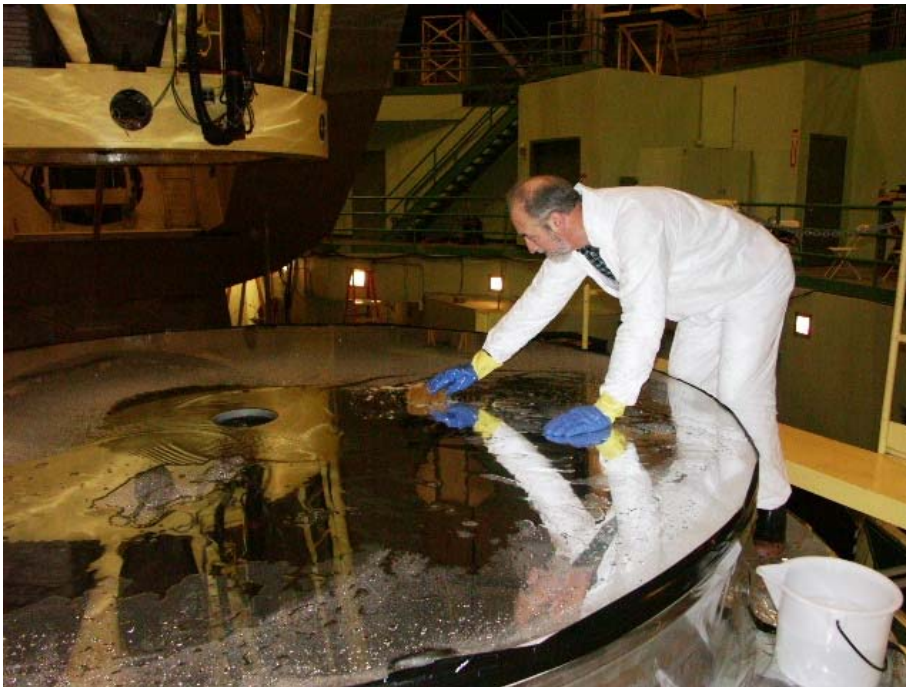
The mirror was then rinsed towards the center hole, washed with Orvus/water using natural sponges and rinsed again with tap water from the spray hose.

After washing we dried just the same four locations for the reflectometer. We repeated the measurements and found that just washing it increased the reflectivity from 73% to 83%. Since we were going to strip it we didn't worry about the water drying in spots.

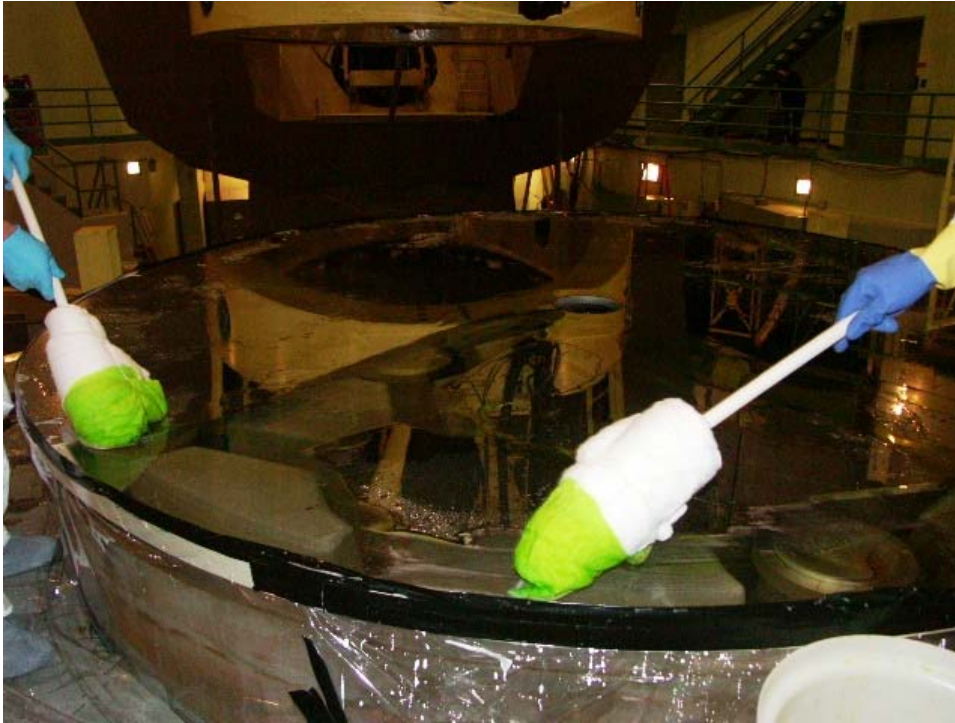
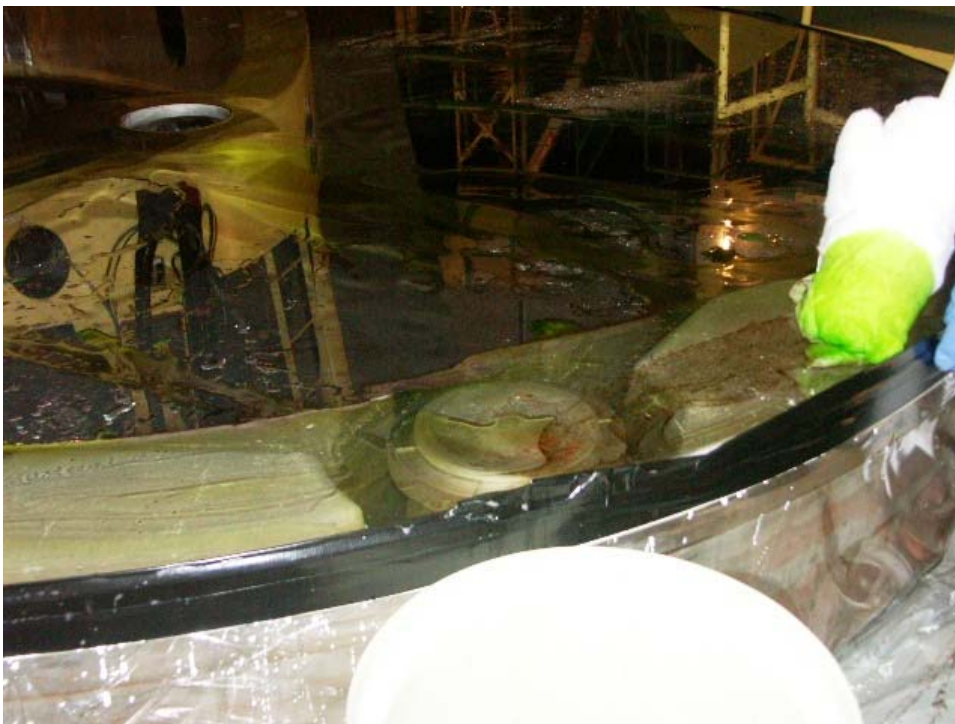
Next we stripped the aluminum off by swabbing it with the giant Q-tips dipped in Green River. It came off easily, revealing the structure of the mirror below.

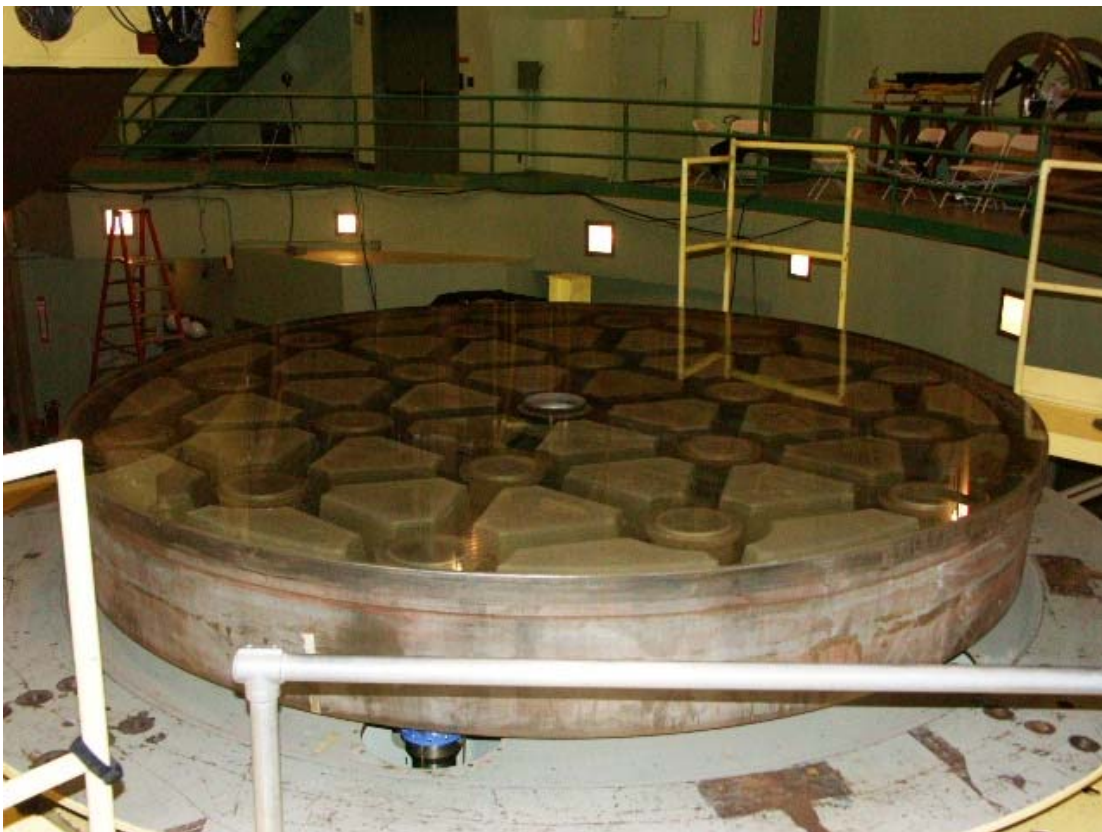
Finally, we carefully removed the vinyl barrier and mopped up any fluids that leaked through to the platform.

The last step for the night was to cover the mirror with cellophane, which came on a roll in a 4' wooden box. We taped it to the edge of the mirror on one side and unrolled it without dragging it on the surface, then taped it down on the other side. This is another area where we suggest improvement...perhaps a giant shower cap made of sail-cloth or some other light material. Something in the center hole would keep it from touching the surface of the mirror.

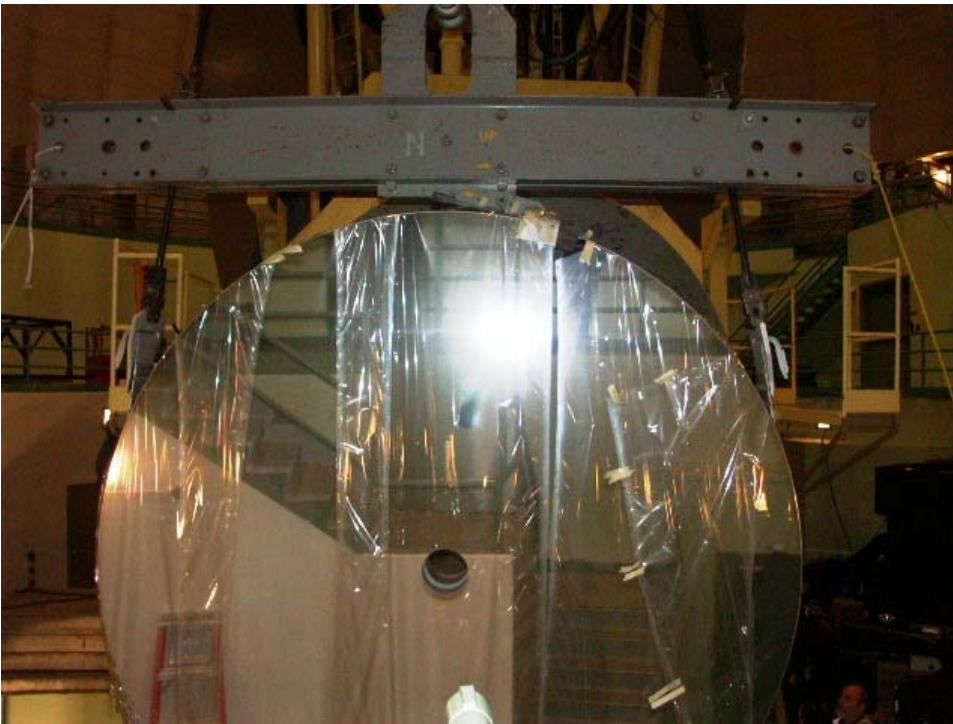
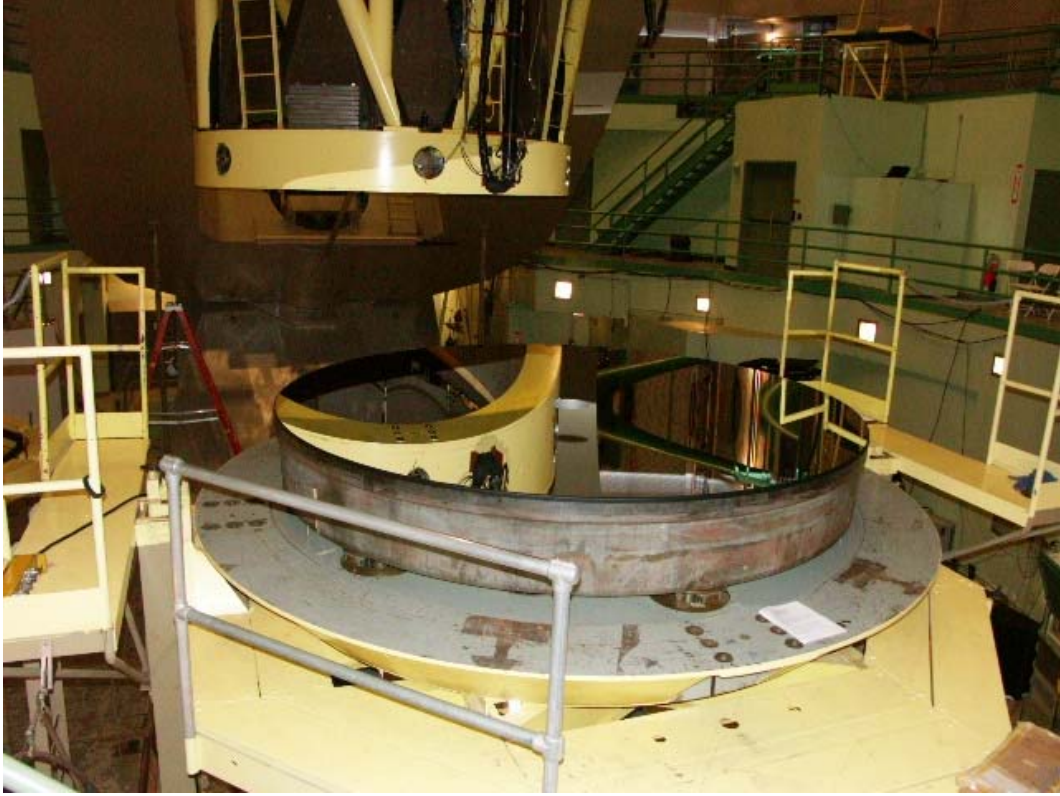
Once there, we put a new skirt of foil around it. We changed the procedure slightly in that we used black duct tape in place of the beige masking tape in direct contact with the mirror. This was because it had been hard to get the old tape off and it was thought that the fiber backing of the duct tape would make it come off easier (we anticipate having to remove more tape residue with acetone).

We noticed when we put corrugated cardboard around it that the cardboard shed lots of fibers onto the surface of the pristine mirror. It was never blown off, to my knowledge. We recommend finding an equivalent material that is lint-free, like a foam strip, perhaps.

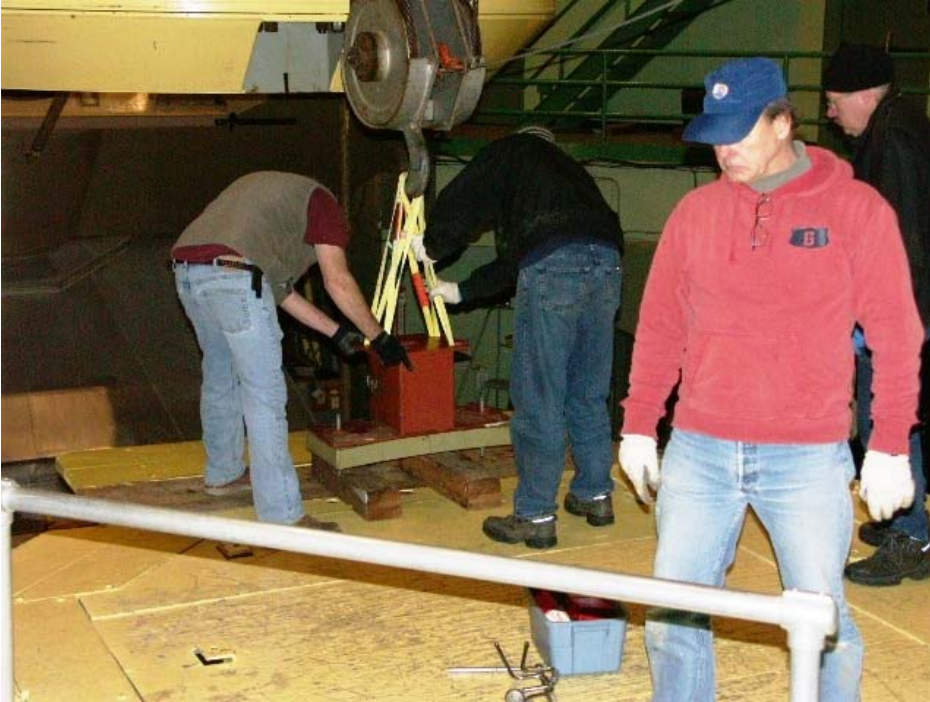
Four heavy weights were bolted to the mirror. For some reason, the southernmost one was put on first, separately from the others.

Later the other three were put on the platform. It was noted that the alignment marks for the weights had been painted over, so there was some pushing and pulling on the massive weights that was required to get them in to position. Next time the mirror comes out the positions of the weights should be re-marked before they are taken off. This will make replacing them much easier.

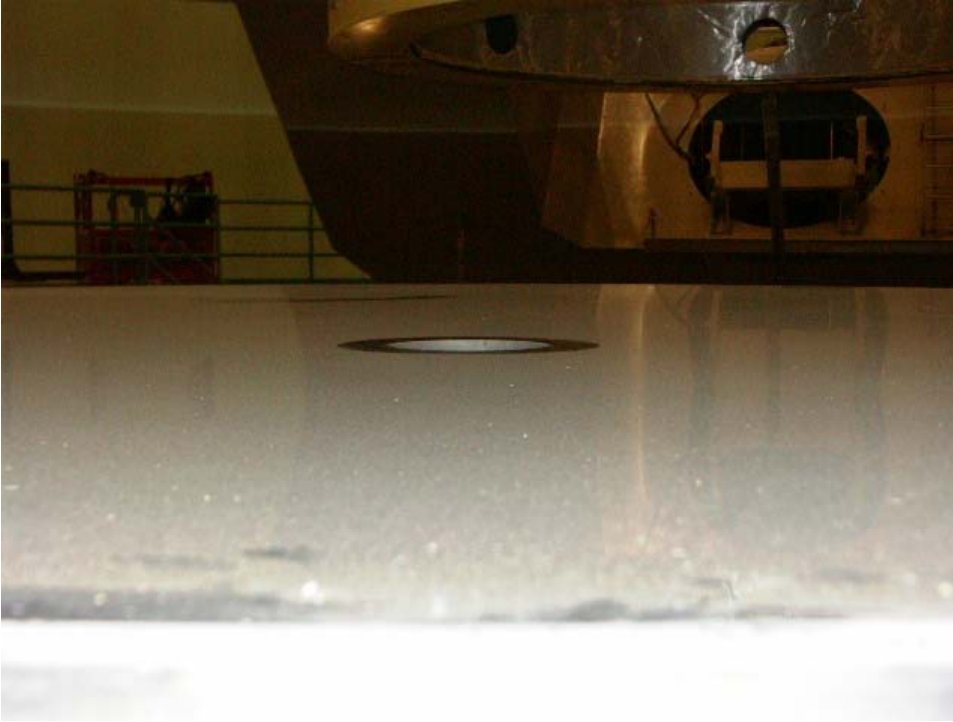
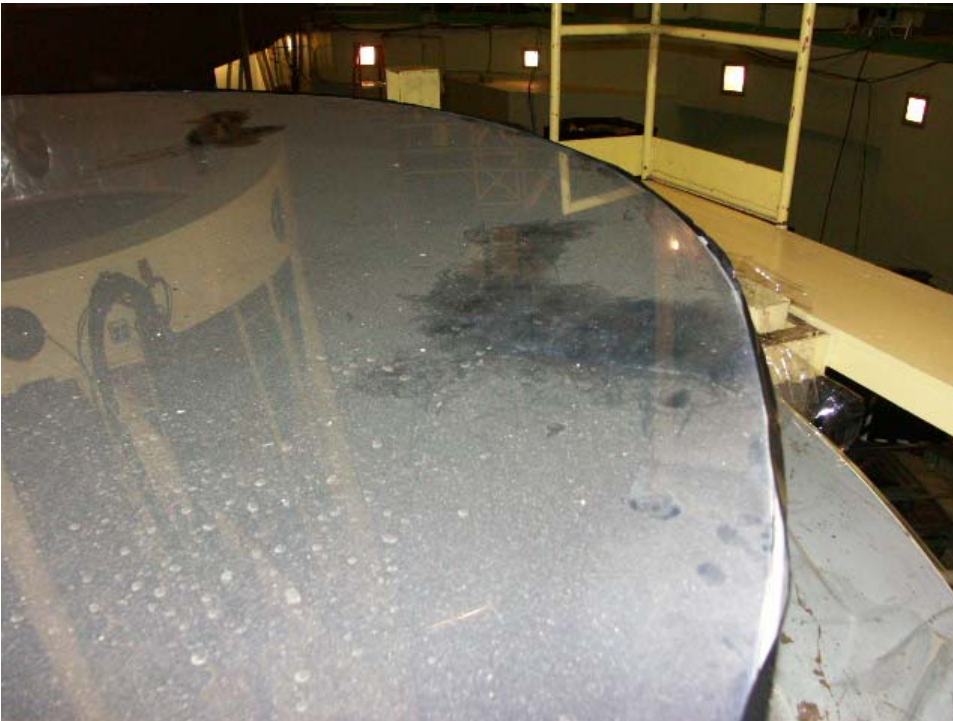
Addendum 2 – Original surface of mirror

The ring near the center was blocked by the “top hat” that goes in the center hole.
