Automated Planet Finder Primary Mirror Cleaning

David Hilyard, Jim Ward and Brian DuPraw

7/11/12

Automated Planet Finder

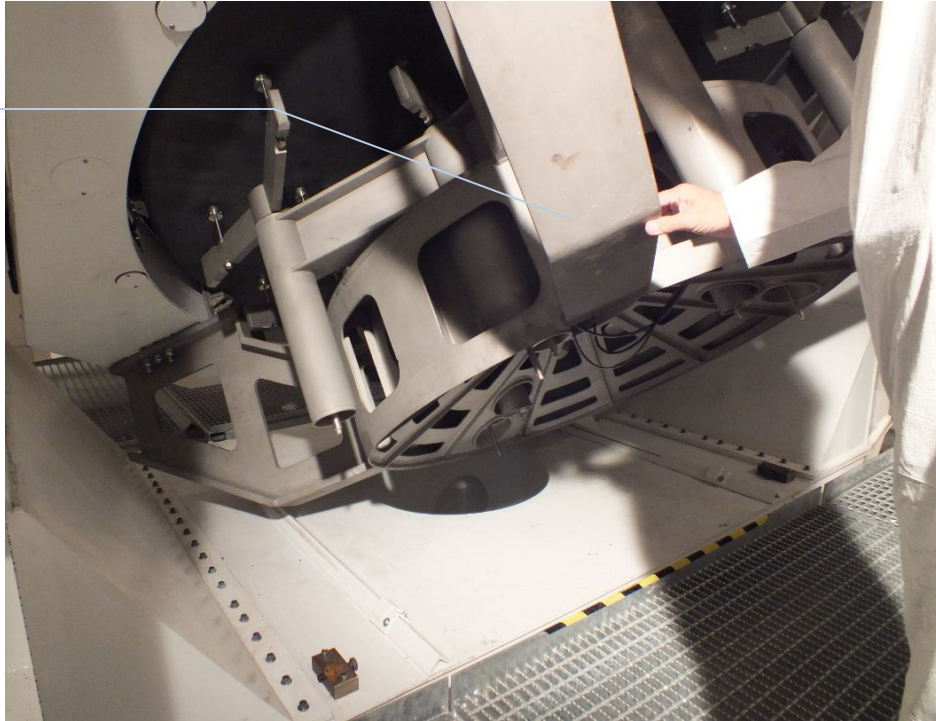
Tilting the telescope down from the back side

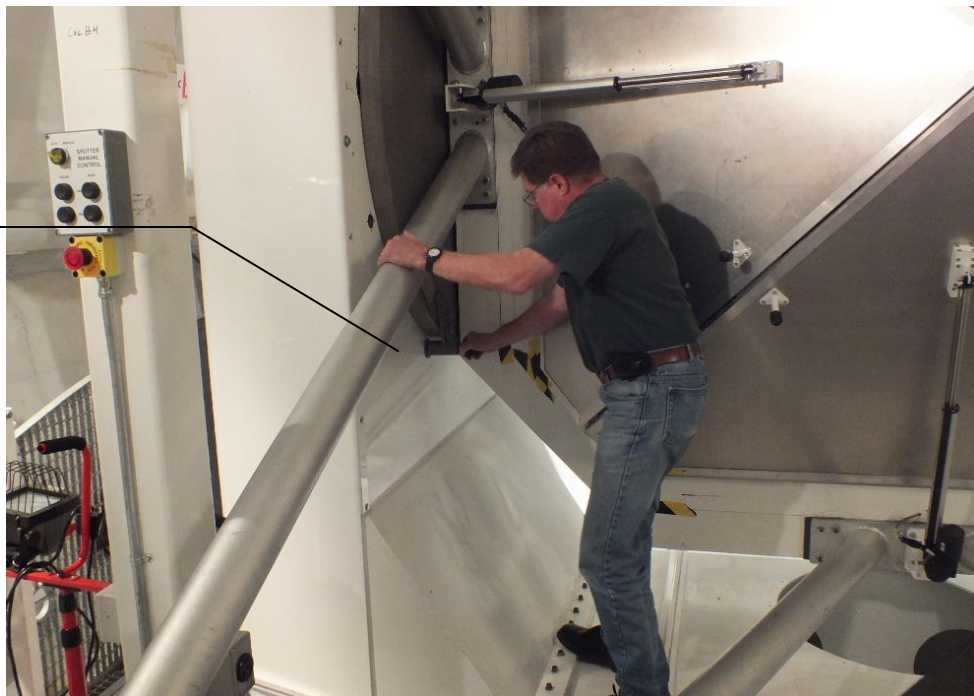
Pinning the telescope in horizontal position

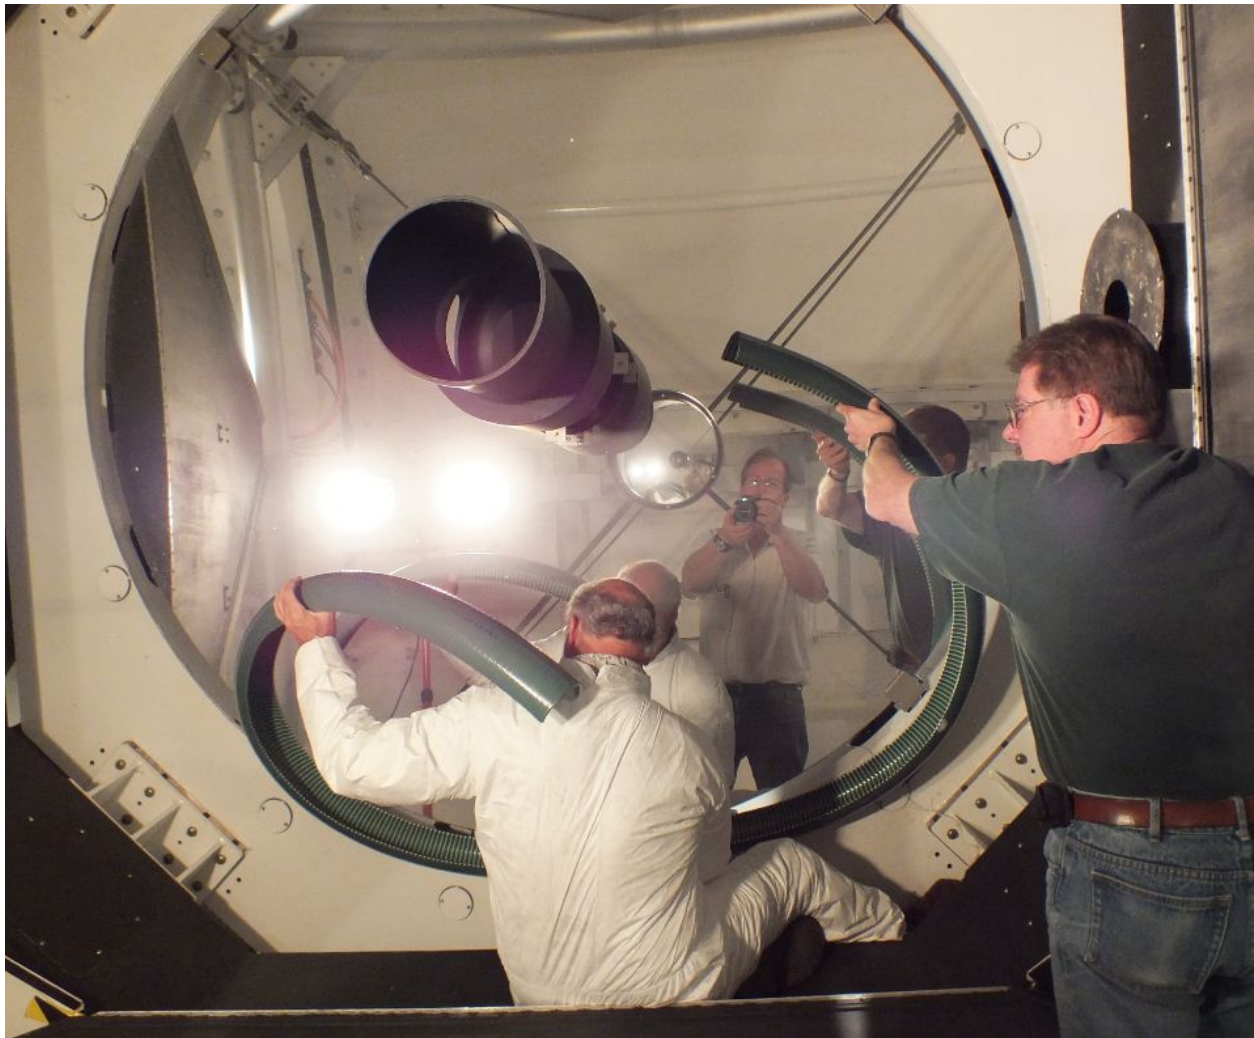
Before beginning the cleaning operation we test-fit the trough for future use, noting where the mirror mounting brackets and other things would require the trough to be modified in order to fit snugly to the mirror.

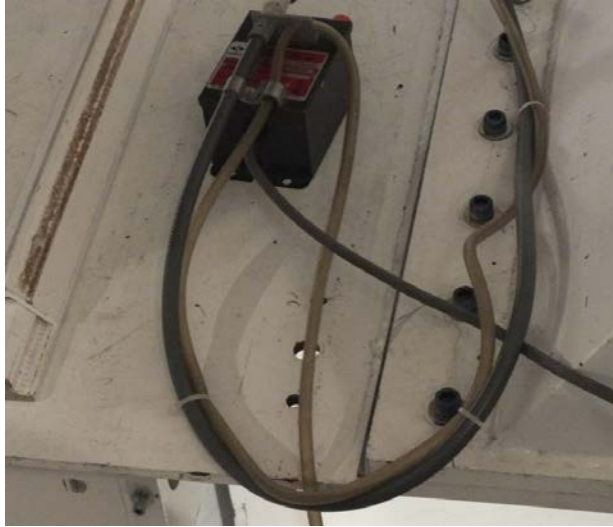
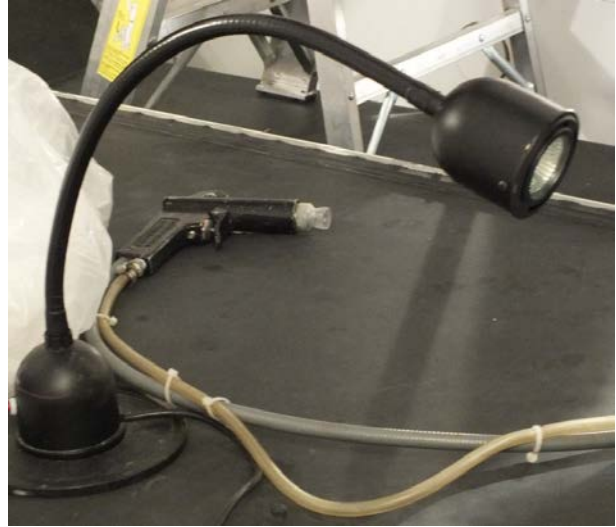
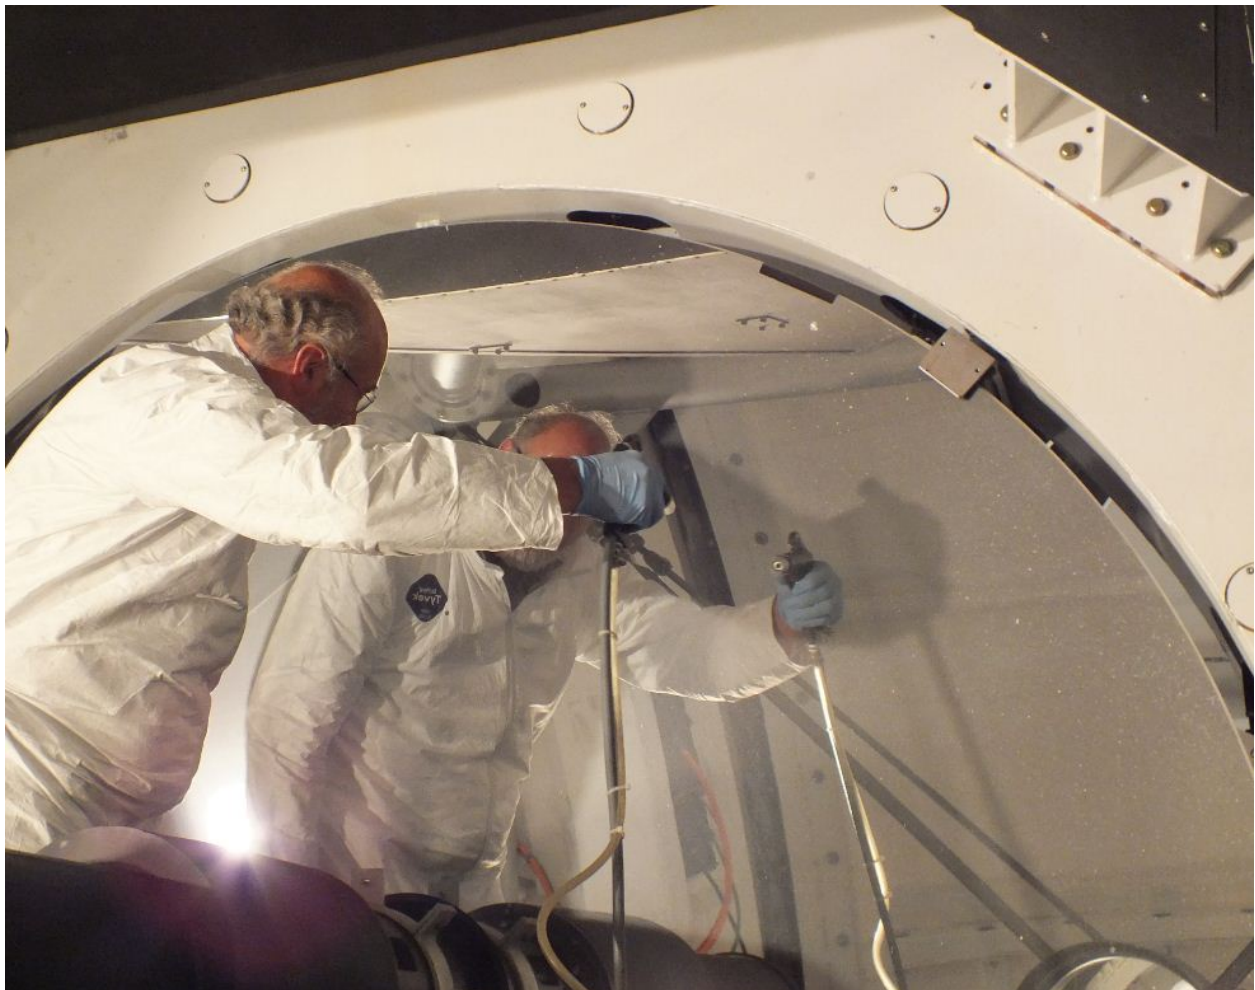
Once the dry nitrogen and its de-ionizing gun were set up Dave blew the primary off, starting at the top and working his way down, while Brian kept the hose away from the mirror. The pressure was limited to 50 PSI, where-as 80 PSI would have been preferable.

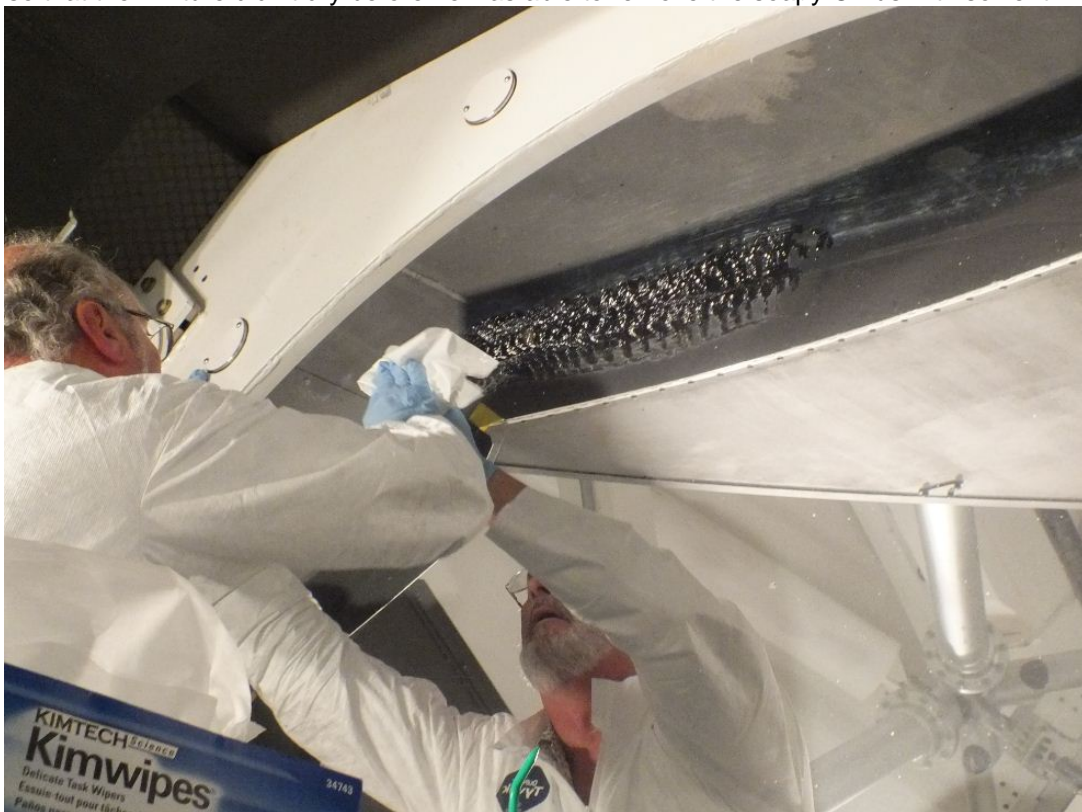
Dave's cleaning technique was to pat the surface with an Orvus/Acetone/H₂O mix, occasionally applying extra water from a spray bottle of distilled, de-ionized water. He worked an area of a couple square feet at a time, so that the mixture didn't dry before he was able to remove the soapy Orvus with solvent.

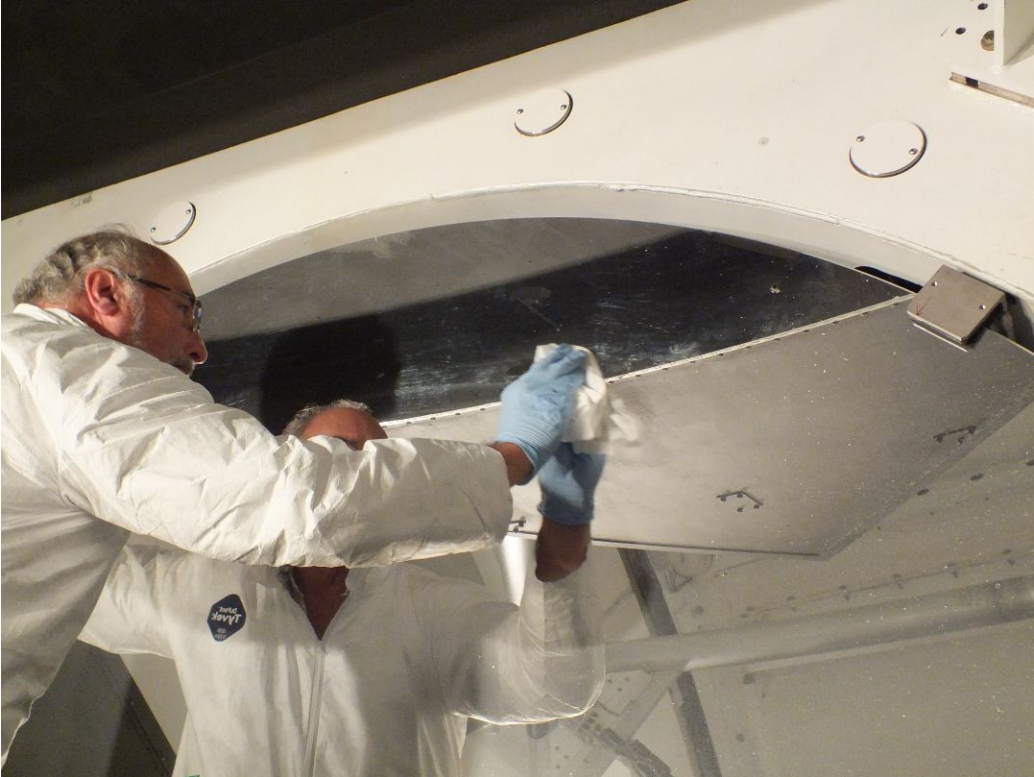
He removed the Orvus/acetone/H2O mix with pure acetone.

In this picture he had already cleaned the top 12" or so all the way across and another 9" – 12" on the left side.
