## Mt. Hamilton Optics Cleaning Trip 8/21/13

David Hilyard and Brian DuPraw

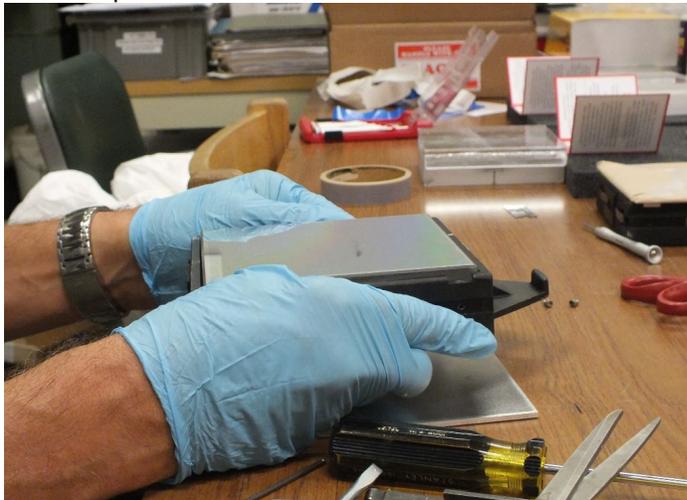
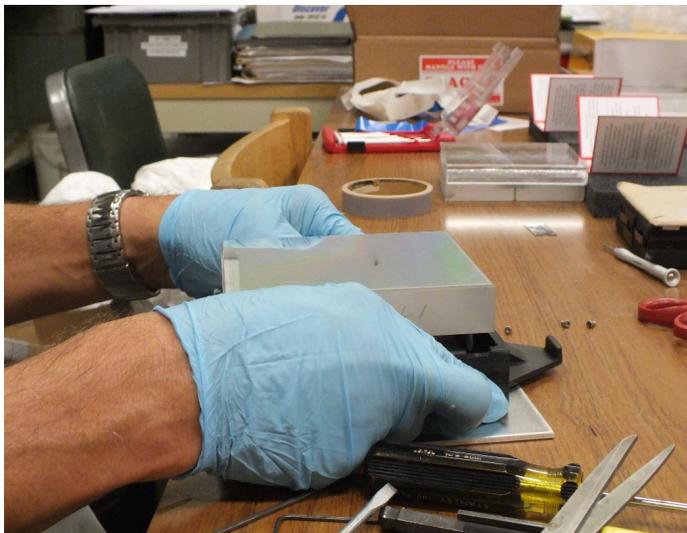
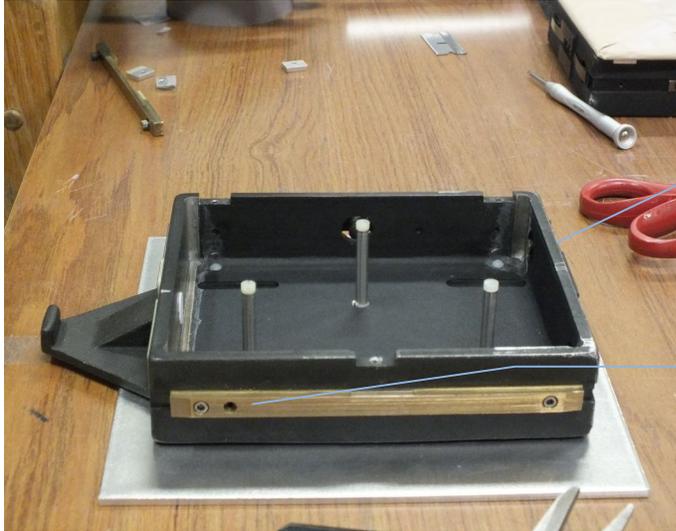
Grating removal jig and cell after grating was removed

Grating angle adjustment screw (one only)

Then he placed each cell on the jig and slowly and evenly lowered it, leaving the grating optic standing on the three posts.
